Landscaping of ASR-cracked retaining wall using HPFRCC shotcretes and observation over 5 years

ABSTRACT: High performance fiber-reinforced cementitious composites (HPFRCCs) were shotcreted onto an ASR-cracked concrete gravity retaining wall on a trial basis primarily for its landscaping. The width of cracks in the HPFRCCs was mostly limited to not more than 0.1 mm even 5 years after application, proving the expected effect of HPFRCCs. Within the range of this application, the effects of placing steel reinforcement and sealing cracks in the substrate concrete were not appreciable. Acrylic coating on the HPFRCC layer had an appearance-improving effect only for a short period.

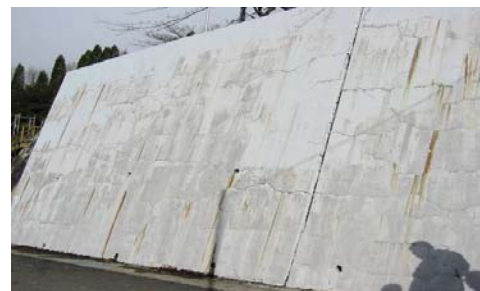
The structure under study is a concrete gravity retaining wall measuring 18 m in width and 5 m in height constructed in the mid-1970s. Since ASR-induced map cracking was recognized on this wall, crack injection and overlay were applied for repair in 1994. However, cracking reappeared on the surface by the time of a survey in 2002 carried out by the authors as shown in Figure 1.

Because of the past survey data and the map cracking of the wall, cores were drilled from the wall (80 cm from the bottom and 50 cm from the surface) to estimate the residual expansion of concrete by the JCI-DD2 method. Since the resulting residual expansion was 0.005 to 0.011%, it was judged that the future expansion of the retaining wall under study would be relatively small.

Figure 1. ASR-cracked concrete retaining wall.

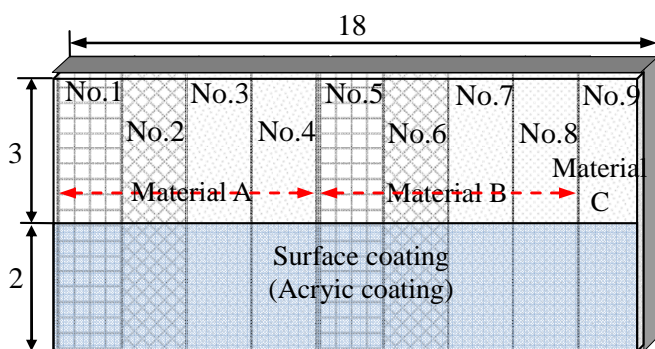
Figure 2. Blocks of different repair types on wall.

Figure 2 shows the blocks of different repair types on the retaining wall. Table 1 shows the repair mate

The nine repair types were combinations of three shotcretes (A, B, and C) and two steel reinforcement types (welded bar mesh and expanded metal), with or without sealing of cracks, each type being applied to nine different blocks. Each block measured 1.8 m in width and 5 m in height. In blocks with crack sealing, a one-can polyurethane sealant was applied to cover 30 mm-wide areas on cracks to a thickness of 5 mm, to provide bondless areas between the HPFRCC and wall concrete, so as to facilitate the distribution of fine cracks in the HPFRCC over the cracked areas. Two days after the application of shotcretes onto the blocks, a one-can acrylic coating compound was applied to an area across all blocks from the bottom edge of the repair area to a level of 2 m. It was anticipated that the expected cracks in the HPFRCCs would not damage the acrylic overcoat because of their small crack widths, thereby making such cracks scarcely visible from outside.

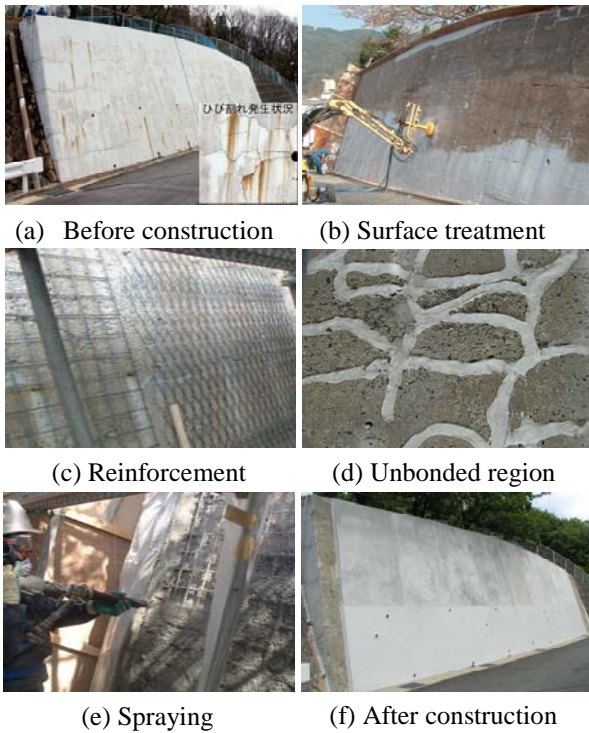
Figure 3. Shotcreting after surface treatment with water jet.

Figure 3 shows the state of shotcreting. Prior to shotcreting, the wall surface was chipped by a water jet to a depth of a few millimeters. The shotcretes were then sprayed to the surface after placing steel reinforcements and sealing the cracks (Blocks 4 and 8). HPFRCC shotcrete A was mixed using a geared mixer with a capacity of 320 liters and pumped with a snake pump for shotcreting. HPFRCC shotcrete B and shotcrete C were produced using a Hobart mixer with a capacity of 120 liters and pumped with a squeeze pump.

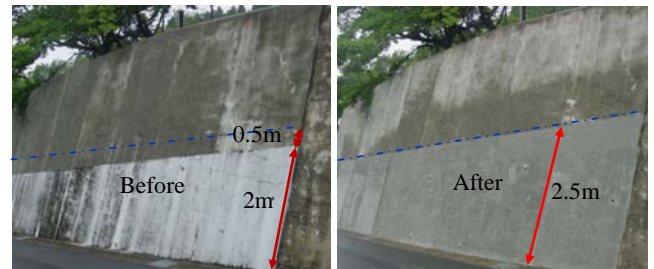
Figure 5. Appearances of wall before after water jet treatment.

In the acrylic-coated area 2 m from the bottom edge, such defective events as blistering, delamination, and cracking began to increase in the coating membrane 2 years after application. Delamination and cracks in the coating membrane became so apparent as to mar the aesthetic appearance by 4 years after application. The uncoated area also became so

dirty that cracks were difficult to define. For this reason, the area from the bottom edge up to a level 2.5 m above was cleaned with a water jet 4 years after application with the aim of improving the aesthetic appearance of the coated area and facilitate crack measurement. Figure 5 shows the appearances before and after treatment with a water jet.

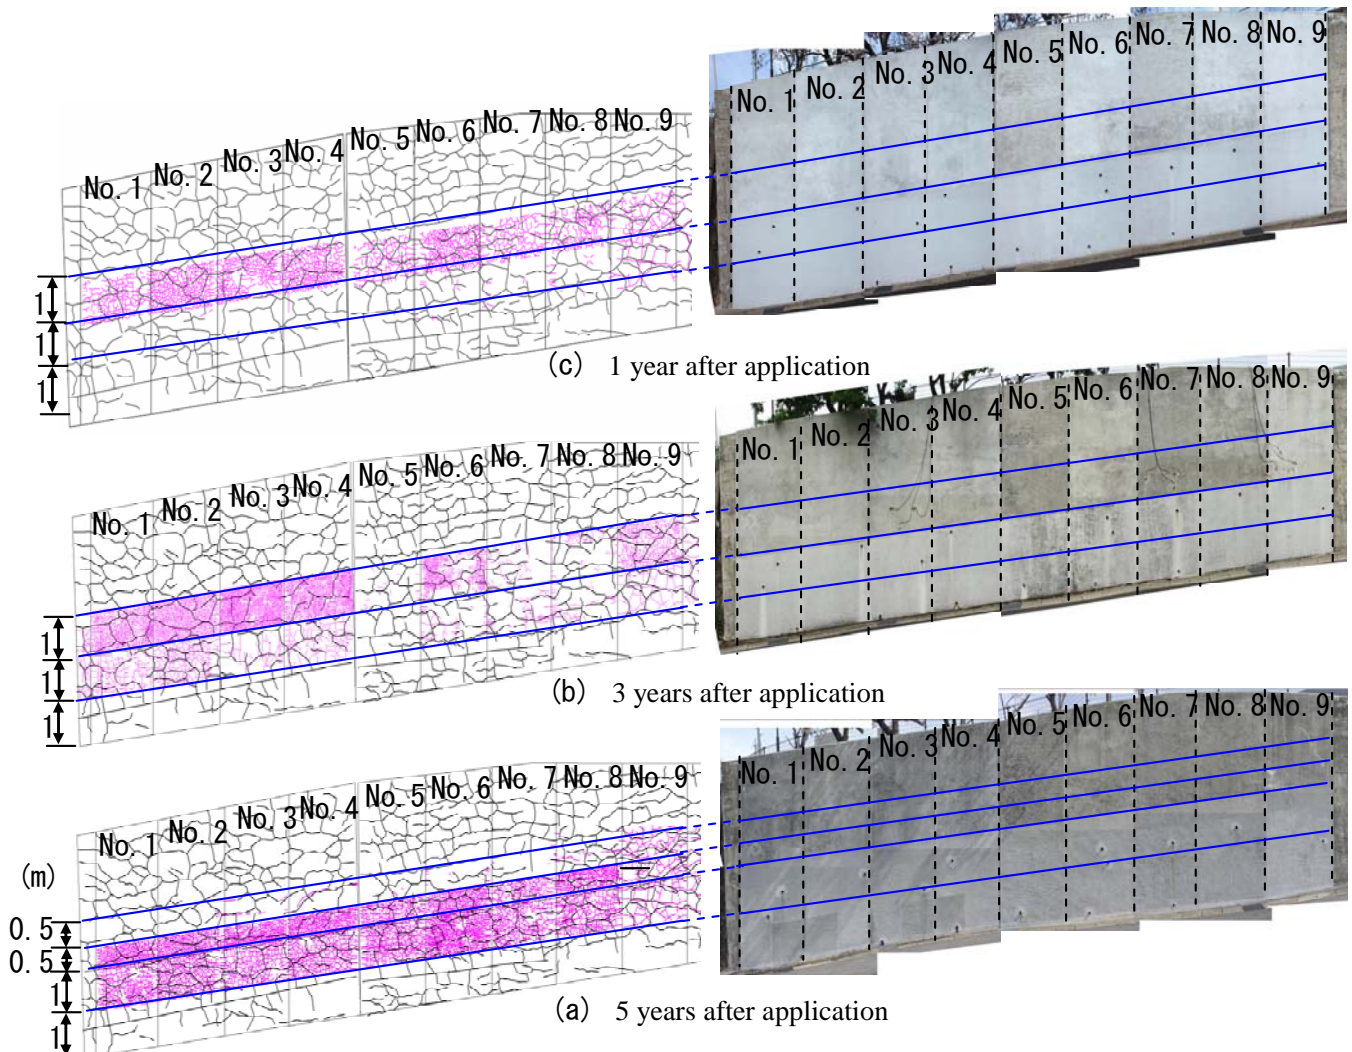
Cracks were marked with chalk in the range between 1 m above (uncoated) and 1 m below (coated) the level 2 m from the bottom edge. These marks were then photographed with a digital camera and made into a crack map by image analysis. Such a crack map was produced 1, 3, and 5 years after application. Figure 6 shows the appearances of the retaining wall surface and the crack maps.

Three years after application, larger numbers of cracks than 2 years before were found in the blocks repaired with HPFRCC shotcrete A (Blocks 1 to 4) and shotcrete C (Block 9). In the blocks repaired with HPFRCC shotcrete B (Blocks 5 to 8), however, the numbers of cracks were smaller than those 2 years earlier. This is presumably because in shotcrete B with a higher fiber content than shotcrete A, more fibers were exposed to the air, being more prone to surface contamination with dust and microbes in the atmosphere, which hid most cracks on the surface of shotcrete B. This can also be inferred from the color

Figure 6. Appearances of wall surface and crack maps.

of shotcrete B, which was darker than those of other shotcretes (Fig. 6 (b)).

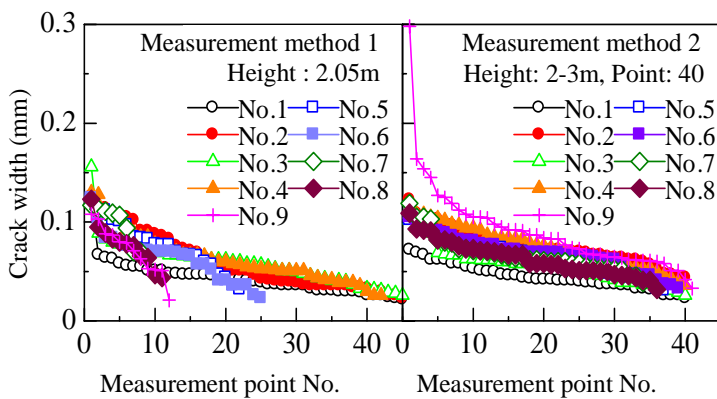
(a) Comparison between measurement methods.

Figure 7(a) shows the results of crack width measurement 2 years after application by methods 1 and 2. The cracks in blocks repaired with HPFRCC shotcretes A and B (Blocks 1 to 8) were 0.1 to 0.15 mm in width at the largest, mostly being fine cracks with a width of less than 0.1 mm. In Block 9 repaired with shotcrete C, the crack width measurements were similar to those in HPFRCC-repaired blocks by Method 1, but the maximum crack width was around 0.3 mm by Method 2, with the width of more than 40% of the cracks being not less than 0.1 mm. The difference of the measurement method may have affected the crack width measurements of shotcrete C, which partially contained large cracks. While Method 2 can emphasize large crack widths, the selection of cracks is subject to the operator's arbitrary decision. It was therefore decided to adopt Method 1 for measurement 3 and 5 years after application. Note that shotcrete C included apparent "through cracks" showing traces of water leakage from the backside.

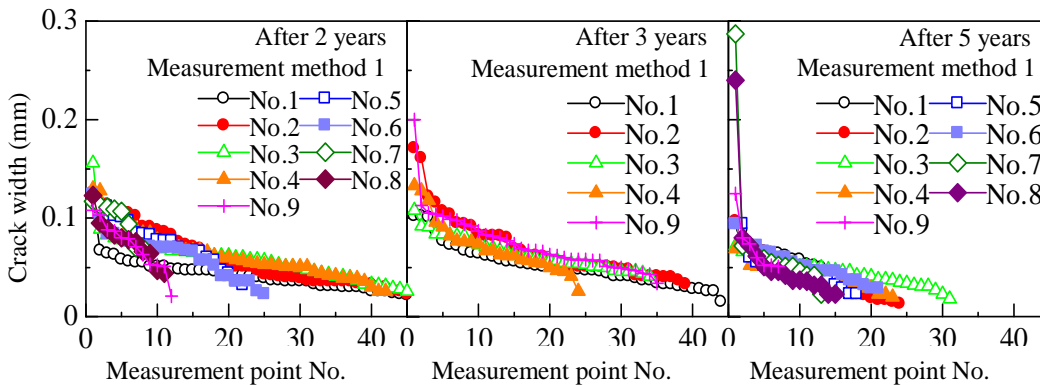
(b) Changes in crack width over time.

Figure 7(b) shows the changes in the crack width over time measured by Method 1 on a horizontal line 900 mm in length from the left edge of each block at a level of 2.05 m. Since it was difficult to measure the crack width in Blocks repaired with HPFRCC shotcrete B (Blocks 5 to 8) due to contamination, only crack widths in blocks repaired with shotcretes A and C (Blocks 1 to 4 and Block 9) were measured 3 years after application. Five years after application, however, the crack widths of all blocks were measured, as surface contamination was cleaned with a water jet a year earlier.

No increase in the crack width over time was observed in all shotcretes, with most crack widths remaining around 0.02 to 0.1 mm. Figure 7(b) shows no large crack widths in shotcrete C, because no large local cracks were included in the measurement range.

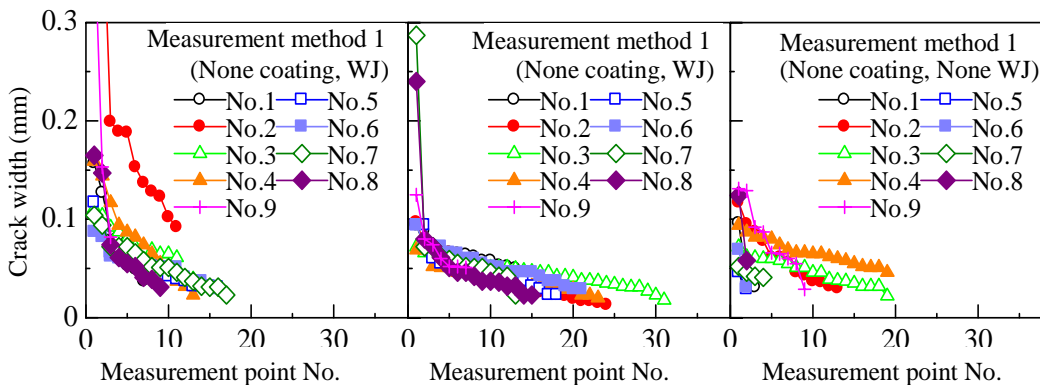
(c) Acrylic overcoat and changes in cracks over time.

Figure 7(c) shows the results of crack width measurement in (a) coated areas cleaned with a water jet (along the line at a level of 1.95 m); (b) uncoated areas cleaned with a water jet (along the line at a level of 2.05 m); and (c) uncoated areas not cleaned with a water jet (along the line at a level of 2.55 m).

As stated above, the crack widths in coated areas tended to be greater than those in uncoated areas. In areas uncoated and not cleaned with a water jet, the widths of most cracks were less than 0.1 mm regardless of the shotcrete type. In regard to HPFRCC shotcretes A and B, this may be because the cracks were measured narrower because of being blocked up with microbes and dirt. In regard to shotcrete C, this may be because large cracks were outside of the measurement range by the adopted measurement method. The fact that crack width measurement in shotcrete C is affected by the measurement method is also recognized in the graphs for uncoated and uncleaned areas in Figure 6, in which few cracks are visually observable in shotcretes A and B, whereas many cracks are observed in shotcrete C. Thus cracks in shotcrete C should have been observed over a wider range.

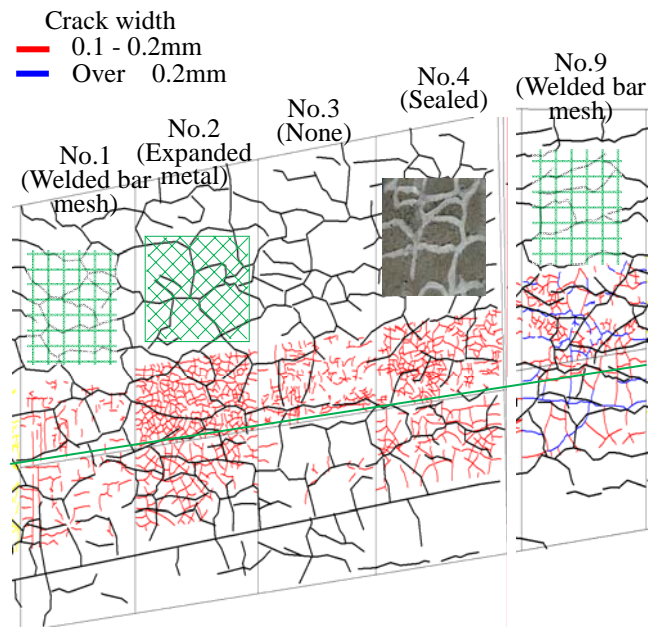
Figure 8. Effects of steel reinforcement and crack treatment.

Figure 8 shows crack maps of HPFRCC shotcrete A and shotcrete C 3 years after application. Only large cracks judged as being 0.1 mm or wider by a crack scale are shown in the figure. As is seen from Blocks 1 and 9 having welded bar mesh, when repaired with shotcrete C, cracks with a width of 0.2 mm or more occur in the shotcrete directly above the underlying cracks in the retaining wall concrete, while smaller cracks 0.1 to 0.2 mm wide developed between these wider cracks. When repaired with HPFRCC shotcrete A, no cracks related to underlying cracks were found, but predominant cracks ran in the vertical and horizontal directions at intervals similar to those of the embedded welded bar mesh. When reinforced with expanded metal, cracks resembling the mesh shape developed. Though steel reinforcement was placed to finely distribute cracks in the HPFRCCs, its effect was not appreciable partly because of the small tensile deformation of the HPFRCC layer.

In Block 4 where the cracks in the retaining wall concrete were sealed beforehand with a sealant, the number of cracks with a width of 0.1 mm or more exceeded that in Block 3 having no steel reinforcement. This tendency was clearer in the area coated with acrylic. Though cracks in the retaining wall were sealed beforehand with the aim of finely distributing cracks in the HPFRCC, the effect of sealing turned out to be not clear partly because of the small tensile deformation of the HPFRCC layer similarly to steel reinforcement.
