A study on re-deterioration of surface-coated sluice structures due to frost damage

I. Naitoh & F. Taguchi

Civil Engineering Research Institute, Sapporo, Japan

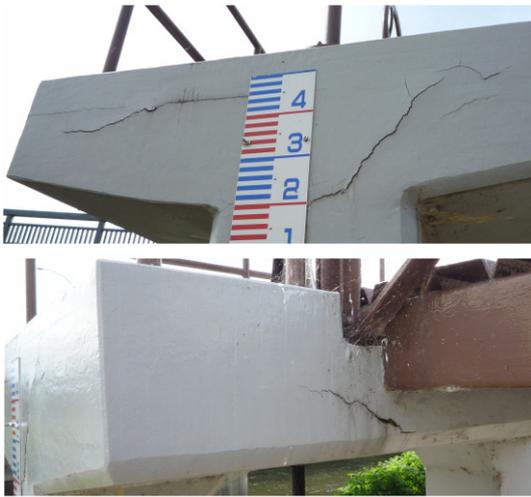
Photo 2. Re-deterioration status.

The sluice structure for which the study on re-deterioration was conducted was constructed in 1961 in Shibetsu City in the Kamikawa region. It was repaired in 2003, 42 years after its construction, using a combination of acrylic resin Patching material and Surface coating material, but cracking was observed 18 months after the repair as shown in Photo 2.

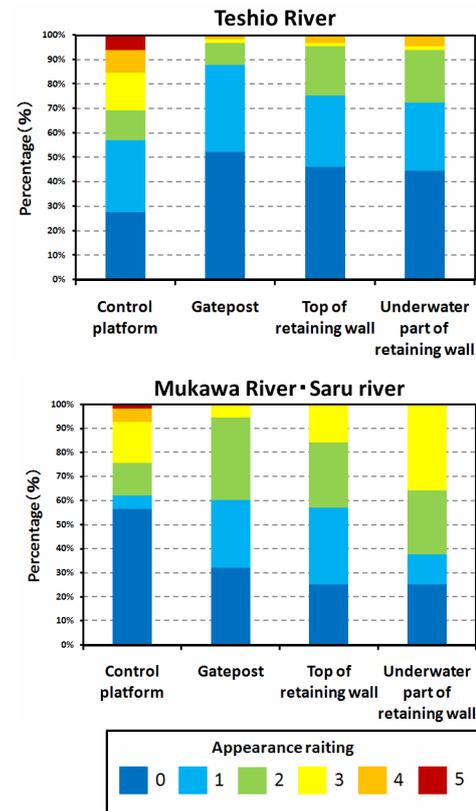
Figure 5. Appearance rating of river sluices by part.

Figure 5 shows the results of appearance rating by section based on external visual inspection, and Figure 6 shows the results of control platform appearance rating by the number of in-service years. By part, the control platform rating was generally the highest, followed by the underwater part of the retaining wall, the top part of the retaining wall and the gatepost. Control platform frost deterioration was especially severe, with a rating of up to 5 in some cases. Since control platforms have a shape on which snow is likely to accumulate and their structure is relatively thin, they are more susceptible to the influence of freeze-thaw action caused by the retention of snowmelt and other factors. Conversely, gateposts are not susceptible to freeze-thaw action as they stand behind control platforms and are minimally exposed to snow accumulation and sunlight. It was found from this that parts directly affected by water supply are also affected significantly by freeze-thaw action, and that the degree of deterioration found in them increases.

By region, the ratio of parts rated three or higher was generally greater on the Mukawa and Saru rivers than on the Teshio River, although no ratings of four or higher were observed except for control platforms. Conversely, while some gateposts and retaining walls were rated four on the Teshio River, the ratio of lower ratings was generally higher compared with those of the Mukawa and Saru rivers. Looking at the number of in-service years, ratings tended to be higher for structures that had been used for 20 years or more on the Teshio River and for 30 years or more on the Mukawa and Saru rivers. It can therefore be said that frost deterioration progressed faster and its degree tended to be greater in the Kamikawa region, while the phenomenon tended to

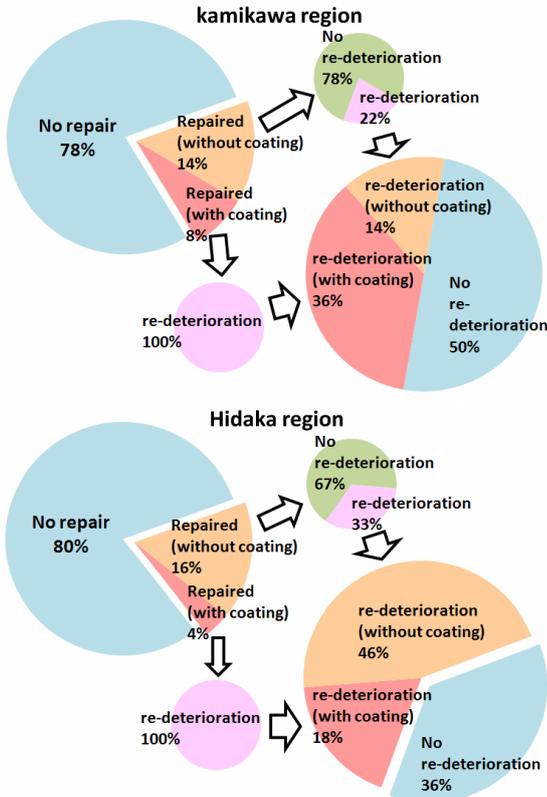
Figure 7. Repair and re-deterioration rates.

occur regardless of part types in the Hidaka region, although the progress of deterioration there was slower and no significant deterioration was observed. Figure 7 shows the repair and re-deterioration rates in the two regions. While the repair rate was around 20% in both, re-deterioration occurred in more than half of the sluices after repair. It also occurred in all surface-coated sluices in both regions.

These results indicate problems regarding the durability of existing repairs in cold, snowy environments.

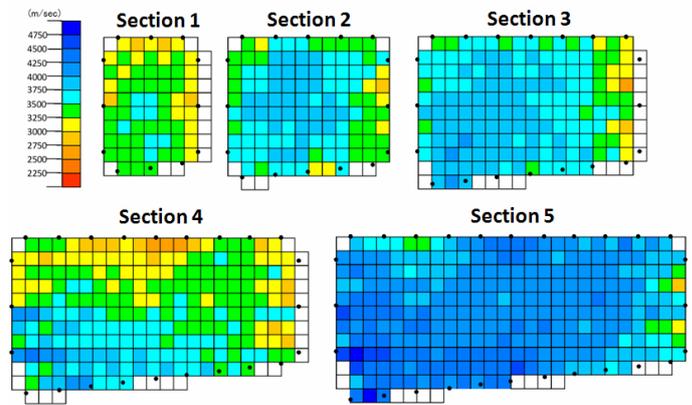
Figure 8. Velocity distribution on each cross-section as found using the tomography method.

Figure 8 shows Ultrasonic Propagation Velocity distribution in Sections 1 to 5 as found using the tomography method. Since the velocity was generally lower on the outside than on the inside and the distribution is round at the corners of each cross-section, it was presumed that Patching was conducted for defective corners. As such defects represent a type of deterioration peculiar to frost damage, it can be assumed that frost deterioration had occurred in Matrix

before repair. It can also be seen that the defect on the west side was slightly deeper and larger in area than that on the north side. This was probably because of the greater influence of freeze-thaw action due to the more abundant sunlight on the west side. In addition, the velocity became very low in a V-shaped part on the top side of Section (4), indicating an internal defect in the vicinity. However, there were generally no clear differences in velocity between the repair material and the deteriorated parts of the matrix.

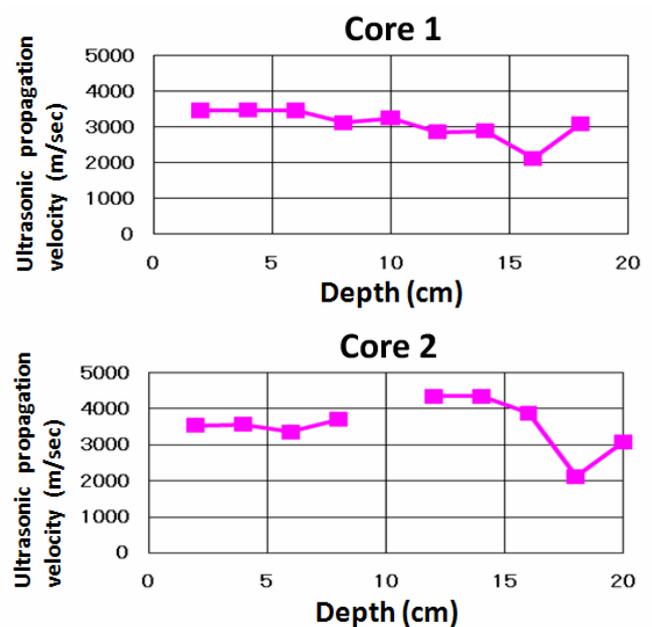
Figure 9. Ultrasonic Propagation Velocity of cores as found using the penetration method.

Figure 9 shows the velocity results for collected cores as assessed using the penetration method. Patching material thickness was around 10 cm and Patching material velocity was around 3,500 m/sec for both cores 1 and 2. While the velocity of concrete is generally 3,500 m/sec or higher, the value was a little higher than 2,000/sec in some parts of Matrixes of both cores, indicating partial deterioration. Since these sections are positioned similarly to the deteriorated part on the top side of Section (4)

where the velocity was low, it was found that the position of internal deterioration can be identified to a certain degree using the tomography method. These results indicate that the internal state and degree of deterioration under Surface coating material can be roughly determined by Ultrasonic Propagation Velocity Measurement, and the technique's validity as a frost deterioration diagnosis method was confirmed.

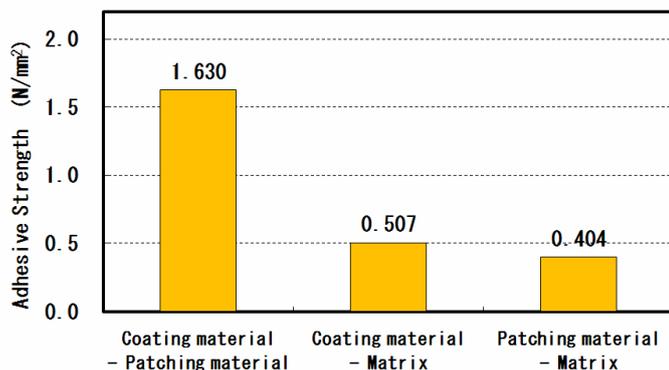
Figure 10. Adhesive Strength.

Figure 10 shows Adhesive Strength test Method results. Adhesive Strength between Surface coating material and Patching material was 1.630 N/mm^2 . The catalog standard value is 1.5 N/mm^2 or larger. Since NEXCO's (Nippon expressway Company) quality standard (JHS-416) (NEXCO.2004) for Patching materials (known as the common reference values for Adhesive Strength in Japan) specifies Adhesive Strength between Surface coating material and Patching material as 1.0 N/mm^2 or higher and that between Patching material and concrete as 1.5 N/mm^2 or higher, Adhesive Strength assessed in this study can be considered sufficient. However, Adhesive Strength values between Surface coating material and Matrix and between Patching material and Matrix were very low (0.507 and 0.404 N/mm^2). In these sections, fracturing occurred in the deteriorated Matrix but not in the adhesive surface with Matrix, as shown in Photo 3. Since external influences had been blocked until cracking in Surface coating material occurred 18 months after the repair, deterioration in sound Matrixes was unlikely at the post-repair stage. Accordingly, it was highly likely that the deteriorated parts of Matrix remained at the time of repair.

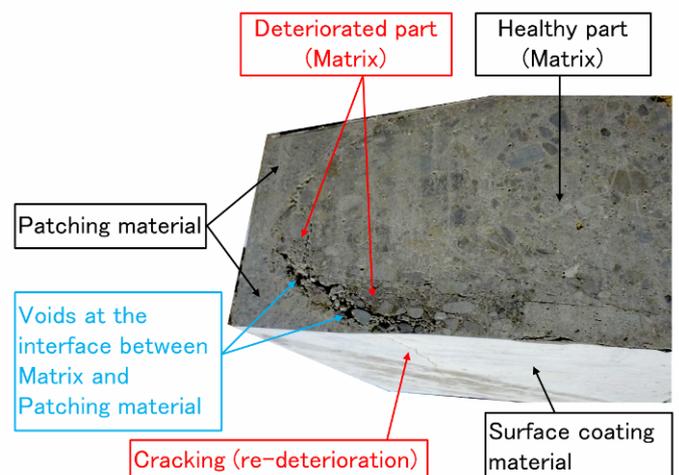
Photo 4. Cross section of the control platform.

Photo 4 shows a cross section created by cutting part of a control platform. Cross-sectional repair using a Patching material had been conducted for the inside of the defective Matrix, and Surface coating material had been applied to the surface. This corresponded roughly with the internal state found in the above-mentioned analysis using the tomography method.

Since voids were observed near the interface between Matrix and Patching material, it was also presumed that deterioration in Matrix near the interface progressed and cracking occurred in Surface coating material at the bottom. This result also supported the outcomes of Adhesive Strength Test Method. Since the repair of this sluice structure was conducted in winter, it is highly likely that removal of the deteriorated part of Matrix was incomplete in the surface preparation before the repair, and that Patching material and Surface coating material were applied while moisture from snow accretion and other sources was still present

inside the voids of the remaining deteriorated part. Accordingly, it is presumed that the progress of frost damage due to moisture retention in the deteriorated part of Matrix caused early re-deterioration, and that the cracks in Surface coating material caused by such deterioration let in more water, thereby accelerating frost deterioration.
