# Mistakes in diagnostics and rehabilitation of concrete structures

**ABSTRACT:** The paper describes frequent mistakes in diagnostics and rehabilitation of building structures which will be demonstrated on a real reinforced concrete conduit in Wastewater Treatment Works. Primary diagnostics of damaged reinforced concrete constructions is over and over again ignored and this situation brings about subsequent unsuitable choice of reconstruction techniques. Together with poor method of execution, the structure rehabilitation became much more expensive and at the end the final result could cause much more serious problems and damages of concrete structure. Nowadays the reinforced concrete discharge conduit which was rehabilitated in 2001 is again in critical condition. Today condition of mentioned construction requires another and much more expensive renewal in relatively short time.

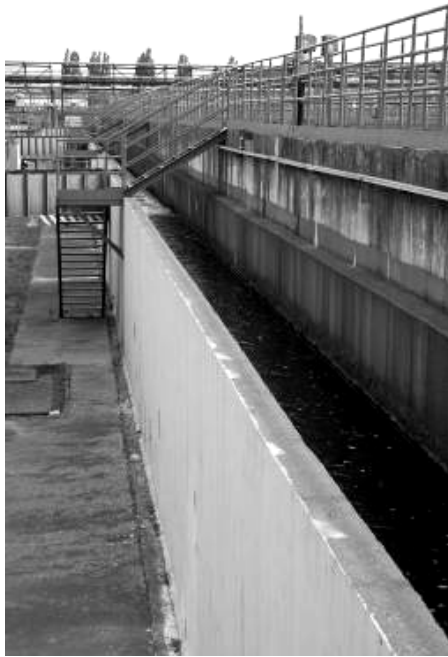
Figure 1. Reinforced concrete discharge conduit from final setting tanks.

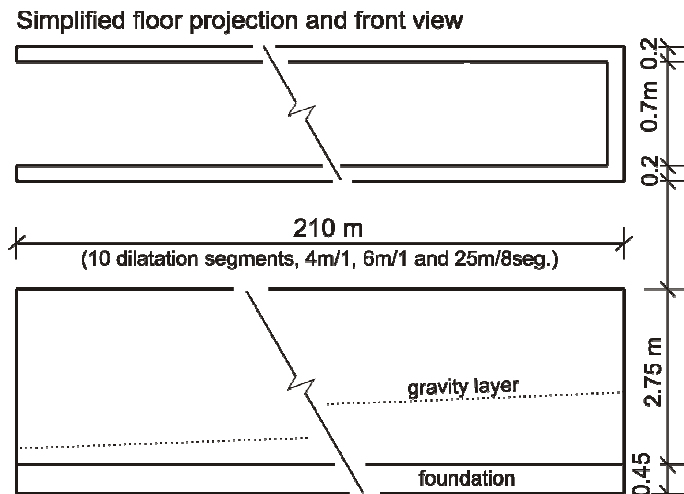
We will focus only on the part of WTW that is at the very end of water treating process – the discharge conduit from final setting tanks. This reinforced concrete discharge conduit is divided into ten dilatation segments. (Fig. 1a).

Figure 1a. Simplified floor projection and front view of the discharge conduit.

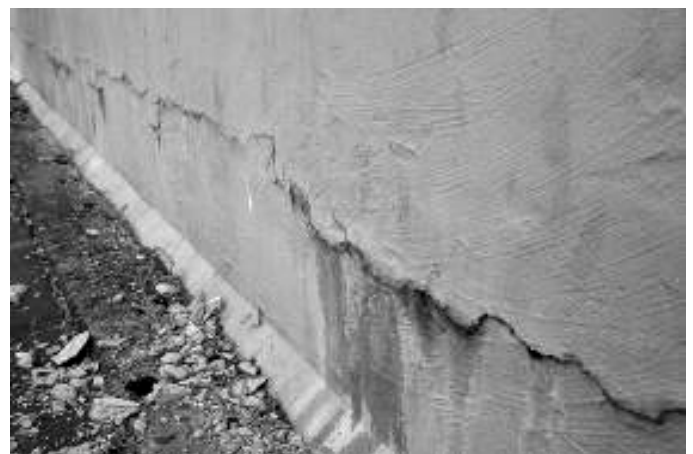
Figure 2. Front face of discharge conduit construction. Detail of crack between foundation and construction of discharge conduit.

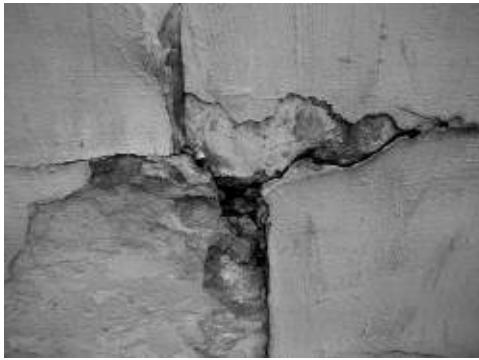
Figure 3. Surface of the wall structure No. 1, external surface. Crack near the dilatation joint, connection of foundations and conduit structure.

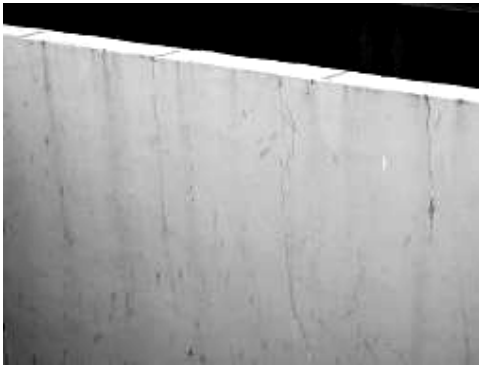
Figure 4. Front face of discharge conduit construction. Vertical cracks from the top to the bottom.

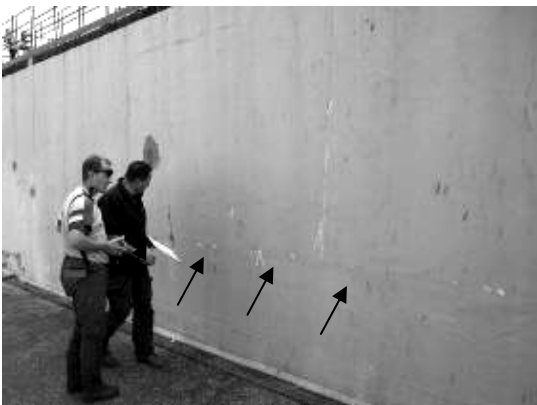
Figure 5. Horizontal crack close to the sealing plate at the height of cca. 700 mm. The crack crosses the entire structure of the conduit.

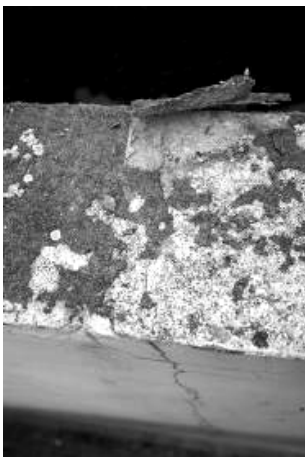
Figure 6. (left) Detail of the top of the conduit wall with corrupted protective coating and typical vertical crack that goes through the whole thickness of the wall.

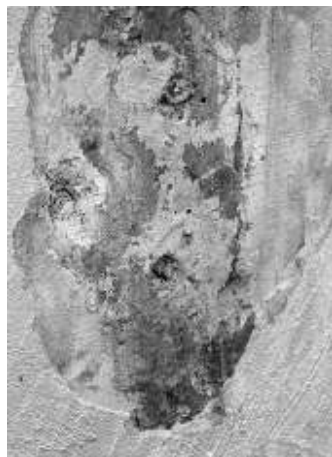
Figure 7. (right) Detail of the injected place – cracks where water from the discharge conduit penetrates again.

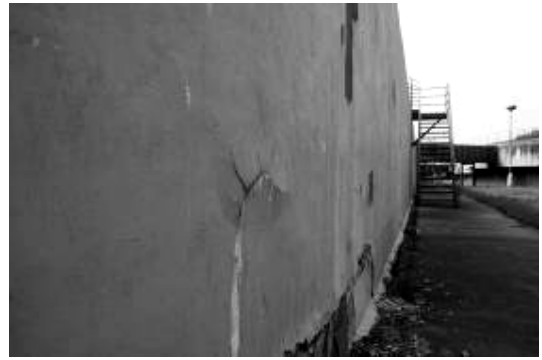
Figure 8. Typical separation of renovation plaster on the front wall of the conduit.

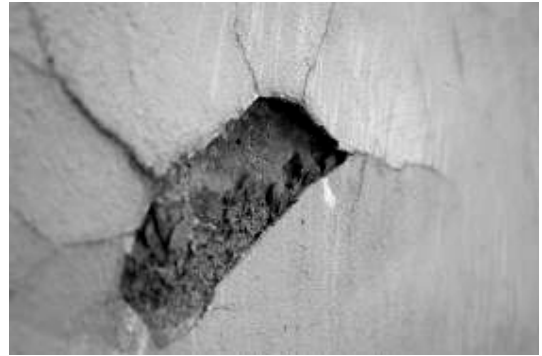
Figure 9. Detail of degraded repair mortar.

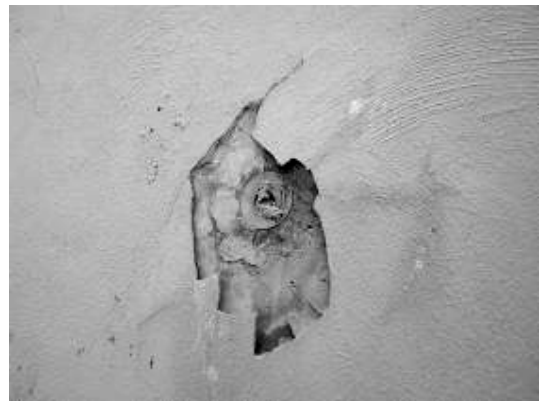
Figure 10. Typical place with left formwork spacer. Water leaks and concrete degrades near the spacer and spacer sealing area.

The area of the guards is now largely filled up with the water or the water flows around the guard body from its outside part (Fig. 10). In the rehabilitated structure, remains of timber formwork have been found – that

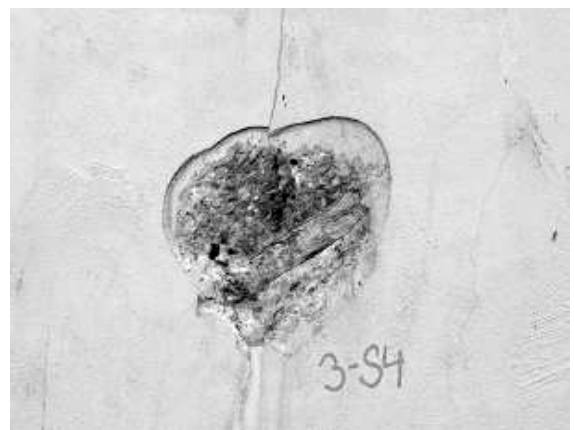
Figure 11. Detail of the place where some formwork was left during construction of the discharge conduit.

formwork was used when concrete was cast into the discharge conduit structure. This is also a proof for poor quality of construction and sluggish approach to the rehabilitation. Timber elements have been found out in places where the plaster peels off on the surface of the concrete. Moisture creeping of the timber caused the surface of concrete to peel off (Fig. 11).

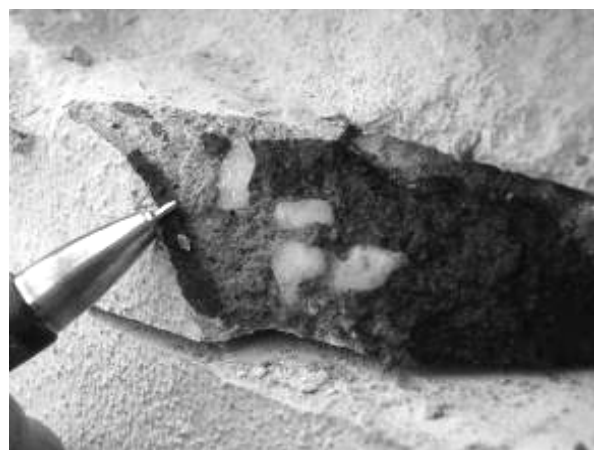
strength of the upper layer of the concrete bed – it is too low and the measure values do not reach the minimum of 0.8 MPa, the average being less than 1.1 MPa. The reason is, in particular, lack of technology discipline during the previous rehabilitation when little attention only was paid to pre-treatment of the surface. General chemical tests were conducted in order to find the depth of concrete carbonation in individual dilatation sections of the discharge conduit. It has been found out that the carbonation reaches the depth down to about 12-25 mm. The cohesion of the protective barrier coating on the inside of the discharge conduit does not meet requirements of TP SSBK II either. The strength of the protective barrier coating should be higher than 0.8 MPa.

Figure 13. Repair materials were applied on carbonated layer of concrete.

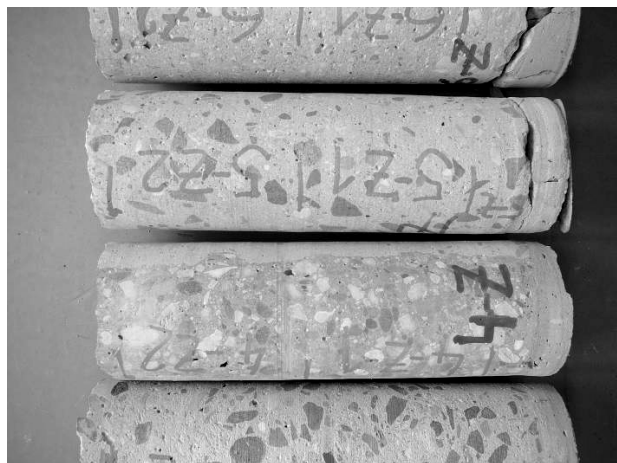
During inspection, locations for core tests were chosen in the structure of the discharge conduit. In order to check the strength of the concrete were totally taken 47 core samples – 9 samples from foundation, 30 from the discharge conduit construction (10 samples in fissures direction) and 8 from gravity layer of the discharge conduit. In cracks, the core samples revealed the depth and direction of the cracks. A drill bit, 100 mm dia., was used to take the core samples. It follows from visual inspection of the core test samples that the concrete originated from two different concrete mixing plants. Differences are clearly visible for coarse gravel aggregate with the grain size above 8 mm: one concrete mixing plant used pre-crushed gravel aggregate, while the other one used crushed gravel aggregate. In some core test samples, the gravel aggregate with the size exceeding 8 mm was not found (Fig. 12).

Figure 12. Core samples and visible differences in used aggregate.

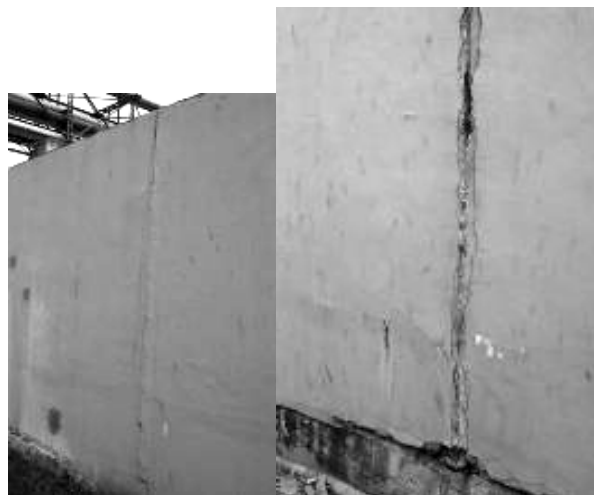
A lot of problems in extensive concrete structures result from the failure to perform well and correctly dilatation sections of the structure. Consequently, the concrete degrades because of tension resulting from movement of individual sections. In this case, the vertical dilatation sections of the discharge conduit were constructed in line with documentation but no attention was paid to the section during application of the renovation plaster. The dilatation sections were covered with the repair mortar that, of course, peeled off soon.

Figure 14a and 14b. Vertical dilatation joint were covered with repair mortar (14a). Typical result of thus rehabilitation is shown on the right (14b).
