REPAIRING OF SHORT REINFORCED CONCRETE CORBEL BY BONDING COMPOSITE MATERIAL UNDER CONTINUOUS LOAD

I. IVANOVA^{*}, J. ASSIH[†] AND D. DONTCHEV^{††}

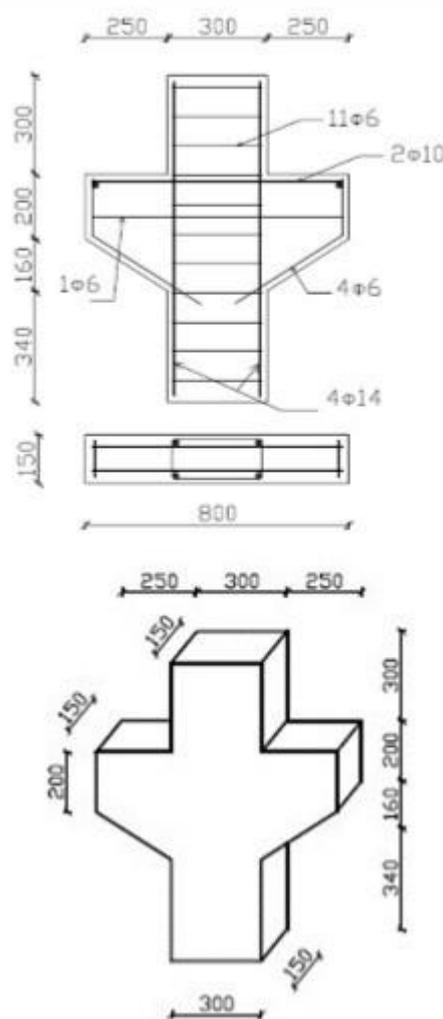
Figure1: Reinforced steel and geometry

strengthened) and three (one without strengthened and two strengthened) are tested under dynamic test by cyclic loading. All reinforced concrete corbel specimens had the same dimensions and are strengthened in the same way detailing, see Figure 1. Steel bars, S500 are used of different diameters: 6, 10, 14mm. The column supporting the two short trapezoidal corbels cantilevering on either side was 150 by 300mm² in cross section and 1000mm long. Reinforced concrete corbels had cantilever projection length of 200mm, with thicknesses of 150mm at both faces of column and the free end.

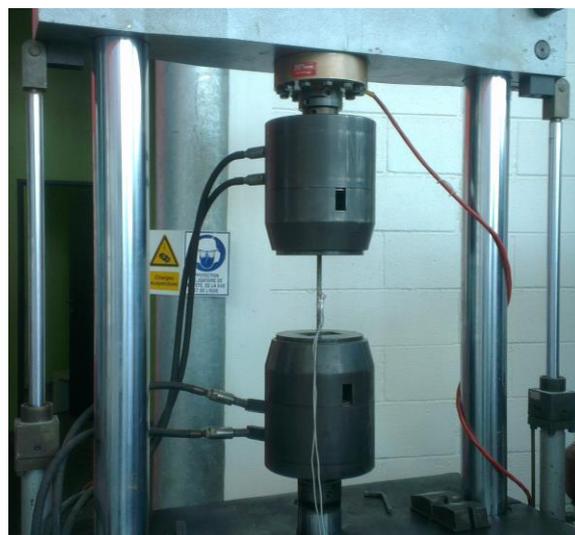
Figure2: Tensile test of reinforced steel

Steel specimens were characterized by tensile

testing, Figure 2. The stress f_u and the modulus of elasticity E values are in Table 1. The high deformation of steel at the failure is 11.04%.

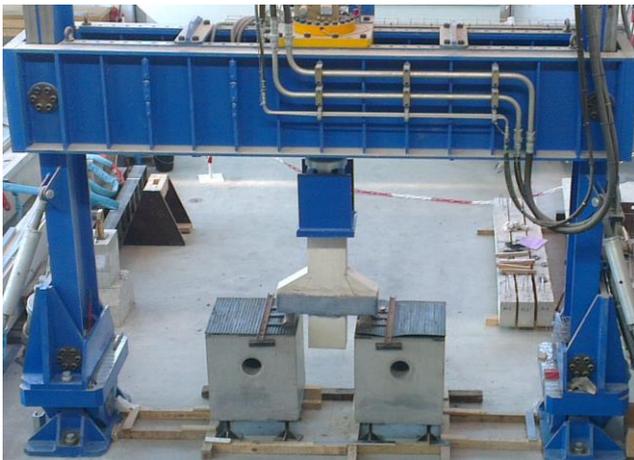
Figure3: Bending test

All the corbels are tested under 3-point bending control see Figure 3. At each test, ultimate loads are noted. Strains of concrete, composite carbon fibers sheet and steel strain are measured at embedding section (where strains are highest) with strain gauges. Corbels are submitted to a vertical load equivalent to the response of the bearing which is half of load. The average loading rate for all experimental tests was 0,2kN/s. Every 0,1 seconds the system data was recorded. The test bending machine have load maximum capacity of 1000kN.

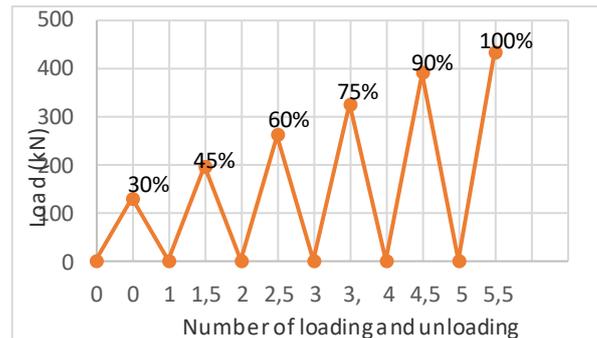
Figure4: Bending test of reinforced concrete corbels

Waiting for the required time of 48 hours, the repaired RC corbel by wrapping is tested under static loading and unloading up to collapse. The value of the incrementing step is 15%, see Figure 4.

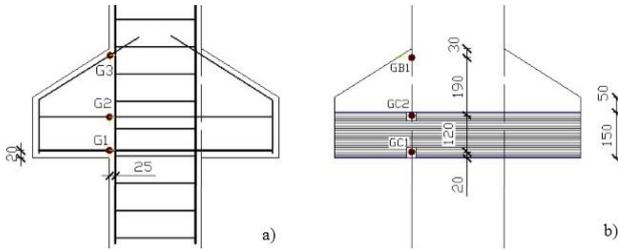
Figure 5: Local instrumentations with strain gauges. (a) steel investigation, (b) composite fabrics and concrete investigations

The electrical strain gauges with different length were used to study the local behavior of the structures. This technique allows to measure the strain of steel, carbon fabrics and concrete. In fact, the load versus strain in cross section between column and corbel are plotted. Figure 11 shows the positions of strain gauges on corbel. The strain gauges G1, G2 and G3 are placed on steel tie rod and they have a length of 5mm, see Figure 11 (a). The strain gauges (GC1 and GC2) are placed on composite fibre fabrics in shear span between

corbel and column, their length is 10mm. (GB1) with length of 30mm is placed on concrete surface, see Figure 5.

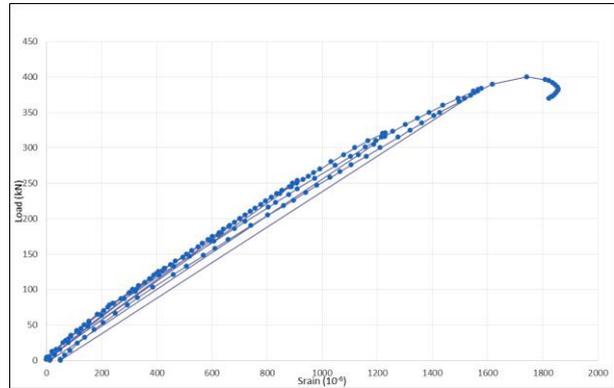
Figure 6: Strain of steel tie in G1 for repaired corbel

Figure 6 shows the local steel deformations in cross section of repaired RC corbel after 500 000 cycles. In fact, the dynamic loading is modified the behaviour of specimen. The

elastic area in steel bar was lost. Still the composite material responds to the stresses that emerge from loading and unloading steps.
