## FAILURE BEHAVIOR OF RC BEAMS BY MEANS OF 3D CONCRETE PRINTING

**Key words:** 3D Concrete Printing, Reinforced Concrete, Failure Behavior

**Abstract:** Flexural tests were conducted on RC beams by using material extrusion 3D printing technology. The used mortar does not include any fibers, and the beams have horizontal and vertical interlayers. It was clarified that the compensation plane was maintained within the cross section, the neutral axis rose with the propagation of flexural cracks. The strain of the mortar at the extreme fiber in compression was about 3000 micron, and flexural failure with interlayer delamination in compression zone was observed finally. In addition, delamination of multiple filament interlayer was observed at the rebar position. The interlayer bond strength was measured and found to be about 30% of the splitting tensile strength of mortar itself.

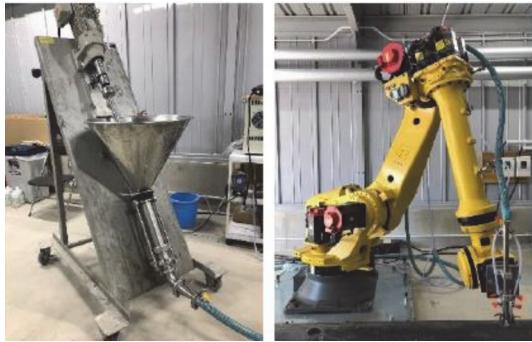
The 3D printer used in this study is shown in Fig. 1. The printing system in this study is consist of a six-axis robot arm and a rotary volumetric uniaxial eccentric screw pump. The pump was chosen to deliver a constant amount without pulsation. In addition, a stainless steel cylindrical pipe with a diameter of 25 mm is attached as the discharge nozzle.

**Figure 1:** 3D printer.**Table 1:** Mix proportions of used mortar

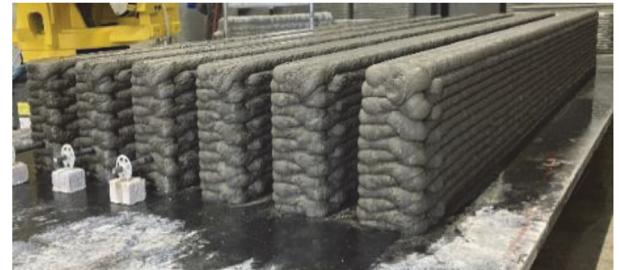
**Figure 3:** Printed specimens.

(outside the mortar specimen) were placed on the printed filaments, and then stacked up to 13 layers totally, as shown in Figs. 2 and 3. The prepared specimens were cured in air for 24 hours at room temperature of 20°C, then wet cured for 14 days, and then sealed cured in the same environment until the age of 27 days.

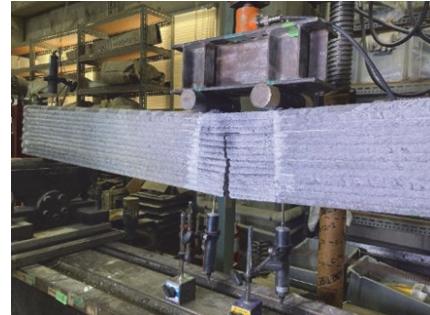
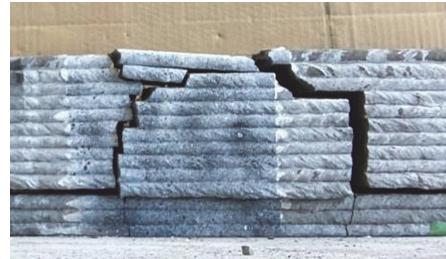
As shown in Figs. 8 and 9, the shape of the cracks differed for each specimen, and in the No. 1 and 3 specimens, interlayer delamination occurred at the rebar position over the entire length of the loading span. At the end of the test, compression failure of mortar of the No.2 specimen was visually confirmed, and the failure behavior was similar to that of conventional RC beam.

Regarding the final stage for 3DCP specimens in this study, interlayer delamination due to compressive stress also observed in the first or second layer from the top of specimen. The failure mode with delamination, which occurred in the compression side, was one of the typical failure modes of the specimen fabricated by 3DCP technology.

(a) No. 1 specimen with multiple cracks and delamination along rebar

(b) No. 2 specimen with single crack

(c) No.1 specimen (close up)

**Figure 9:** Failure mode.

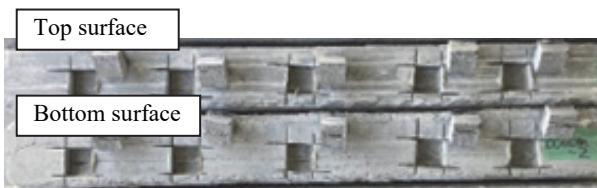
Using the unreinforced specimens after the flexural test, interlayer bond strength test was conducted, as shown in Fig. 5. Table 4 tabulates the obtained bond strength and Fig. 13 shows the delaminated interface. All fracture locations coincided with the interlayer locations.

The upper interlayer bond strength is about 20% lower than that of the lower layer. It seems that the lower interlayer bond strength increases because of the compaction due to stacking of upper layer during printing.

**Figure 13:** Fractured specimens for bond strength tests.
