CRACK PATTERNS AND BOND EFFECTS IN THE PROGRESSIVE COLLAPSE OF LOCAL PRESTRESSED CONCRETE SUBSTRUCTURES

Abstract: In large buildings, the combined application of long-span prestressed concrete beams and short-span reinforced concrete beams is common. Such structures are designated as local prestressed concrete (LPC) structures. LPC structures could be classified into two types: unbonded local prestressed concrete (UBLPC) structures and bonded local prestressed concrete (BLPC) structures. Nevertheless, the crack patterns of LPC structures under progressive collapse remains unclear. The bond effect between prestressed tendon and concrete on crack development and load-carrying capacity is yet to be elucidated. Therefore, this paper tested the progressive collapse resistance of BLPC and UBLPC substructures. The results indicated that LPC substructures exhibited the resistance mechanism comprising two distinct stages: beam-beam stage and beam-link stage. A main crack appeared at the junction of the reinforced and non-reinforced regions of the longitudinal rebar in long-span beam, with surrounding clusters of cracks. The cracking at the ends of short-span beam was significant. Mechanist

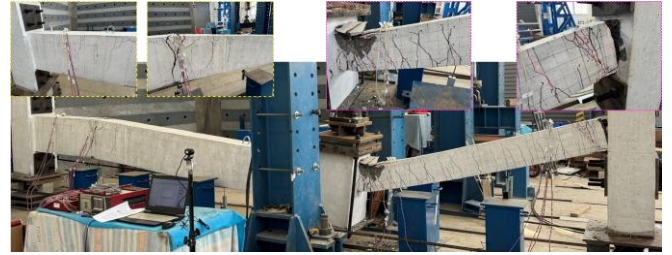
Figure 3: Crack pattern and failure mode of BLPC.

The crack patterns and failure mode of BLPC specimen are shown in Figure 3. A main crack in the form of a tortoise shape was formed at HS1, extending to the bottom. The width exceeded 12 mm. There were also compressive cracks at the bottom of HS1. The cracks became increasingly narrow and fewer as the distance from HS1 increased. The concrete at the upper section of HS2 was entirely crushed. The protective layer spalled extensively. Longitudinal reinforcement flexed. Tension cracks were distributed along the entire length of the short-span beam. Most of them exceeded 200 mm in length. For the short-span beam, only the bottom longitudinal reinforcement of HS3 was connected to the side column, with the rest being separated. The

short-span beam lost its bending capacity and was severely damaged.

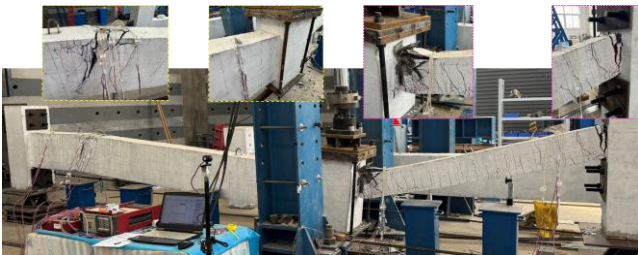
The crack patterns and failure mode of USRC specimen are shown in Figure 5. The cracks in USRC specimen at HS1 developed rapidly and eventually formed a concentrated large crack (the main crack). The cracks around the main crack were sparse. This was distinct from the narrow and scattered cracks observed in the BLPC and UBLPC specimens, due to lack of prestressing. Moreover, the lack of reverse tension from the prestressed tendon resulted in faster development of compressive cracks at HS2. The concrete crushing at HS2 was severe and spread to the lower section. USRC specimen had only two cracks in the vicinity of HS3, except for the large crack at the beam end.

Figure 5: Crack pattern and failure mode of USRC.

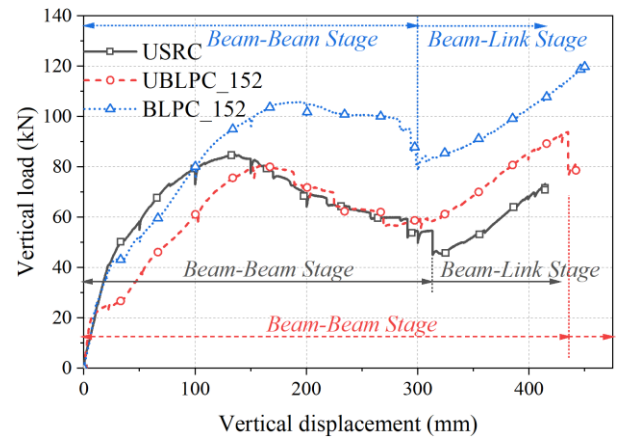
Vertical resistance is the most important indicator of the structures against progressive collapse. The vertical resistance-vertical displacement curves of the specimens are shown in Figure 6. The progressive collapse curves of these test specimens could be divided into beam-beam stage and beam-link stage. This kind of division emphasized the mechanism transformation at the structural level.

Figure 6: Vertical resistance curves.

The CAA peak of BLPC specimen was the largest, reaching 105.7 kN, corresponding to a vertical displacement of 196.5 mm. Subsequently, the resistance of BLPC specimen decreased. The two longitudinal rebars at the top of HS3 fractured at 293.6 mm and 298.3 mm, resulting in a sudden decline in the resistance from 98.7kN to 79.8 kN. Moreover, the concrete at HS2 crushed, while the steel rebars flexed. The short-span beam sustained significant damage to the extent that it could no longer carry bending loads. Due to the long-span beam, the specimen exhibited beam-link action, which gradually increased the resistance with increasing displacement.

The CAA peak of UBLPC specimen was 80.5 kN, which corresponded to a vertical displacement of 157.5 mm. Thereafter, the resistance decreased. The lowest resistance was 56.1 kN, which was 69.7% of CAA peak. The resistance rose again as CA developed. The top reinforcement at HS3 fractured simultaneously at 435.9 mm, resulting in an

abrupt decline from 93.8 kN to 76.5 kN.

USRC specimen had the weakest CAA with a peak load of 84.6 kN. The resistance of USRC specimen exhibited a continued decline following the peak, which was different from BLPC and UBLPC specimens. This is due to the fact that the equivalent axial compressive force and bending moment of the prestressed tendon contributed to the maintenance of resistance at beam-beam stage. Following rebar fractures, USRC specimen entered beam-link stage. While exhibiting a consistently lower resistance than that observed in BLPC and UBLPC specimens, it still presented a discernible increase in beam-link stage.

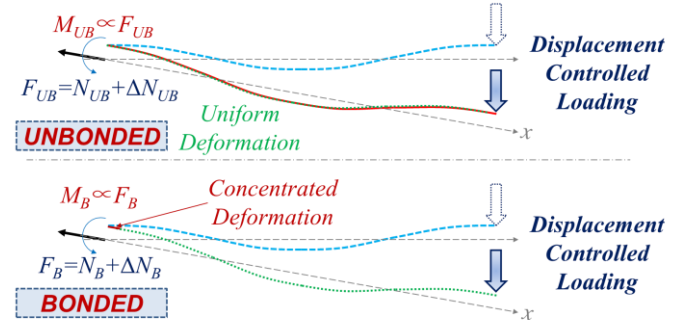
The resistance provided by the prestressed tendon is essentially derived from the axial tension. The axial tension force is equal to the sum of the pre-tension and the tension increment, as illustrated in Figure 8. The tension increment of unbonded prestressed tendon (ΔN_{UB}) is primarily attributable to the tendon deformation and friction, while that of bonded prestressed tendon (ΔN_B) is attributable to the tendon deformation and bonding force. It is assumed that the deformation of unbonded prestressed tendon is uniformly distributed under progressive collapse. For bonded prestressed tendon, it is assumed that the deformation is concentrated in the plastic hinge.

Figure 8: Prestressed tendon resistance: unbonded and bonded prestressing.

By making a difference, it can be found that the resistance of bonded prestressed tendon is consistently greater than that of unbonded prestressed tendon. However, it should be noted that the bonded prestressed tendon fractures earlier due to the concentration of deformation.
