# Horizontal and slanting reinforced concrete slabs for structurally dissipating rock-shed: experimental analysis

M. Mommessin, A. Agbossou, F. Delhomme, J.P. Mougine, N. Henriet  
*LOCIE (ESIGEC-Université de Savoie), Savoie Technolac, Bourget du Lac, FRANCE.*

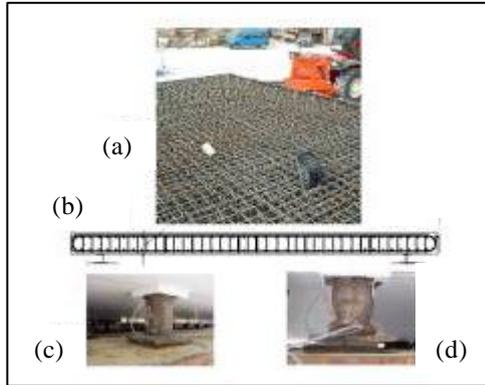
Figure 1. (a) Reinforcement steels of SDR-slab, (b) cross-section of SDR-slab on its supports, (c) Undamaged support, (d) Support damaged by impact load on slab side.

The originality of this concept is to find solutions to the two functions above without a need for bank-run gravel over the slab. Therefore, we realize and design the SDR-slab (thickness, steel reinforcement, ... (Fig. 1a, b)) in order to absorb the impact loads by bending deformation in elastic domain (deformation without great damage for usual rock falls). About the impacts on the slab sides, we realize specific steel supports (Fig. 1c), which aim to absorb impact load by their plastic and crash deformation (Fig. 1d).

In addition to the weight reduction of the rock-shed, this concept could allow easy repairs. Indeed, for local impact damage in the middle area, the damaged concrete can be removed (Fig. 2a) by a high-pressure water jet (hydro demolition). Then the concrete can be rebuilt (Fig. 2b) after changing the broken reinforcement steels. About the impact on the slab sides, the repair could consist in a simple change of damaged supports (Fig. 1d). Besides, for weak impact energy, the slab behaves

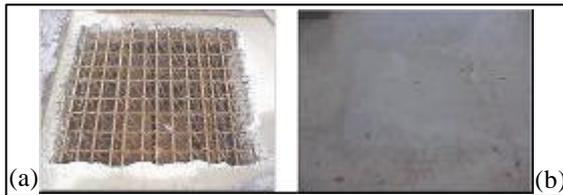
Figure 2. (a) Damaged concrete removed by a high-pressure water jet (hydro demolition) (b) repaired slab.

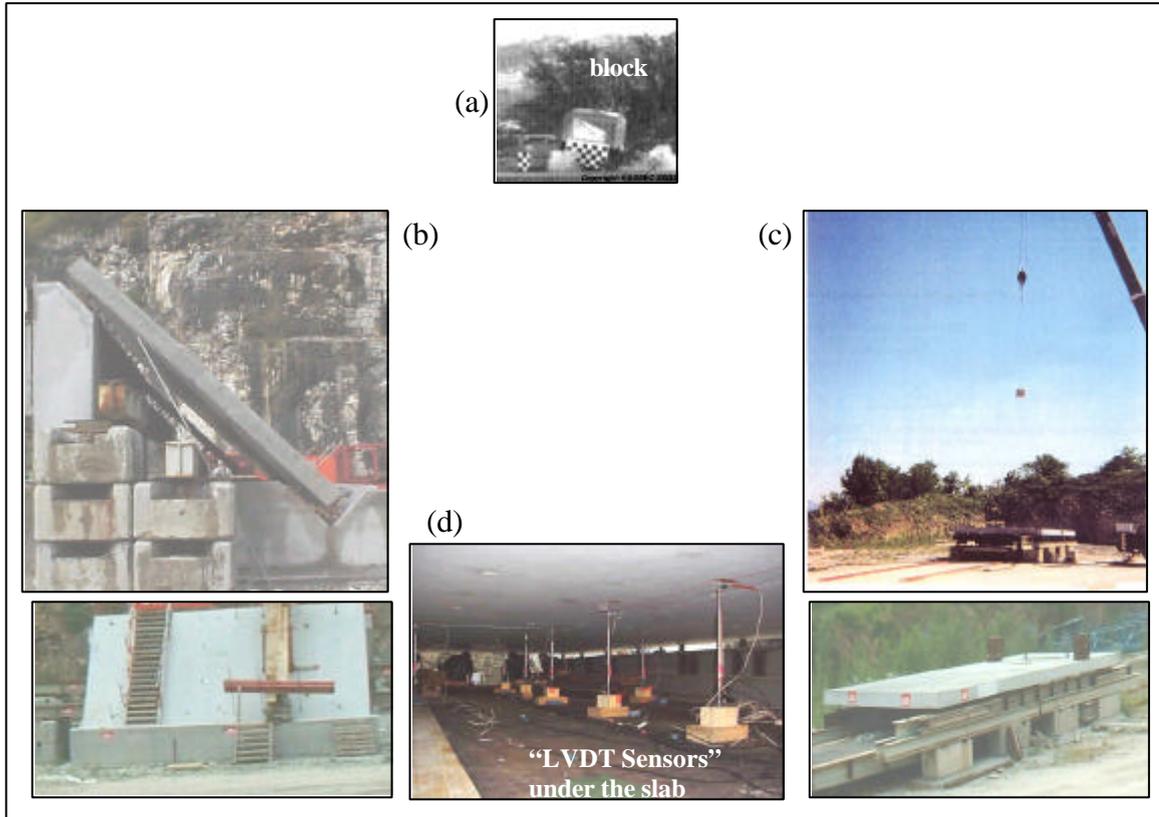
Figure 3. View of: (a) block, (b) slanting slab, (c) Horizontal slab and (d) Displacement transducers (LVDT) situate under the slab.

The block is lifted to the dropping height by a crane (Fig. 3-a, 3-c). A specific device (Mougin et al. to be publish) allows to drop the block without any initial speed. The block is fitted out with accelerometer and crash test checkerboard (Fig. 3-a) is attached on the block in order to allow the analysis with a high-speed camera.

Two slabs have been tested: a horizontal slab (12m x 4.8 m x 0.28m; Fig. 3-c) and a slanting slab (8m x 4.8m x 0.28m, slab slope 45°; Fig. 3-b) that both represent model slabs on the scale of 1/3 scale. The horizontal and slanting slabs are respectively made of B30 and B35 concrete. The reinforcing steel bars are 8 mm in diameter for shear reinforcement (vertical reinforcement), 14 mm diameter for longitudinal reinforcement and 16 mm diameter for cross reinforcement. The steel bars have an average modulus and an elastic yield stress respectively equal to 200 GPa and 500 MPa. The reinforcement steel ratio is approximately 270 kg of steel bar per  $1 \text{ m}^3$  of concrete.

For a complete analysis of impact behavior, we have fitted out the slabs with many sensors like: (i) strain gages, initially fixed on reinforcement steels, (ii) LVDT transducers (Fig. 3-d), used to measure the bending displacement as shown in Figure 4, (iii) specific stoneware clay devices developed (Mougin et al. to be publish) to determine maximal displacements, (iii) accelerometers placed under the slabs and close to the LVDT transducers,

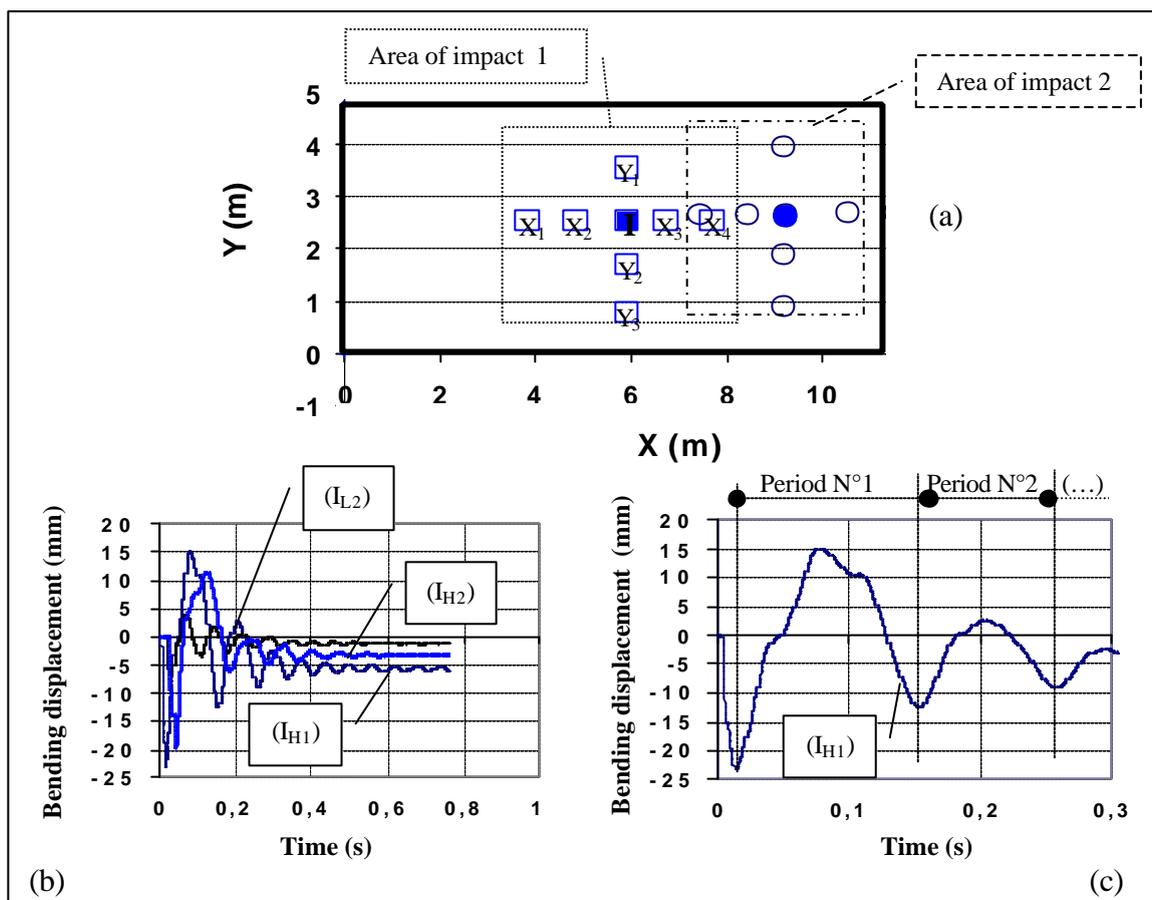
Figure 4. Localisation of displacement (LVDT) transducers and typical experimental displacements at the point impacted. The subscripts H1, H2, L2 correspond to tests on horizontal slab in area 1 & area 2 and slanting slab in area 1 respectively.

The tests are done in two areas of the slabs mark on Figure 4-a by square and circle charts. The references to the LVDT transducers are square charts in area 1 and circle charts in area 2. We call ( $X_1$  to  $X_4$ ) and ( $Y_1$  to  $Y_3$ ) the transducers in the direction of slab length and width respectively (Fig. 4a). The transducer close to the point of impact is referred as I.

Figure 4 presents the typical curves in area 1 and 2 of horizontal and slanting slabs. These curves show the bending displacements versus time at three different points of impact: ( $I_{L2}$ ) impact on slanting slab at point, which correspond to dark circle on Figure 4-1, ( $I_{H1}$ ) and ( $I_{H2}$ ) impact on horizontal slab at point, which correspond to dark square and circle respectively on Figure 4-1. The Figure 4-2 shows an extending of the curve ( $I_{H1}$ ).

The curves on Figure 4 are similar to those often obtained when studying the vibration of dampening structures. The detailed analysis and discussions about these curves are presented in section 3.3.

(i) One can observe (Fig. 4b) that the final values of bending displacement are not equal to zero. The analysis of strain measure in steel shows that the reinforcement steel bars didn't reach their elastic limit for tests under EULS condition ( $E = 135 \times 10^3$  joules). Therefore, the effects of the non-zero value of displacement is due to the micro-cracks in concrete, which load reinforcing steel bars and create such final displacements (Fig. 4-2). The value of the final displacement is more important for the horizontal slab than for the slanting slab. These observations are in agreement with the

(ii) A qualitative analysis of curves (Fig. 4) shows that the apparent displacement period first decreases and bottoms out (Table 1). The Fast Fourier Transform analysis confirms this observation, which shows that two principal vibration modes could control the deformation of the SDR-slab. The variations in the period of the bending displacements can also be observed through the discontinuity on the curves as shown in Figure 4-c. These discontinuing lines could be due to the two principal vibration modes according to which the SDR-slab would vibrate. Therefore, the displacement, which takes the following form in general case:

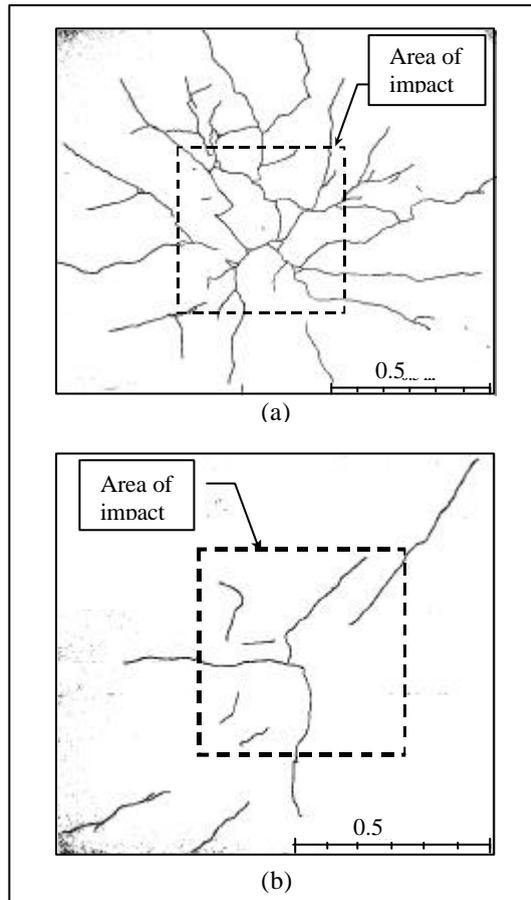
Figure 5. Typical cracks under the point of impact: (a) Horizontal slab and (b) slanting slab.

The cracks due to impact loading are presented in Figure 5. As expected for an impact at 24.5 m/s, the cracks are significantly more important in the horizontal slab than in slanting one. Indeed, in the slanting slab, only a part of the impact energy contributes to damage of the concrete (crack, failure, ...). The other part of the impact energy generates tangential loads in the plane of the slab. Due to this tangential load, the slab supports have to be designed and placed correctly in order to withstand these tangential loads. The improvement due to slanting slab is visible as the concrete cracking is limited and natural ejection of the blocks is made possible.

The star-shaped cracks (Fig. 5-a) are due to our loading and boundary conditions, which are closed to the used conditions of the slab. These conditions are difficult to obtain with laboratory set-up.

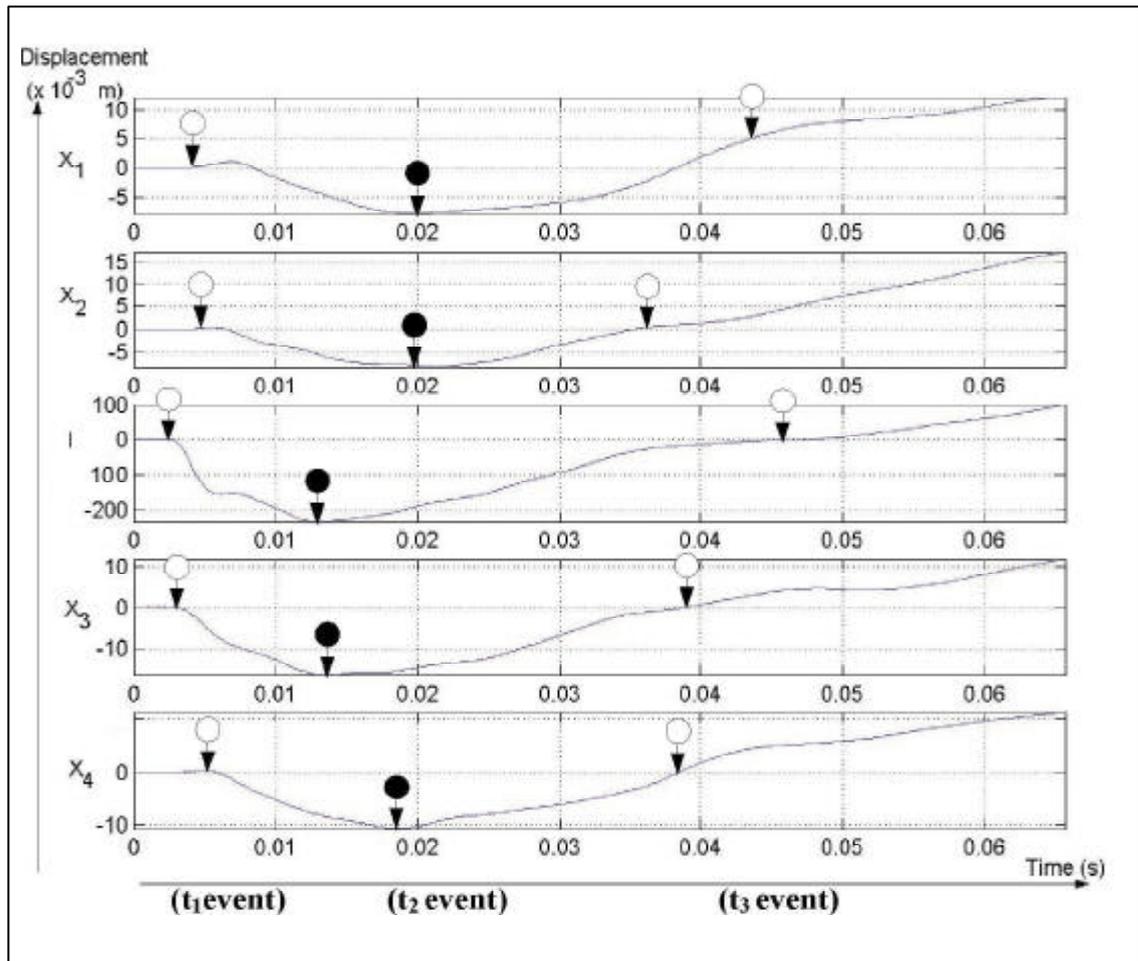
Figure 6. Typical velocity effects during the first half-period. Impact behavior of a horizontal SDR-slab. Impact point (I) in area of impact 1.

We analyze the bending displacement of LVDT transducers  $X_1$  to  $X_4$  (lengthwise transducers). The results of the analysis presented in Figure 6 are similar to those obtained with transducers  $Y_1$  to  $Y_3$  (transducers along the width; Fig. 4).

Figure 6 shows the starting times of particular events occurring in the slab: (i) starting time ( $t_1$ ) of slab deformation, (ii) time ( $t_2$ ) to reach the first maximal or minimal displacement, (iii) time ( $t_3$ ) to get back to zero displacement. In static analysis all such events occur at the same time.

One notes here a significant shift in the occurring of the same event. This illustrates the existence of a time dependence (inertia) phenomenon. The simple way to describe this inertia effect can be summary

as follow: for impact velocity about 24.5 m/s, before the SDR-slab supports start reaction, the slab deforms at the point of impact. This unusual phenomenon in classic design of reinforced concrete structures must be took into account for optimized modeling.
