Strengthening of unreinforced masonry walls using ECC for impact/blast resistance

ABSTRACT: This paper presents the results of quasi-static and low-velocity projectile impact tests on unreinforced masonry (URM) walls retrofitted with a cementitious-based material known as Engineered Cementitious Composite (ECC). A total of 18 masonry wall panels were tested to assess the extent to which ECC can enhance the impact/blast resistance of the strengthened masonry walls by subjecting these series of panels to three types of load patterns namely patch load, uniformly-distributed load and impact load. Test results reported in this paper demonstrate the efficiency of the ECC-strengthening system in improving the ductility of URM walls, increasing their ultimate load-carrying capacity, enhancing their resistance against multiple low-velocity impacts and preventing sudden and therefore catastrophic failure.

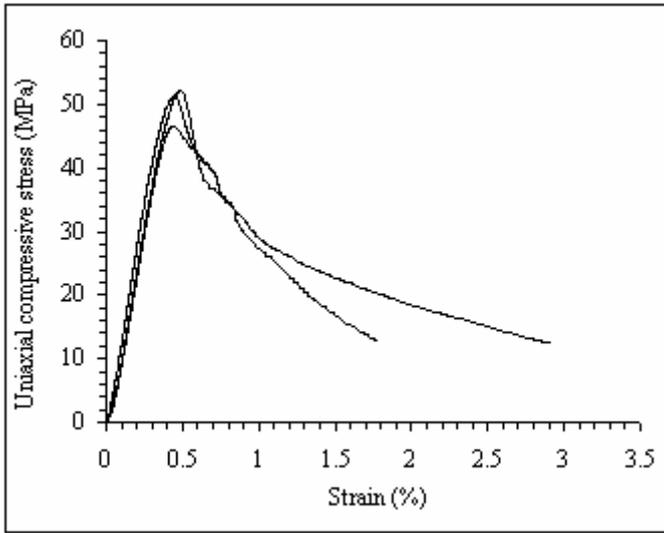
Figure 1. Typical hybrid-fiber ECC uniaxial compressive stress-strain curves.

In a study conducted by Zhang et al. (2004), a hybrid-fiber ECC using proper volume ratio of high and low modulus fibers was developed to better meet the functional requirement for impact- and blast-resistant structures. This hybrid-fiber ECC mix containing 0.5 % steel and 1.5 % Polyethylene (PE) fibers (by volume), has displayed an optimal balance between ultimate strength and strain capacity. Typical uniaxial compressive and tensile stress-strain curves of the hybrid-fiber ECC material are presented in Figures 1 and 2, respectively. Maalej et al. (2005) studied the high velocity impact resistance of this hybrid-fiber ECC experimentally, demonstrating its high energy absorbing capacity and its ability to resist multiple impacts with little spalling, fragment ejection and small crater size on the impact face. It was concluded from the above study that ECC is a good material for impact and blast-resistant design of building structures.

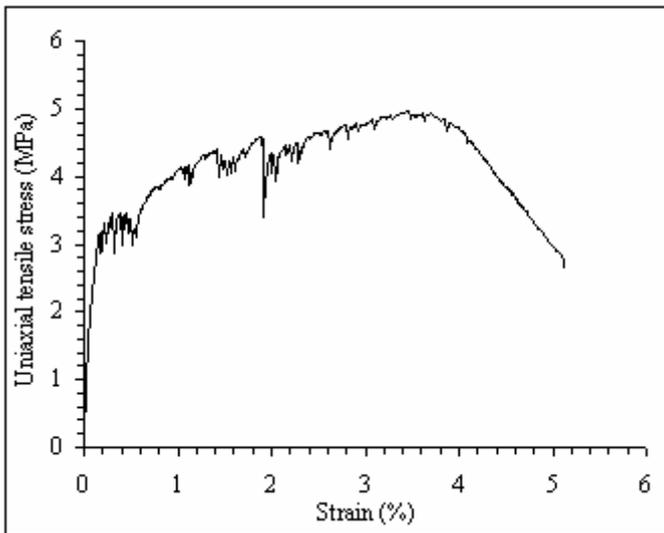
Figure 2. Typical hybrid-fiber ECC uniaxial tensile stress-strain curve.

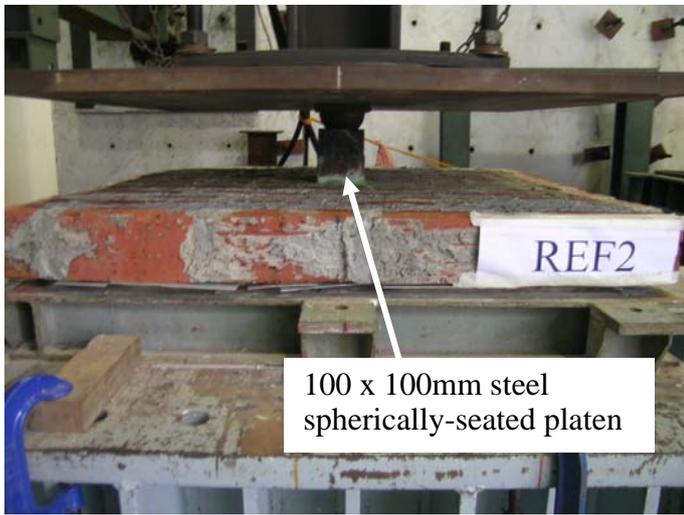
Figure 3. Quasi-static patch load test set-up.

The test set-ups for Series I and II are shown in Figures 3 and 4, respectively. The test wall was laid horizontal with the leveled face or the reinforced face downwards, and simply-supported along four

sides on round steel bar supports without edge restraint. This means that the corners of the test wall were free to uplift. The effective span of the panel in both directions was 900mm.

The test set-ups for Series I and II were similar except for their loading areas. For Series I test, a patch load of 100 x 100 mm was applied at the center of the test specimen through a spherically-seated platen by means of a MTS hydraulic jack head and the load was applied using displacement control at a constant rate of 0.1 mm/min. For Series II test, a uniformly-distributed load of 780 x 780 mm was applied at the center of the test specimen using a Kevlar reinforced airbag of size 900 x 900 mm and the loading rate was controlled by the inflation of the airbag at an approximate rate of 1.5 kN/min.

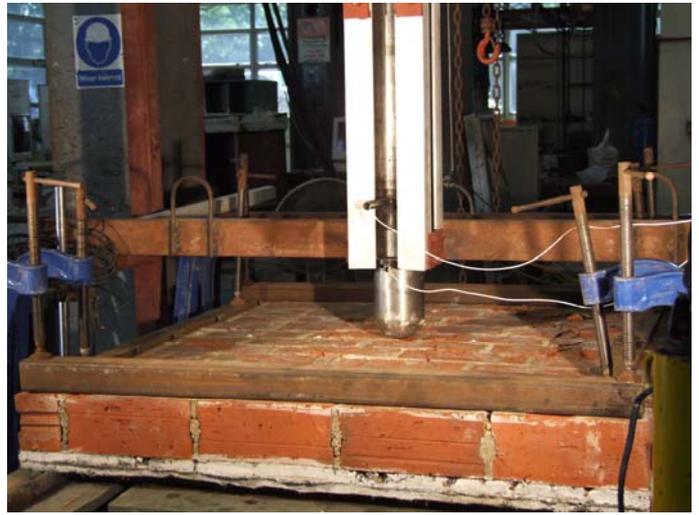
Figure 5. Low-velocity projectile impact load test set-up.

A drop weight impact facility similar to the one used by Ong et al. (1999) was adopted in this study (see Figure 5). This test facility consisted of a square steel frame welded on rigid columns that were bolted to the strong floor. Similarly, the specimen was laid horizontal with the leveled face or

reinforced face downwards, and simply-supported along four sides on round steel bars welded to a square frame. The effective span of the slab in both directions was 900mm. To prevent the specimen from bouncing under the impact, the test wall was clamped with a steel strip at the top face using G-clamps along the support line.

The impact was achieved by dropping a projectile of mass 51 kg from a height of 4 m. This test facility made use of a manually-operated winch system to raise the hammer to the desired height. The impact point was locked at the center of the test specimen using a vertical aluminum square guide. The hammer was then allowed to slide freely through the use of smooth rollers, greased to minimize friction effects. The average velocity of the projectile measured from the experiment was 8 m/s.

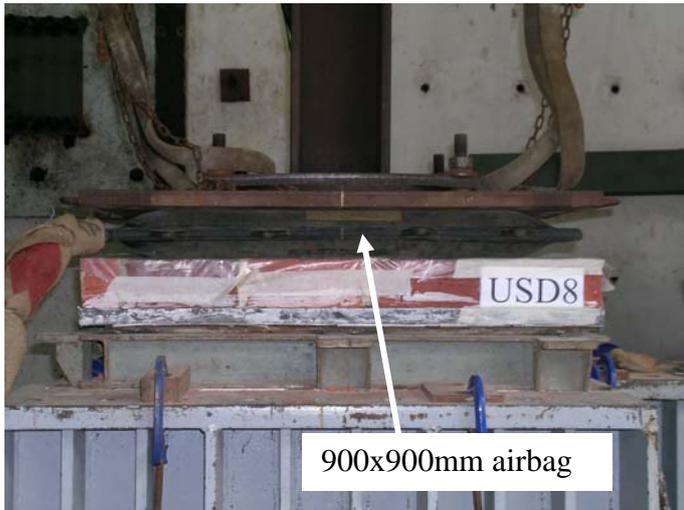
Figure 4. Quasi-static uniformly-distributed load test set-up.

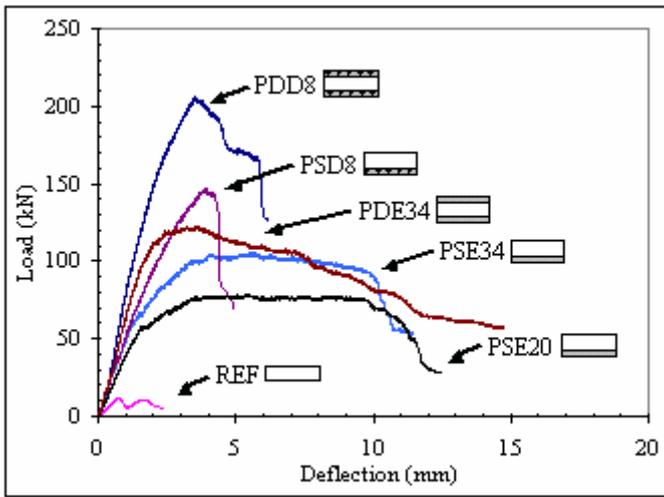
Figure 6. Load-deflection responses of wall components in Series I tests.

The load-deflection responses of Series I and Series II test walls are shown in Figures 6 and 7, respectively. The applied load was recorded by the hydraulic actuator load cell, while the deflection of the specimen was measured at its center using a 100mm-range LVDT.

Series I test results for the masonry walls incorporating single ECC-strengthening layers with 20mm- (PSE20) and 34mm- (PSE34) diameter steel mesh were used to study the effect of the thickness of the ECC layer on the load and deflection capacity. The load-deflection responses of the reinforced walls were similar as shown in Figure 6; the only difference was the ultimate load-carrying capacity. Despite being thicker by 70%, the ultimate load-carrying capacity of PSE34 was only 35% higher than that of PSE20. It was found from section analysis that the strain in the ECC-strengthening layers directly beneath the loading area of PSE20 and PSE34 was 3.54% and 2.43%, respectively (both below the tensile strain capacity of the ECC material). These observations suggest that in specimen PSE20 the ECC layer had a higher contribution to ultimate load-carrying capacity than in specimen PSE34.

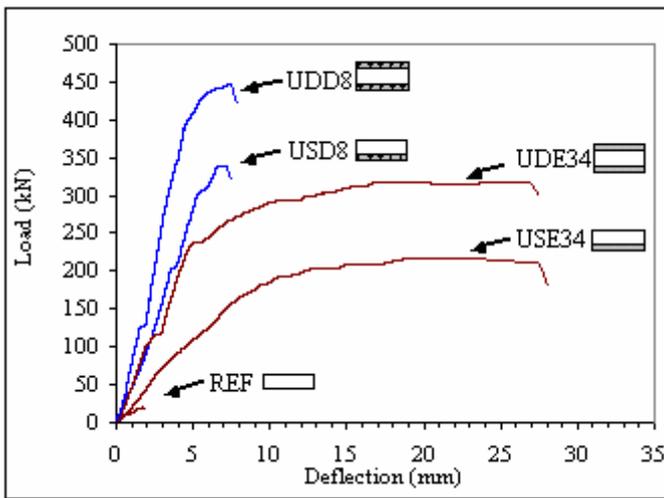
Figure 7. Load-deflection responses of wall components in Series II tests.

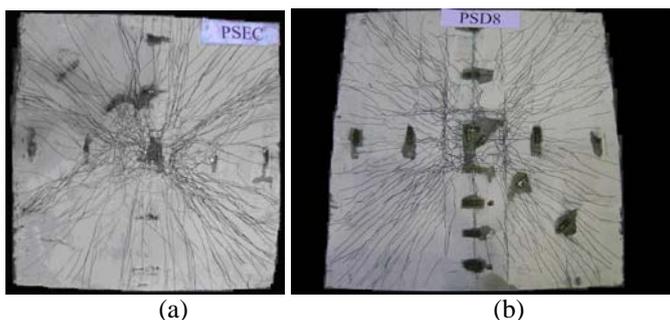
Figure 8. Typical cracking pattern of the ECC-strengthening layers (a) without steel mesh (b) with steel mesh

In general, the ECC-strengthening layer with or without steel mesh displayed very good stress distribution, having well-distributed cracks beneath the loading area stretching out towards the support in a radial pattern as shown in Figure 8. The only difference was that the cracks were less dense in the ECC-strengthening layer with the 8mm-diameter steel mesh indicating that the stresses were mostly distributed through the steel mesh. Lastly, it was interesting to note that as the steel mesh was pressing against the ECC layer, the shape of the steel mesh was visible from the crack patterns.

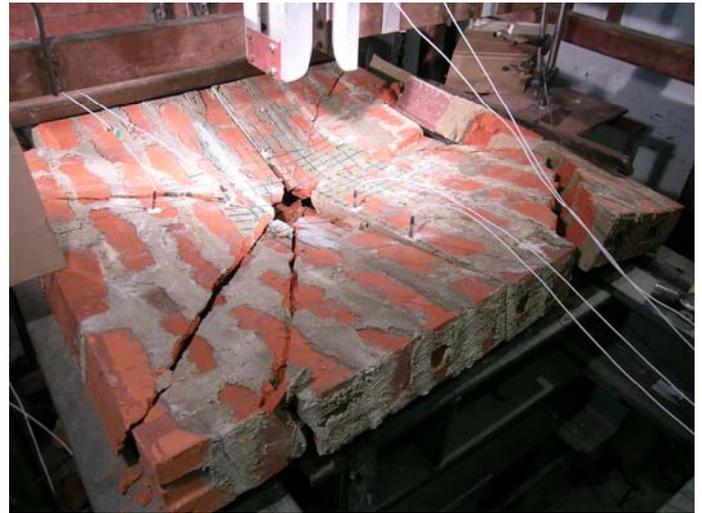
Figure 9. Failure of unreinforced masonry wall under impact loading.

The importance of retrofitting an unreinforced masonry wall was demonstrated in this Series of tests when such wall exhibited sudden and therefore catastrophic failure upon its first impact loading. The unreinforced masonry wall was perforated by the projectile upon impact and shattered into a few pieces as shown in Figure 9. A large amount of fragment ejections were observed during the impact.

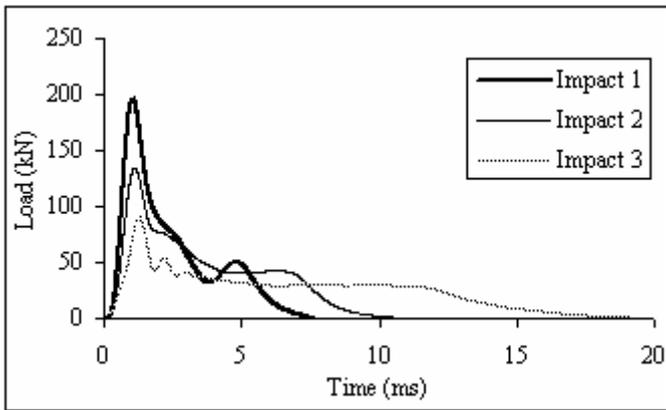
Figure 10. Load versus time graph for the first 3 impacts of ISE34.

The impact load versus time graphs obtained from the first 3 impact loadings applied to Series III test walls are shown in Figures 10-13. In general, two peak loads can be identified from each of the impacts. The primary peak load occurs within 2 ms upon impact, corresponding to the instant when the projectile strikes the specimen accelerating it downwards, and the secondary peak load takes place when the accelerating specimen loses its kinetic energy and rebounds upward, increasing its contact pressure with the on-coming projectile.

On the whole, the duration of the impact (taken to be the time upon the impact until the load was smaller than 5 kN) ranges from 4.315 to 16.370 ms, depending on the interaction between the projectile and the specimen before the projectile rebounded.

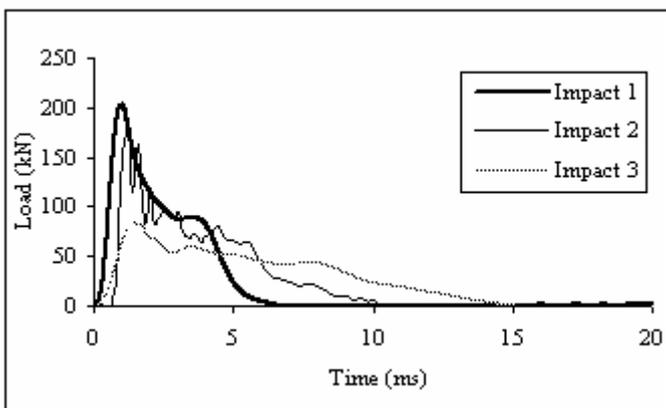
Figure 11. Load versus time graph for the first 3 impacts of ISD8.

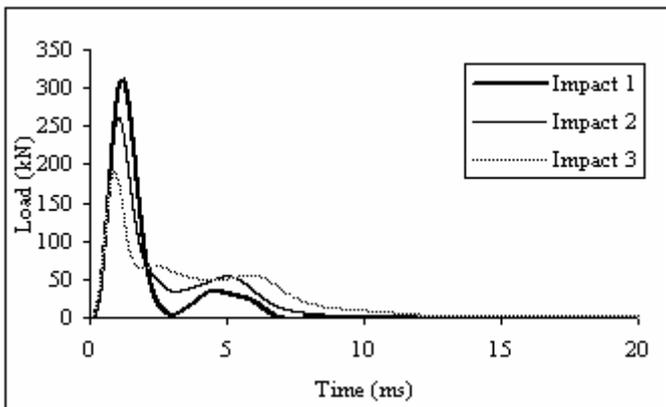
Figure 12. Load versus time graph for the first 3 impacts of IDE34.

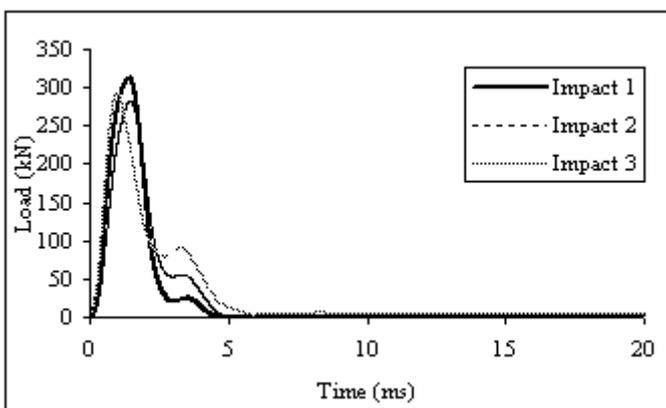
Figure 13. Load versus time graph for the first 3 impacts of IDD8.

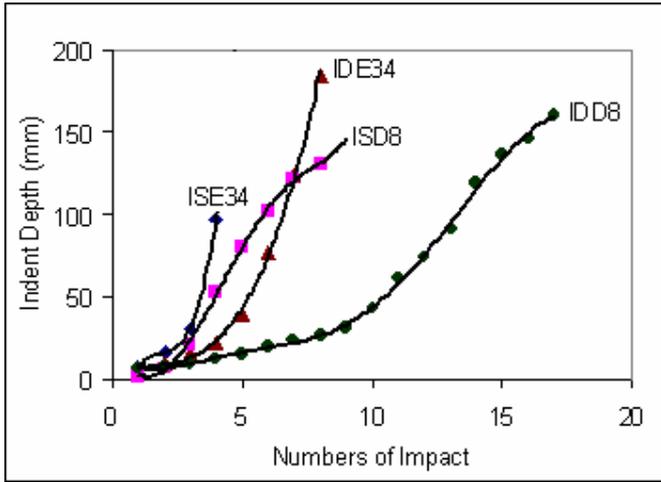
Figure 14. Plot of indent depth development.

To evaluate the penetration resistance of each ECC-strengthening system, the indentation depths and crater diameters created on the impact face were plotted against the number of impacts as presented in Figures 14 and 15, respectively. From the two figures, it can be observed that the indentation depths as well as the crater sizes of the reinforced walls decreases with the addition of the 8mm-diameter steel mesh, for both singly and doubly-reinforced walls, at the same number of impacts. Double-faced reinforced masonry walls displayed higher penetration resistance with lesser indentation depth and smaller crater size compared with single-faced reinforced masonry walls. This is because the ductile ECC-strengthening layer at the impact face of the wall absorbed a significant part of the impact energy, thereby protecting the brittle masonry sandwich layer and resulting in a smaller degree of damage.

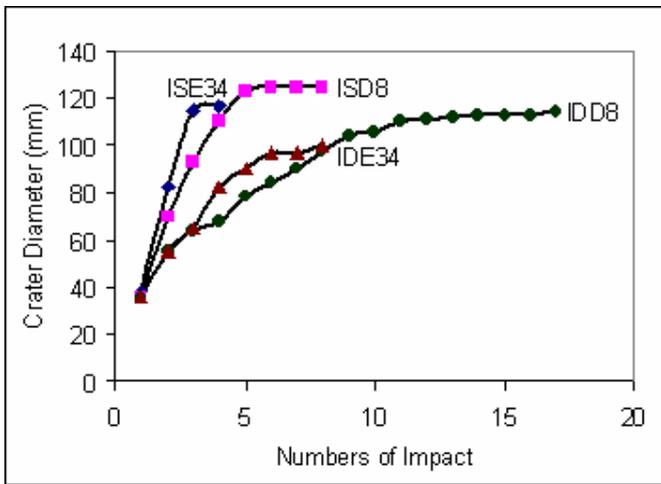
Figure 15. Plot of crater diameter development.

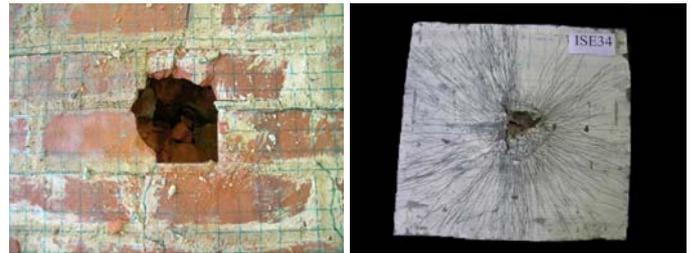
Figure 16. Impact and distal face of ISE34 after perforation.

Figures 16-19 show the impact and distal faces of the specimens at perforation. All the ECC-strengthened masonry wall panels remained structurally intact and showed only localized damage af-

ter being perforated. In general, all reinforced walls had cracks on the distal side that propagated from the impact point towards the support edges. Under point-load impact, the panel tried to bend close to a conical shape with high hoop stress. The cementitious matrix of the ECC material being brittle then fractured but the cracks were arrested by the bridging action of the fibers, resulting in a well-distributed radial pattern. It was also observed that the ECC-strengthening layer without steel mesh had very densely distributed cracks, while the ECC-strengthening layer with steel mesh had cracks that were sparsely distributed, indicating that the stresses were largely distributed by the steel mesh rather than the ECC-strengthening layer.

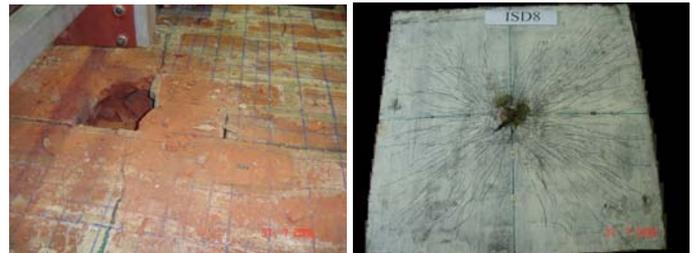
Figure 17. Impact and distal face of ISD8 after perforation.

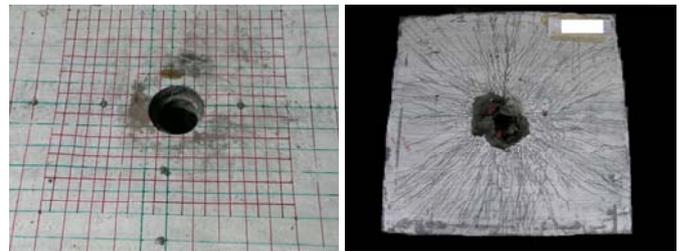
Figure 18. Impact and distal face of IDE34 after perforation.

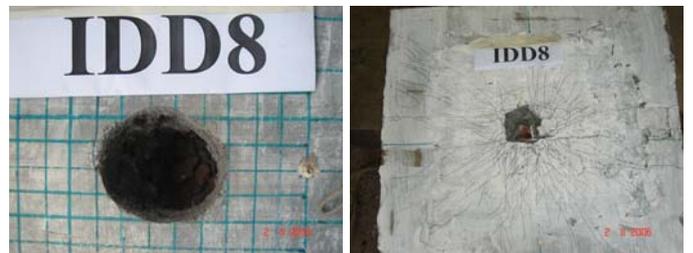
Figure 19. Impact and distal face of IDD8 after perforation.
