Development of bottom ash and PP fiber added fire protection coating mortar for NATM tunnel concrete lining

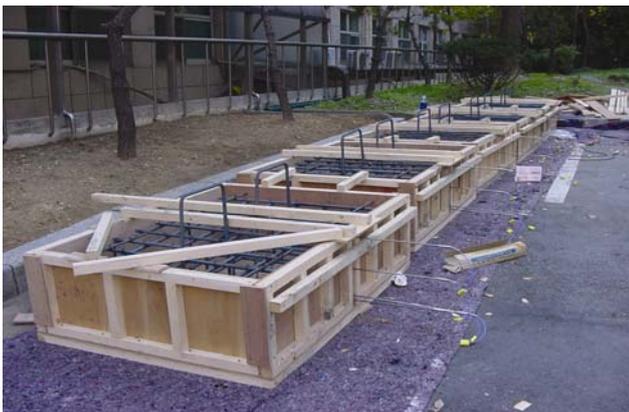
Figure 6. Formwork and reinforcing.

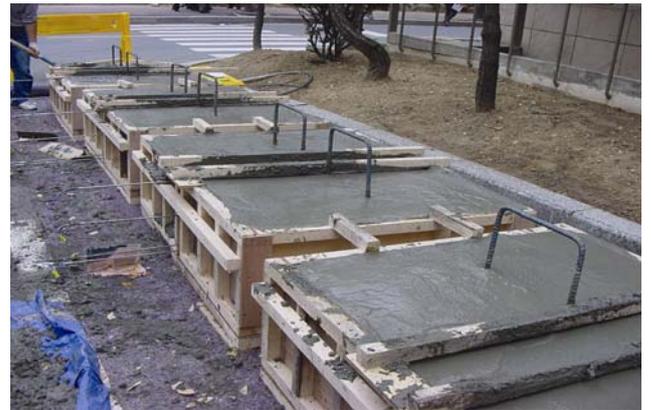
Figure 8. Concrete casted specimens.

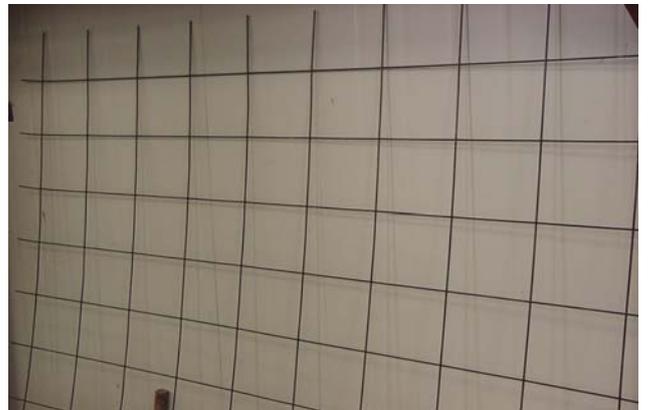
Figure 9. Steel wire mesh.

First, 1400mm×1000mm size of steel wire mesh was fixed to enhance interface bonding between specimen and fire protection coating. And after 28 days,

dry cured specimens were coated with fire protection material by hand. Single specimen was produced for each thickness and single non-coated specimen was tested as a control specimen. Figures 9 and 10 are the photos of steel wire mesh to strengthen interface and application of the newly developed fire protection material on the specimen, respectively.

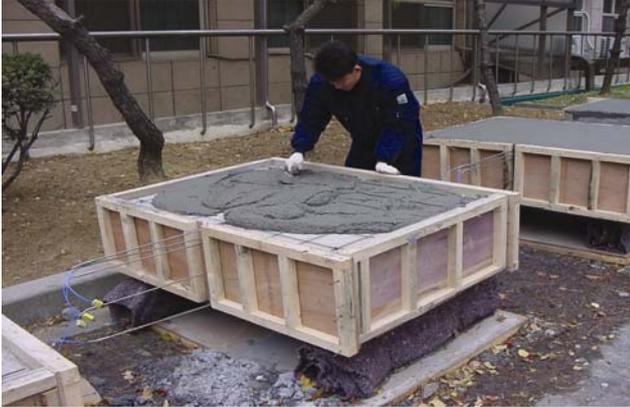
Figure 10. Coating the fire protection material by hand.

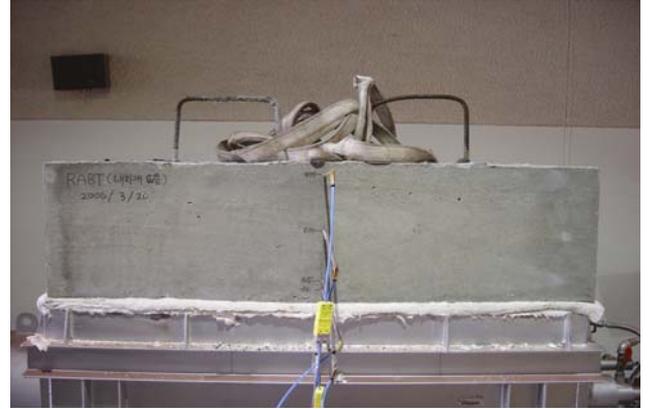
Figure 12. Concrete lining specimen without fire protection coating.

Figures 12 and 13 are photos of uncoated RC lining specimen setup on the furnace and temperature ver-

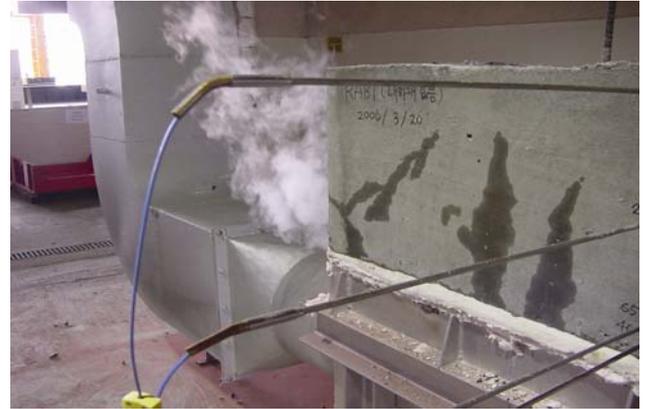
Figure 17. Vapor eruption from cracks of the specimen.

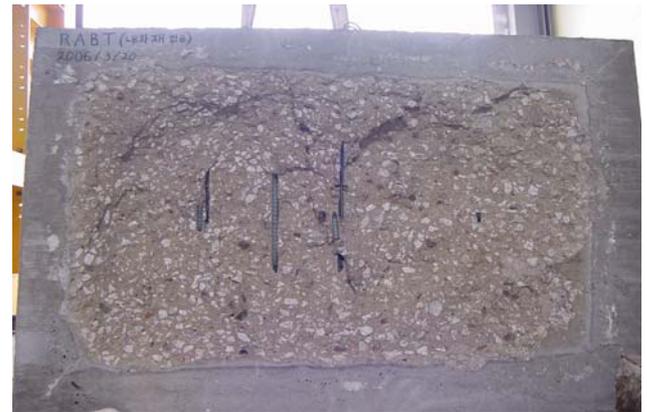
Figure 18. Bottom surface of the specimen after test.

As shown on Figure 14, when the furnace temperature reaches 1200°C, temperature at mid depth of concrete cover abruptly increased due to the cover thickness spalling caused by high temperature. About 20 minutes after the start of the test, concrete surrounding the reinforcements also spalled off followed by rapid increase in temperature of the bottom reinforcement. On the other hand, Figure 13 shows that the mid-depth of RC lining specimen was not affected by the fire. During the test, water and steam were continuously released from the cracks progressed from the side surfaces of specimen. The cracks were propagated toward the upper part of the specimen at the side surfaces. The highest temperature measured at mid-depth of concrete cover was 1197°C, at surface of bottom reinforcing bar was 1075°C, at the mid-depth of specimen was 111°C, and at the mid-depth of back concrete lining was 33°C. Figure 16 is a photo of concrete lining specimen's bottom surface where the fire is applied. After the concrete lining cover was spalled off, exposed surface of concrete and aggregates could be identified. Figure 17 is a photo of cracks and eruption of steam from the cracks. Figure 18 shows surface of concrete lining cover after the test. Concrete lining cover was severely damaged by spalling and main reinforcement bar was exposed.

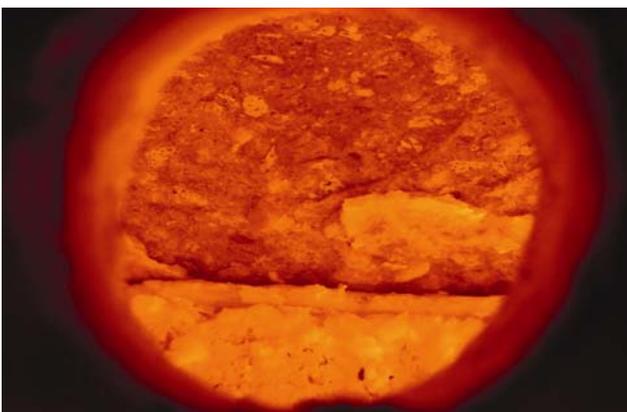
Figure 16. Surface of the specimen inside of the furnace after spalling.

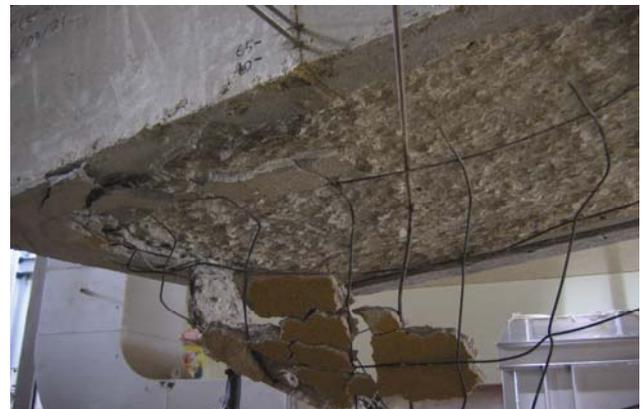
Figure 25. Separated fire protection coating.

Figure 24 is photo of fire protection coating surface in the furnace before explosion of fire protection coating. Figure 25 is bottom surface of the specimen after the test. The figure shows that concrete lining cover and fire protection coating was severely damaged by impact of explosion. And steel wire mesh for strengthening the interface was separated from the specimen.

The spalling of the coated material shows that 20mm thickness is insufficient for resisting RABT fire curve's maximum temperature of 1600°C.

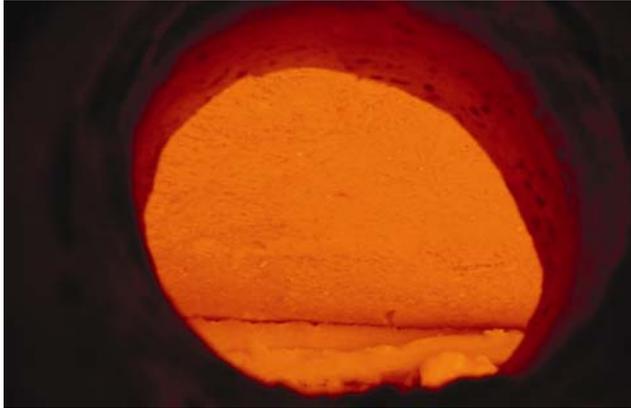
Figure 31. Surface of fire protection coating in the furnace.

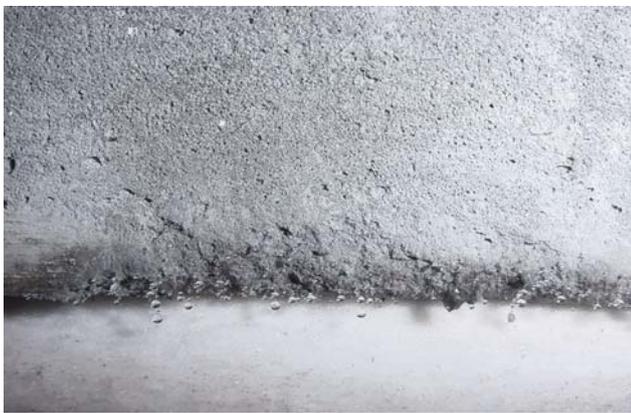
Figure 32. Water drops formed on the fire protection coating.

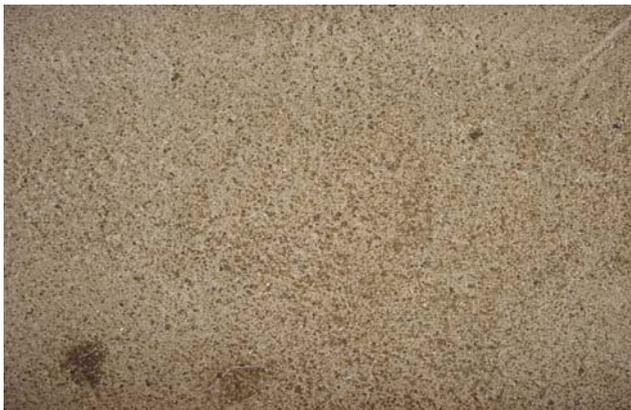
Figure 33. Surface of fire protection coating after test.

The behavior of concrete lining specimen with thickness of 30mm fire protection coating which was different than that of the specimen with thickness of 20mm fire protection coating, was stable during the test. 20 minutes later after the start of the test, temperature of interface between concrete lining cover and fire protection coating increased significantly. Significant amount of steam is released from the gaps between thermo-couples and specimen and also fire protection coating during the test, but the amount of steam is less than that shown from the specimen with thickness of 20mm coating. There were no cracks found on the specimen. The highest temperature measured at interface were 473°C, at mid-depth of concrete cover was 163°C, at surface of lower reinforcing bar was 129°C, at the mid-depth of specimen was 40°C, and at the mid-depth of back concrete lining was 16°C. Figure 31 is a photo of surface of the fire protection coating in the furnace from window. There were no changes of the surface during the test. Figure 32 shows vapors formed from released steam at the fire protection coating. Figure 33 is fire applied surface of the fire protection coating after the test and showed no significant damages

except slight color change. The results show that the newly developed coating material with 30mm thickness is sufficient in resisting the temperature up to 1600°C.

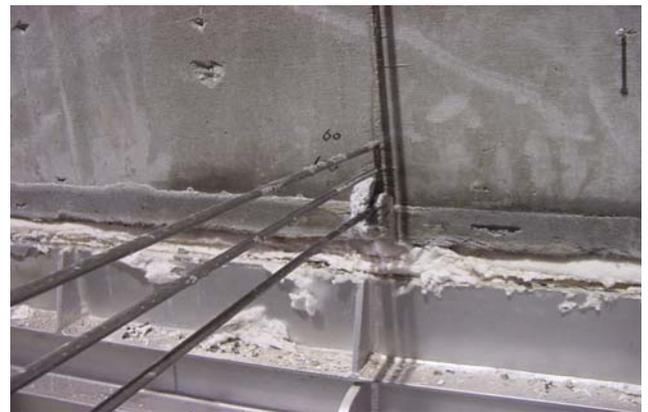
Figure 40. Water steam stain at the interface.

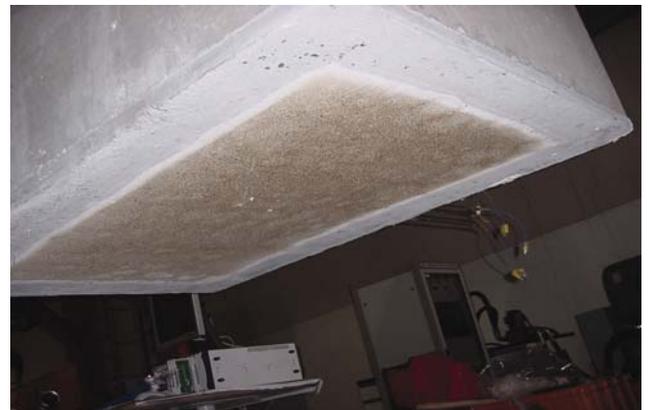
Figure 41. Surface of fire protection coating after test.
