Effect of crack control in hybrid fiber reinforced concrete composites on corrosion rate of steel reinforcing bars

C.P. Ostertag & J. Blunt
University of California, Berkeley, USA

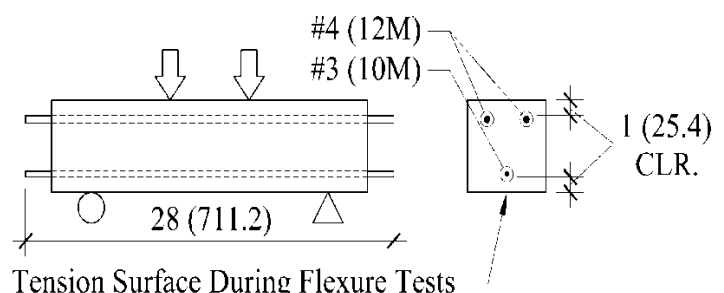
Figure 1. Beam specimen rebar layout and orientation during casting and testing [in (mm)].

Plain and HyFRC beam specimens were used for the corrosion experiments because they provided a convenient configuration to examine the impacts of flexural load induced cracking on corrosion behavior. The HyFRC utilizes steel macrofibers and PVA microfibers. The fiber properties and mix design of the HyFRC are described in reference (Blunt & Ostertag 2009b). The specimens were wet cured for 7 days followed by 21 days of dry curing. The beams specimens (150mm x 150mm x 600mm) shown in Figure 1 were subjected to flexural loading to induce surface cracking prior to exposure to a corrosive environment.

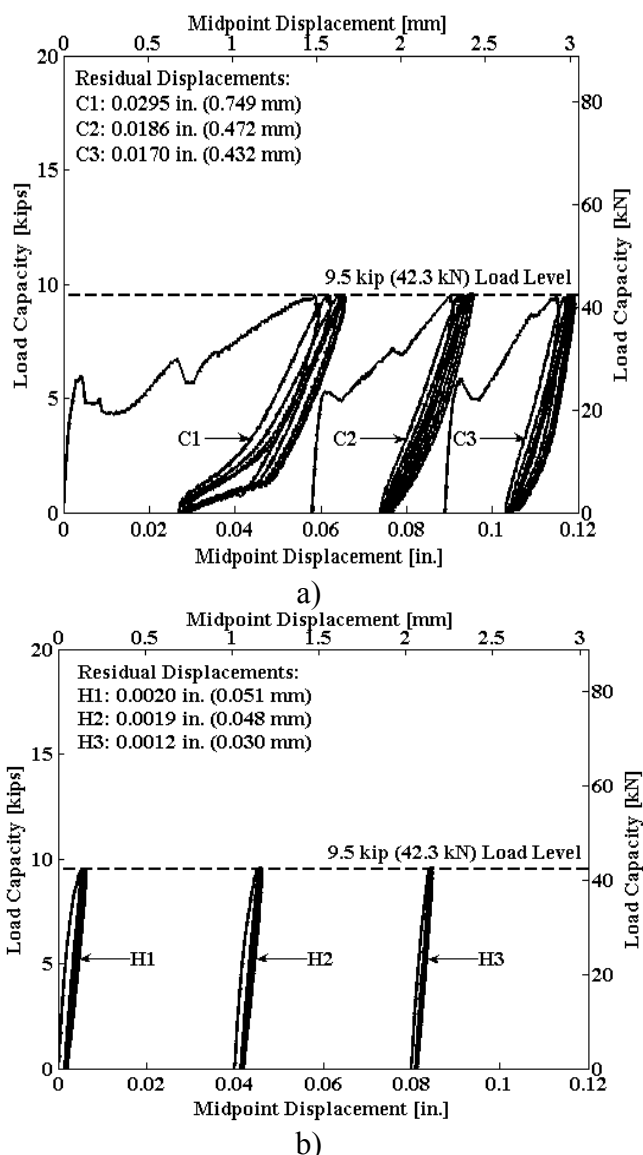
Figure 2. Cyclic flexure behavior for a) reinforced plain concrete and b) reinforced HyFRC subjected to same load level.

Cyclic flexural loading was carried out under deflection control; however a maximum load was specified. The load level was chosen in order to maximize cracked displacement, while not exceeding the yield strength of the rebar. A load level of 42.3 kN was chosen based on the performance of the reinforced plain concrete specimens. This load remained constant between the plain concrete and HyFRC specimens in order to approximate conditions where load based demands control their behavior. Five complete cycles of loading from 0 to the 42.3 kN load level and back were performed on 3 samples of each type of material. The results of the cyclic load tests are provided in Figure 2. The “C” designation represents the plain concrete specimens while the “H” designation represents that of the HyFRC. It is noted that per the conventions of this study, plain concrete and HyFRC refer to the matrix compositions. Due to the fact that we are exploring the corrosion behavior of rebar in these different matrices any reference to the different matrix types implies that rebar is also present in the specimens.

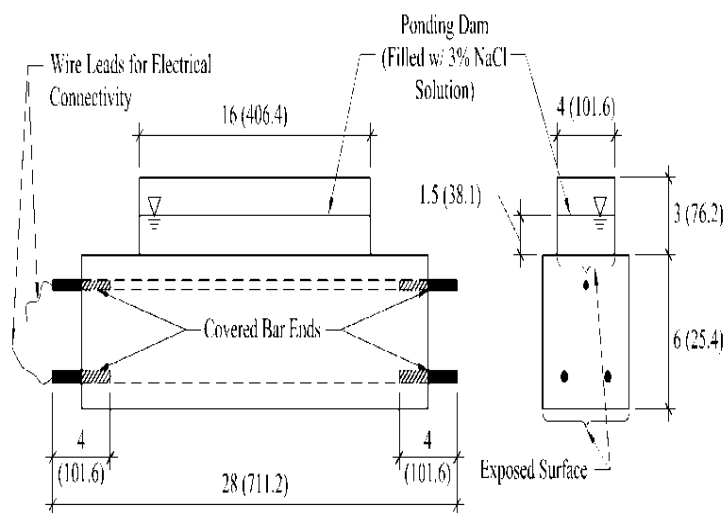
Figure 3. Beam specimen configuration for salt water ponding [in. (mm)].

After cyclic loading corrosion of the rebar was induced by ponding a salt water solution in the configuration shown in Figure 3. The proposed test method is very similar to that specified in ASTM G109 with the major exceptions being that the beam element dimensions have been modified and a potentiodynamic method was used for corrosion monitoring. The ponding dams were constructed out of 3.2 mm thick PVC and were adhered to the concrete surface with a Neoprene™ super flash cement caulk. All beam surfaces not designated as an “exposed surface” (see Fig. 3) were coated with a polymeric based sealant. The intent behind the sealing method was to increase the driving force behind the solution’s intrusion into the beam matrix. The exposed bottom surface provided the only evaporation sink, which would effectively pull the solution through the matrix and create a vertical moisture gradient.

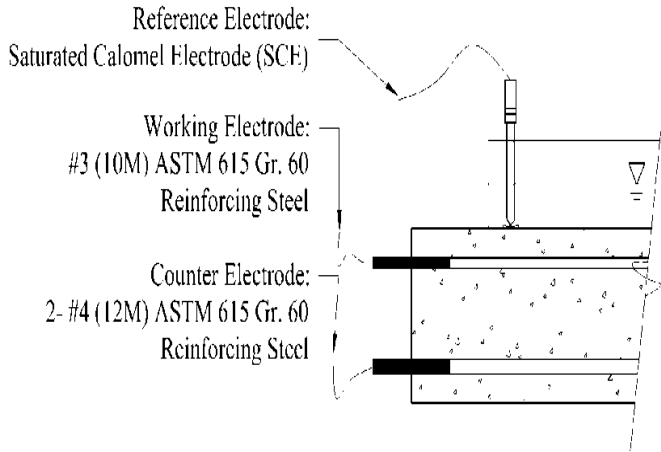
Figure 4. Embedded cell for corrosion monitoring experiments.

For corrosion monitoring, the electrochemical cell was created by placing a saturated calomel electrode (SCE) directly into the ponding dam (Fig. 4). The SCE was used as the reference electrode. The top most #3 (9M) rebar was used as the working electrode (WE) and the two #4 (12M) bottom bars were connected and used jointly as a counter electrode (CE). The beam elements were stored in a hot chamber at 50°C at 50% RH in between

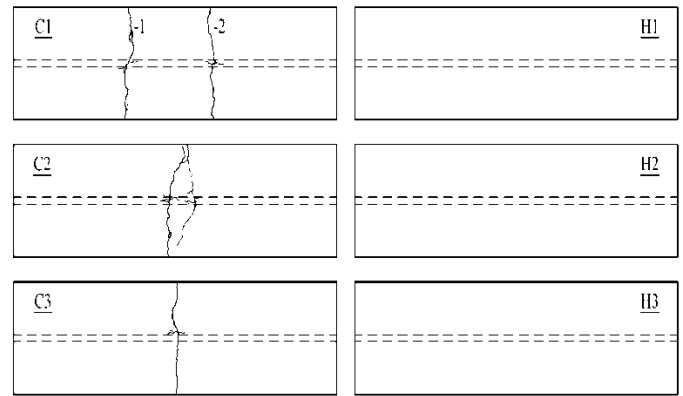
Figure 5. Beam tensile surfaces after cyclic flexure tests (dashed line represents position of the tensile rebar).

Immediately following the cyclic load tests, the tension surfaces of the beam specimens were examined in order to characterize the state of cracking. Schematics of the tensile surface cracking are shown in Figure 5.

The reinforced plain concrete specimens showed localized, transverse surface cracks ranging from 300 – 400 μm in width. Fine, longitudinal cracks (parallel to the direction of the rebar) propagated from the transverse cracks directly over the rebar and ranged in width from 70 – 100 μm . Two transverse cracks formed in the C1 specimen while one formed in both the C2 and C3 beams. This can account for the significantly greater residual displacement in the C1 specimen after load cycling.

Surface cracking was not detectable in the HyFRC specimens.

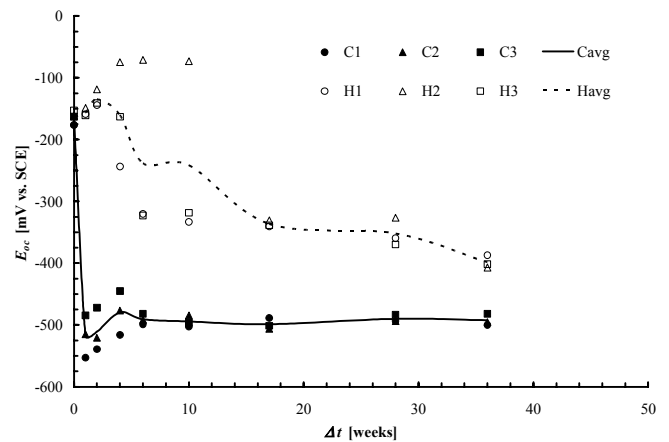
Figure 6. Corrosion potential E_{oc} measurements.

Electrochemical data are plotted as discrete points for each specimen representing the discrete nature of the proposed monitoring technique. The continuous line represents an idealized average behavior through the discrete data points. The values for the corrosion potential E_{oc} and the total corrosion current density i_{tot} are given in Figures 6 and 7. The values for i_{tot} are normalized against the entire exposed surface area of the WE.

Comparison between the different electrochemical monitoring techniques reveals consistency among the measurements. Specimens with more negative E_{oc} 's (the "C" type specimens) showed higher i_{tot} . The average difference ranges between a factor of 8-10 along the corrosion monitoring interval. Corrosion in the reinforced plain concrete specimens was significant enough such that corrosion products were visible at the crack surface. This is shown in Figure 8.

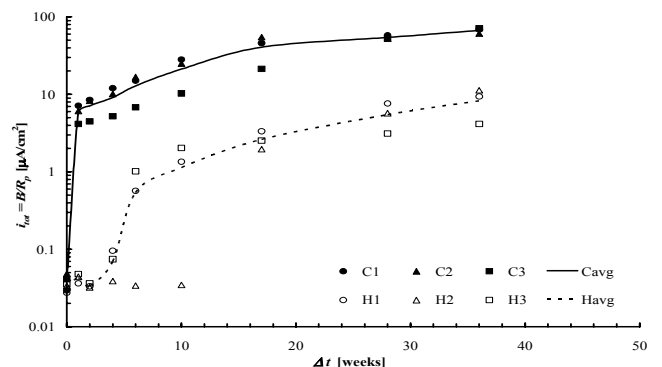
Figure 7. Estimated cracked beam specimen corrosion current densities.

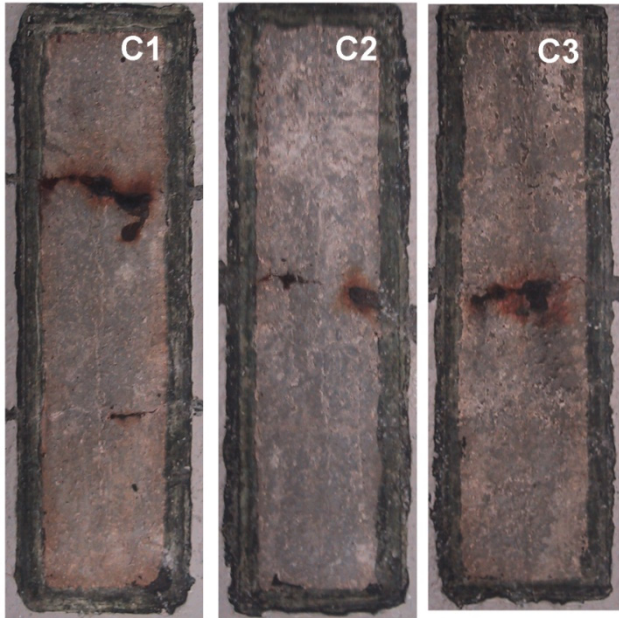
Figure 8. Reinforced plain concrete surface condition following salt water ponding (the black rectangular shape at the periphery of each specimen is the residue from the mastic caulk used to adhere the ponding dams to the concrete surface).

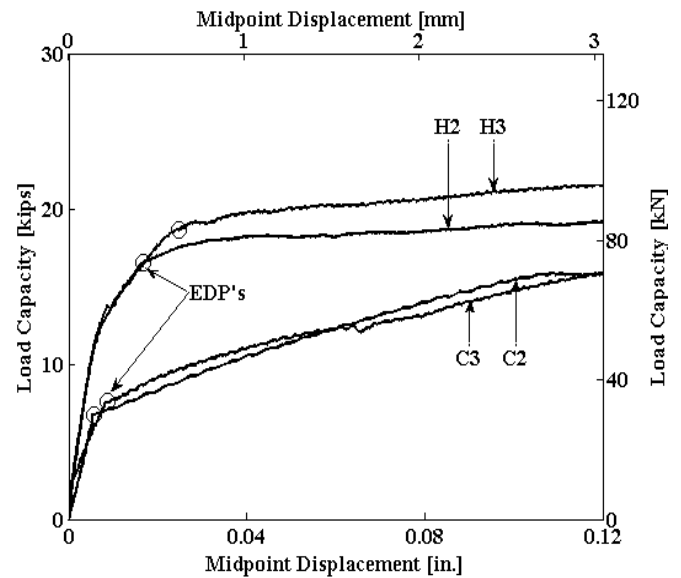
Figure 9. Monotonic flexure tests following 9 months of salt solution ponding.

A series of destructive tests were conducted to characterize the material post corrosion behavior after 9 months of Cl⁻ induced corrosion from salt water ponding. Monotonic, 4 point flexure tests were performed on 2 of the 3 samples for each material type and these results are presented in Figure 9.

Note that cyclic flexural tests (described in section 2) up to a load level of 42.3 kN (9.5 kips) were conducted on these specimens prior to salt solution ponding and that the load level was chosen so as to maximize the reinforced plain concrete cracked displacement while not exceeding the yield strength of the rebar. In Figure 10 the yield point of the rebar is highlighted as engineering design parameters (EDP) for both the reinforced plain concrete and reinforced HyFRC specimens. For both of the reinforced plain concrete specimens, the yield point of the rebar fell below the 42.3 kN (9.5 kip) mark, suggesting that significant section loss from corrosion had occurred where the rebar bridged the crack. In specimen C2, the post-yield flexural

stiffness began to flatten near a displacement demand of 3 mm so flexural testing was continued until rebar fracture occurred at an ultimate displacement of 3.1 mm.

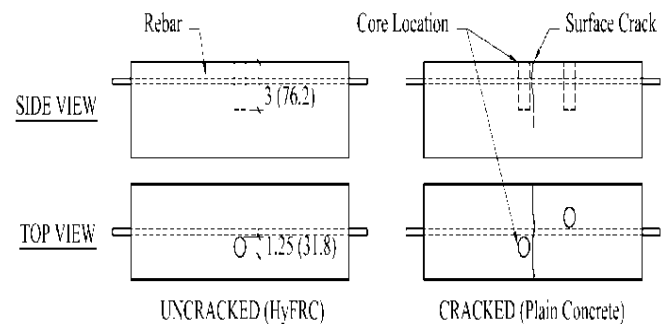
Figure 10. Schematic of core extraction location in beam specimens in [mm].

Following the flexure tests, the beam specimens underwent a series of procedures designed to determine the Cl⁻ concentration through the depth of the specimen and to extract the corroded rebar for visual and gravimetric assessment. In order to conduct the Cl⁻ concentration measurements 31.8 ϕ x 76.2 mm cores were taken through the top surface of beam element adjacent to the WE. One core was taken from the central region of the beam, however for the case where visible surface cracks were present during corrosion monitoring (plain concrete specimens) two cores were taken; one adjacent to the crack and another relatively far (76.2-101.6mm) from the crack (Fig. 10). Core samples were dry cut in to 25.4 mm long segments to characterize the Cl⁻ concentration with depth. They were then prepared and tested per ASTM C1152 for acid soluble chloride content. These results are provided in Figure 11.

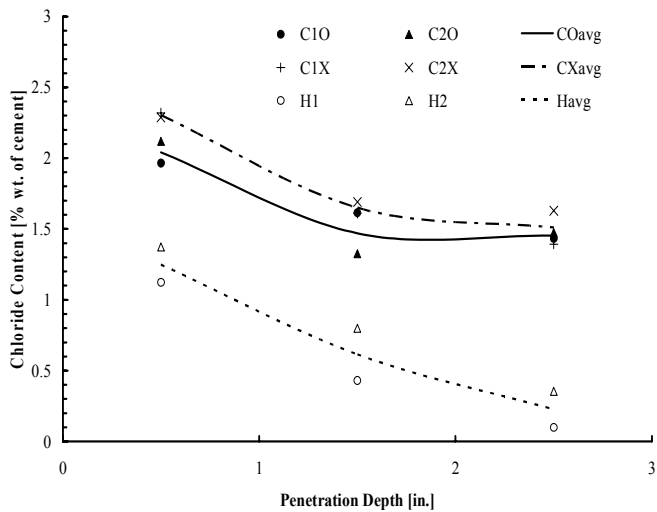
Figure 11. Chloride concentration profiles.

The convention employed for the “C” type specimens is such that an “O” following the specimen designation stands for the samples taken far from the crack and an “X” designates samples that were taken adjacent to the crack. Average behavior is characterized by an idealized, smooth line similar to the one used for the electrochemical measurements. Examination of Figure 11 shows a clear distinction between the HyFRC and plain concrete specimens, which is consistent with the electrochemical data. However, the distinction between the CO and CX specimens is not as clear. Some sensitivity to the transverse crack is apparent with slightly higher Cl⁻ concentrations in the CX specimens; however the difference between the “C” type and “H” type is much greater. It was anticipated prior to testing that the CO specimens would show Cl⁻ concentrations very similar to the H type because the cores were taken sufficiently far from the crack to represent an uncompromised matrix. Surface examinations of the “C” type beams after cyclic loading, prior to the start of ponding, provided validation for this assumption because surface cracks were not visible. However, the data suggests some mechanism is present in the “C” type specimens that is effectively increasing their permeability to Cl⁻.

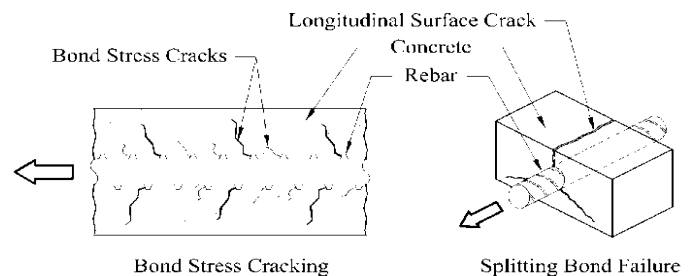
Figure 12. Cracking mechanisms from rebar/matrix bond interaction.

One possible explanation could be the presence of internal cracking from bond stresses. The magnitude of cracking is dependent on multiple factors which include the load on the rebar, the geometry of the rebar and the quality of and thickness of the surrounding concrete. Figure 12 schematically represents possible modes of cracking from rebar/matrix bond interaction which was shown to exist by others (Tepfers 1979). A close examination of the high resolution digital scans of the control specimens revealed fine cracks parallel to the rebar. This is consistent with splitting bond failure. Due to the fact that the cores were extracted

adjacent to the rebar, any internalized system of cracking that propagates from the surface of the rebar would increase the effective permeability of surrounding portions of the matrix which would show up in the Cl⁻ concentration profiles. The presence of the fibers in the H type specimens would assist in resisting this mechanism of cracking by two means. First, due to the fact that load based demands were used in flexure, the presence of the fibers effectively reduces the load demand on the rebar, thereby reducing the bond stresses that develop between the bar and matrix. This alone may have been sufficient to prevent cracking. Secondly, if cracks had formed the fibers would provide sources of toughening in the matrix, thereby reducing the magnitude of crack propagation and growth. It is important to note that the relatively aggressive curing regime of the beams (7 day wet, 21 day dry) may have contributed to cover cracking through mechanisms such as drying shrinkage. These explanations could not be verified directly, however, because of the destructive nature of core sampling and bar removal.

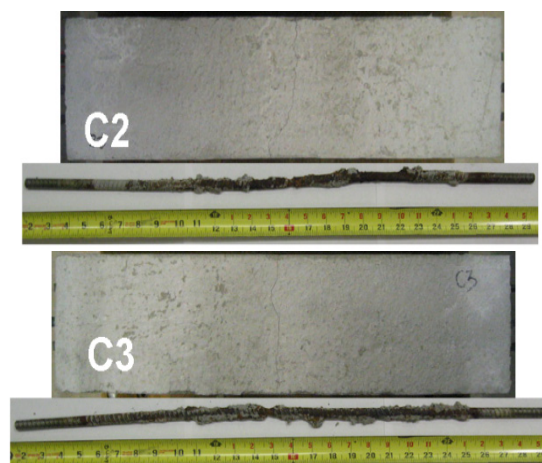
Figure 13. Corroded rebar in plain concrete beam specimens.

Following core extraction, the rebars were removed by destroying the surrounding matrix. The amount of corrosion product deposition along the bar was noted (see Figs. 13-14) and the rebars were then cleaned in an acid bath per ASTM G1-03. Following cleaning, the rebars were immediately weighed and digital scans were made of the area of greatest section loss (see Fig. 15).

It is noted that the 101.6 mm end segments of all the bars were tapped and covered to prevent exposure during corrosion testing which is the reason for the discoloration in the figures. Corrosion product deposition was observed over 87% and 99% of the exposed top surface area of the bars in specimens C2 and C3 respectively with a region of localized section reduction at or adjacent to the location of the visible surface crack. In the HyFRC specimens corrosion product deposition was observed in the central region of the bar (area of highest tensile demand during cyclic loading) covering 24% and 28% of the exposed surface area for specimens H2 and H3 respectively.

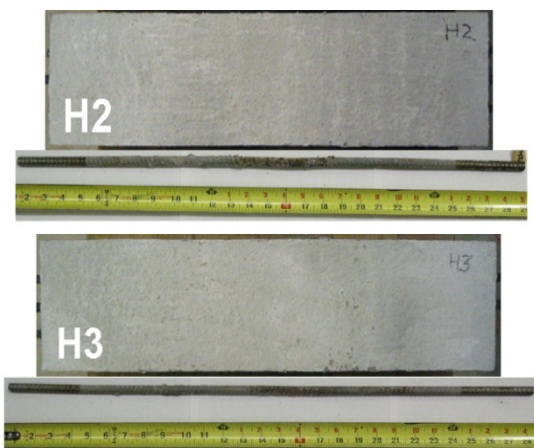
Figure 14. Corroded rebar in HyFRC beam specimens.

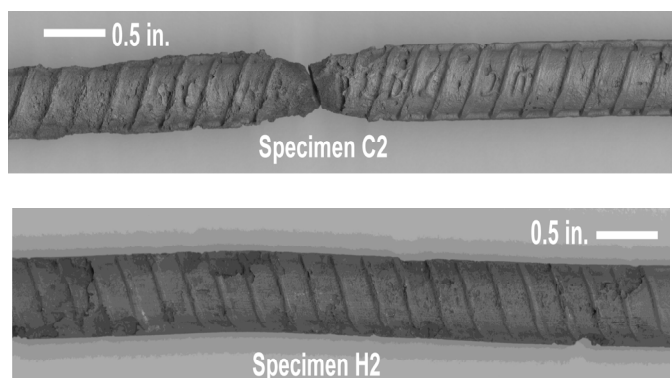
Figure 15. High resolution digital scans of the region of greatest section loss.

The digital scans of Figure 15 were of specimens C2 and H2 and represented the region of greatest damage to the rebar. From a qualitative perspective it is apparent that significantly more damage is visible on the C2 specimen. Note that C2 fractured during post corrosion flexural testing so it becomes difficult to differentiate between necking due to plastic deformation of the bar and section reduction due to localized corrosion at the crack. The remnants of a bar rib are visible across the fracture surface of C2 so it is apparent from a comparison of the surrounding ribs that a significant degree of localized corrosion was in fact happening at the point of fracture. The measured mass loss of the
