Effect of crack control in hybrid fiber reinforced concrete composites on corrosion rate of steel reinforcing bars

C.P. Ostertag & J. Blunt
University of California, Berkeley, USA

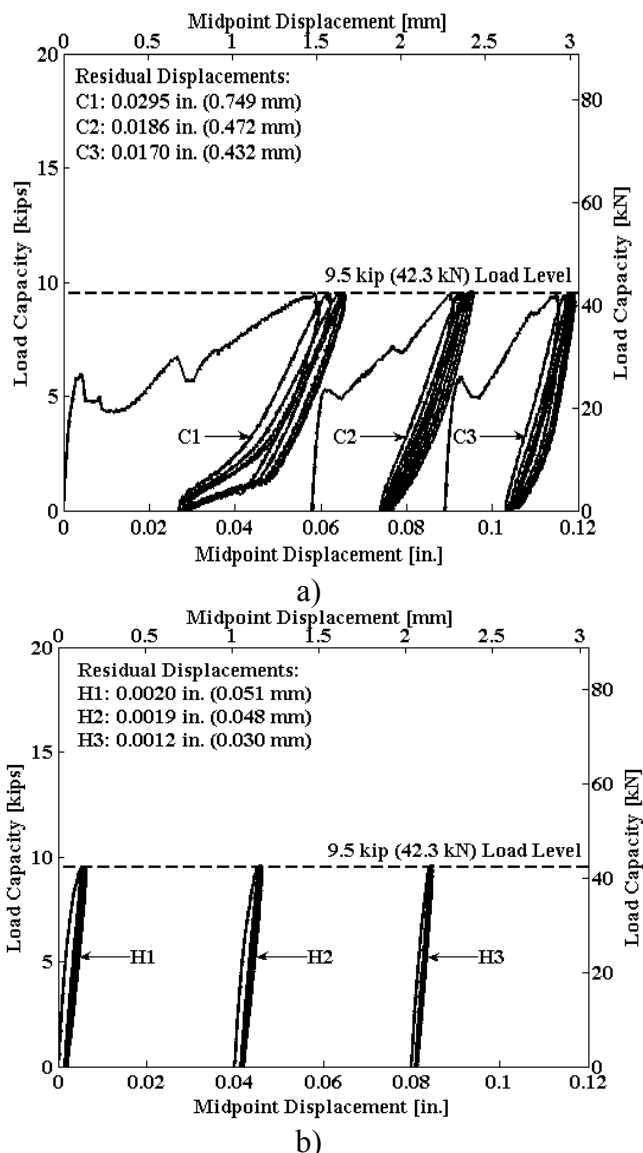
Figure 2. Cyclic flexure behavior for a) reinforced plain concrete and b) reinforced HyFRC subjected to same load level.

Cyclic flexural loading was carried out under deflection control; however a maximum load was specified. The load level was chosen in order to maximize cracked displacement, while not exceeding the yield strength of the rebar. A load level of 42.3 kN was chosen based on the performance of the reinforced plain concrete specimens. This load remained constant between the plain concrete and HyFRC specimens in order to approximate conditions where load based demands control their behavior. Five complete cycles of loading from 0 to the 42.3 kN load level and back were performed on 3 samples of each type of material. The results of the cyclic load tests are provided in Figure 2. The “C” designation represents the plain concrete specimens while the “H” designation represents that of the HyFRC. It is noted that per the conventions of this study, plain concrete and HyFRC refer to the matrix compositions. Due to the fact that we are exploring the corrosion behavior of rebar in these different matrices any reference to the different matrix types implies that rebar is also present in the specimens.

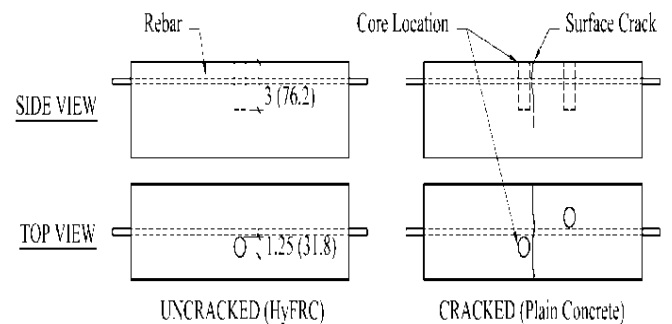
Figure 10. Schematic of core extraction location in beam specimens in [mm].

Following the flexure tests, the beam specimens underwent a series of procedures designed to determine the Cl⁻ concentration through the depth of the specimen and to extract the corroded rebar for visual and gravimetric assessment. In order to conduct the Cl⁻ concentration measurements 31.8φ x 76.2 mm cores were taken through the top surface of beam element adjacent to the WE. One core was taken from the central region of the beam, however for the case where visible surface cracks were present during corrosion monitoring (plain concrete specimens) two cores were taken; one adjacent to the crack and another relatively far (76.2-101.6mm) from the crack (Fig. 10). Core samples were dry cut in to 25.4 mm long segments to characterize the Cl⁻ concentration with depth. They were then prepared and tested per ASTM C1152 for acid soluble chloride content. These results are provided in Figure 11.

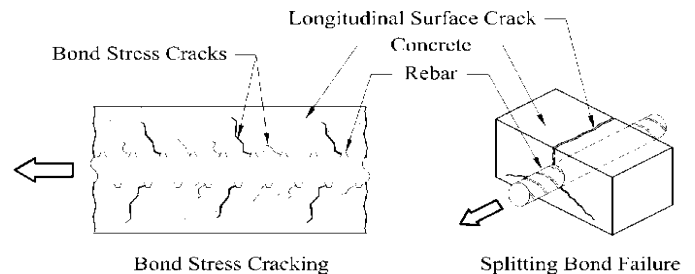
Figure 12. Cracking mechanisms from rebar/matrix bond interaction.

One possible explanation could be the presence of internal cracking from bond stresses. The magnitude of cracking is dependent on multiple factors which include the load on the rebar, the geometry of the rebar and the quality of and thickness of the surrounding concrete. Figure 12 schematically represents possible modes of cracking from rebar/matrix bond interaction which was shown to exist by others (Tepfers 1979). A close examination of the high resolution digital scans of the control specimens revealed fine cracks parallel to the rebar. This is consistent with splitting bond failure. Due to the fact that the cores were extracted

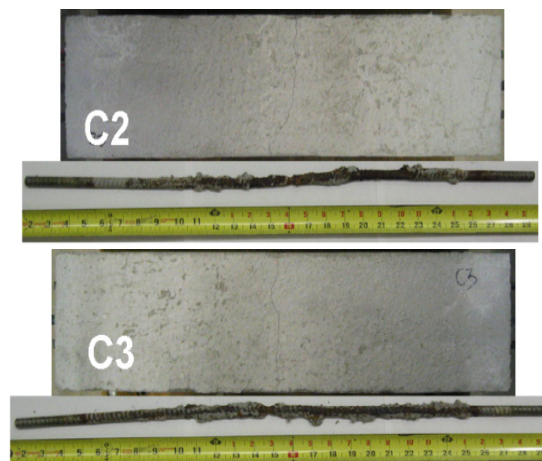
Figure 13. Corroded rebar in plain concrete beam specimens.

Following core extraction, the rebars were removed by destroying the surrounding matrix. The amount of corrosion product deposition along the bar was noted (see Figs. 13-14) and the rebars were then cleaned in an acid bath per ASTM G1-03. Following cleaning, the rebars were immediately weighed and digital scans were made of the area of greatest section loss (see Fig. 15).

It is noted that the 101.6 mm end segments of all the bars were tapped and covered to prevent exposure during corrosion testing which is the reason for the discoloration in the figures. Corrosion product deposition was observed over 87% and 99% of the exposed top surface area of the bars in specimens C2 and C3 respectively with a region of localized section reduction at or adjacent to the location of the visible surface crack. In the HyFRC specimens corrosion product deposition was observed in the central region of the bar (area of highest tensile demand during cyclic loading) covering 24% and 28% of the exposed surface area for specimens H2 and H3 respectively.

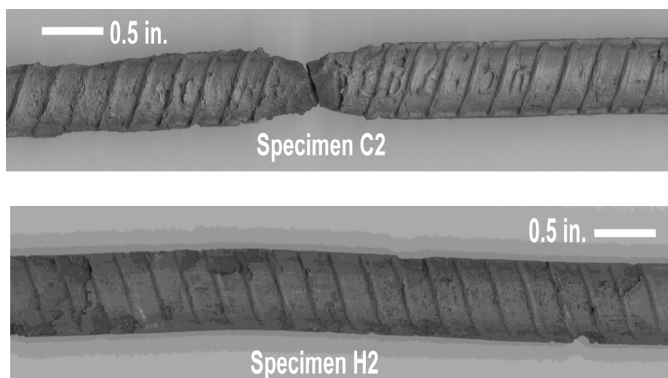
Figure 15. High resolution digital scans of the region of greatest section loss.

The digital scans of Figure 15 were of specimens C2 and H2 and represented the region of greatest damage to the rebar. From a qualitative perspective it is apparent that significantly more damage is visible on the C2 specimen. Note that C2 fractured during post corrosion flexural testing so it becomes difficult to differentiate between necking due to plastic deformation of the bar and section reduction due to localized corrosion at the crack. The remnants of a bar rib are visible across the fracture surface of C2 so it is apparent from a comparison of the surrounding ribs that a significant degree of localized corrosion was in fact happening at the point of fracture. The measured mass loss of the
