Effect of crack control in hybrid fiber reinforced concrete composites on corrosion rate of steel reinforcing bars

C.P. Ostertag & J. Blunt
University of California, Berkeley, USA

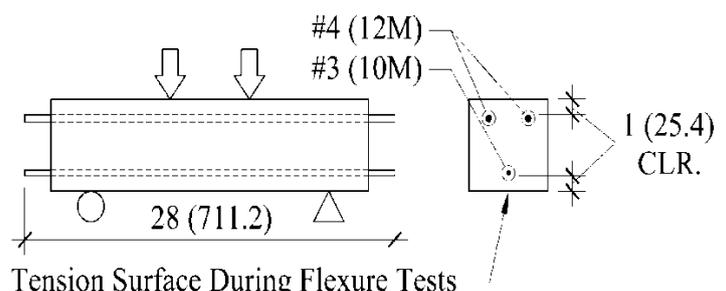
Figure 1. Beam specimen rebar layout and orientation during casting and testing [in (mm)].

Plain and HyFRC beam specimens were used for the corrosion experiments because they provided a convenient configuration to examine the impacts of flexural load induced cracking on corrosion behavior. The HyFRC utilizes steel macrofibers and PVA microfibers. The fiber properties and mix design of the HyFRC are described in reference (Blunt & Ostertag 2009b). The specimens were wet cured for 7 days followed by 21 days of dry curing. The beams specimens (150mm x 150mm x 600mm) shown in Figure 1 were subjected to flexural loading to induce surface cracking prior to exposure to a corrosive environment.

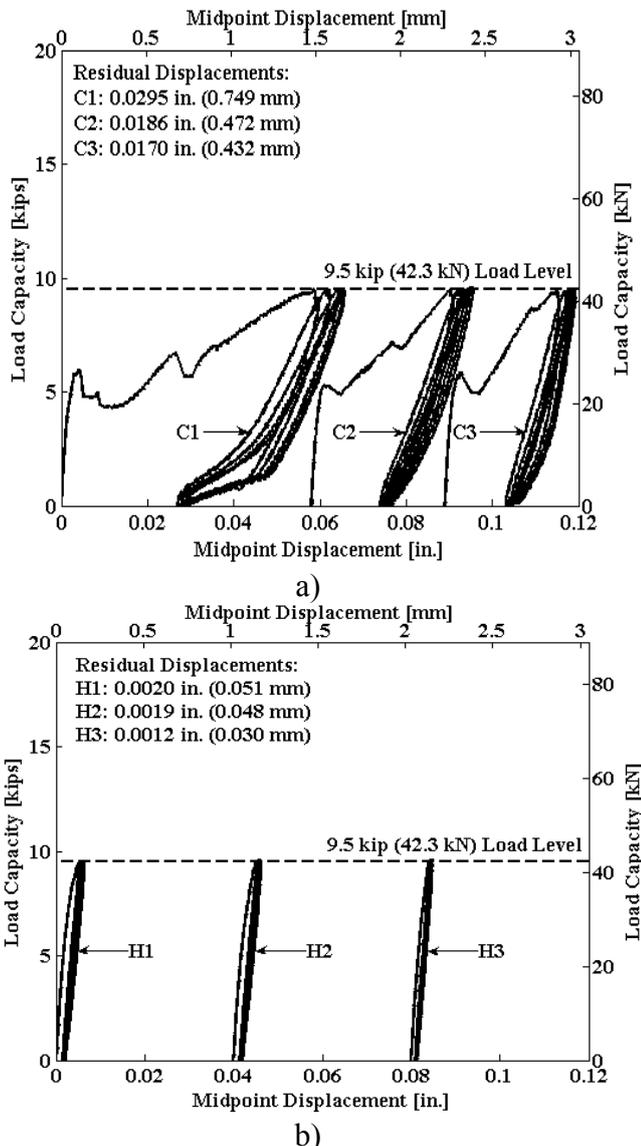
Figure 2. Cyclic flexure behavior for a) reinforced plain concrete and b) reinforced HyFRC subjected to same load level.

Cyclic flexural loading was carried out under deflection control; however a maximum load was specified. The load level was chosen in order to maximize cracked displacement, while not exceeding the yield strength of the rebar. A load level of 42.3 kN was chosen based on the performance of the reinforced plain concrete specimens. This load remained constant between the plain concrete and HyFRC specimens in order to approximate conditions where load based demands control their behavior. Five complete cycles of loading from 0 to the 42.3 kN load level and back were performed on 3 samples of each type of material. The results of the cyclic load tests are provided in Figure 2. The “C” designation represents the plain concrete specimens while the “H” designation represents that of the HyFRC. It is noted that per the conventions of this study, plain concrete and HyFRC refer to the matrix compositions. Due to the fact that we are exploring the corrosion behavior of rebar in these different matrices any reference to the different matrix types implies that rebar is also present in the specimens.

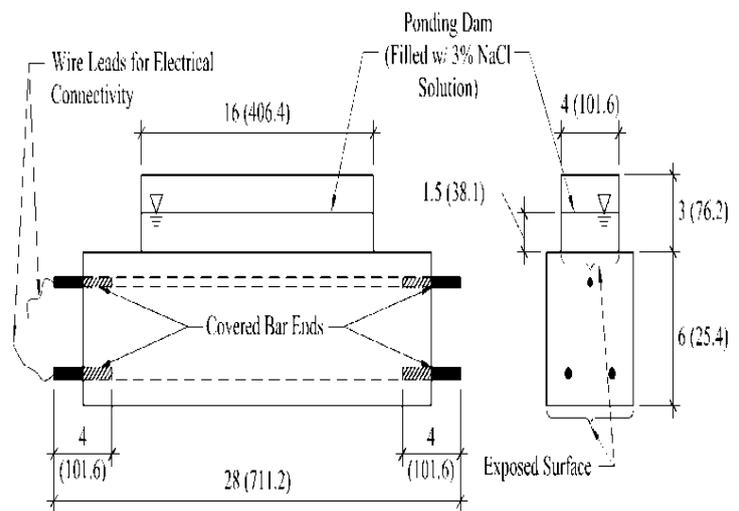
Figure 3. Beam specimen configuration for salt water ponding [in. (mm)].

After cyclic loading corrosion of the rebar was induced by ponding a salt water solution in the configuration shown in Figure 3. The proposed test method is very similar to that specified in ASTM G109 with the major exceptions being that the beam element dimensions have been modified and a potentiodynamic method was used for corrosion monitoring. The ponding dams were constructed out of 3.2 mm thick PVC and were adhered to the concrete surface with a Neoprene™ super flash cement caulk. All beam surfaces not designated as an “exposed surface” (see Fig. 3) were coated with a polymeric based sealant. The intent behind the sealing method was to increase the driving force behind the solution’s intrusion into the beam matrix. The exposed bottom surface provided the only evaporation sink, which would effectively pull the solution through the matrix and create a vertical moisture gradient.

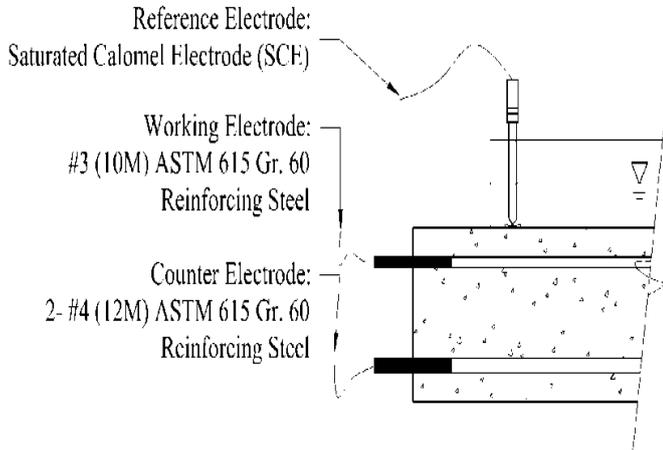
Figure 4. Embedded cell for corrosion monitoring experiments.

For corrosion monitoring, the electrochemical cell was created by placing a saturated calomel electrode (SCE) directly into the ponding dam (Fig. 4). The SCE was used as the reference electrode. The top most #3 (9M) rebar was used as the working electrode (WE) and the two #4 (12M) bottom bars were connected and used jointly as a counter electrode (CE). The beam elements were stored in a hot chamber at 50°C at 50% RH in between

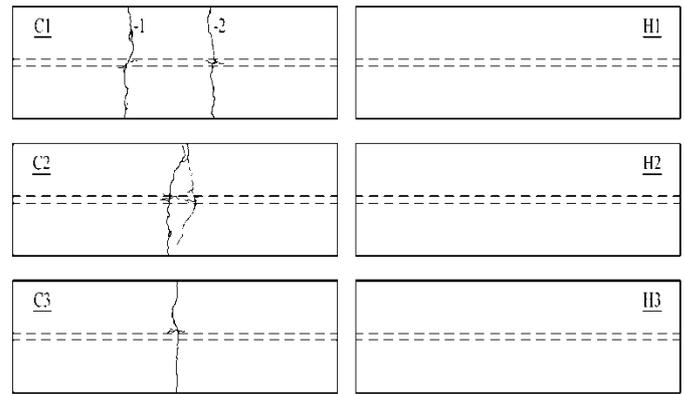
Figure 5. Beam tensile surfaces after cyclic flexure tests (dashed line represents position of the tensile rebar).

Immediately following the cyclic load tests, the tension surfaces of the beam specimens were examined in order to characterize the state of cracking. Schematics of the tensile surface cracking are shown in Figure 5.

The reinforced plain concrete specimens showed localized, transverse surface cracks ranging from 300 – 400 μm in width. Fine, longitudinal cracks (parallel to the direction of the rebar) propagated from the transverse cracks directly over the rebar and ranged in width from 70 – 100 μm . Two transverse cracks formed in the C1 specimen while one formed in both the C2 and C3 beams. This can account for the significantly greater residual displacement in the C1 specimen after load cycling.

Surface cracking was not detectable in the HyFRC specimens.

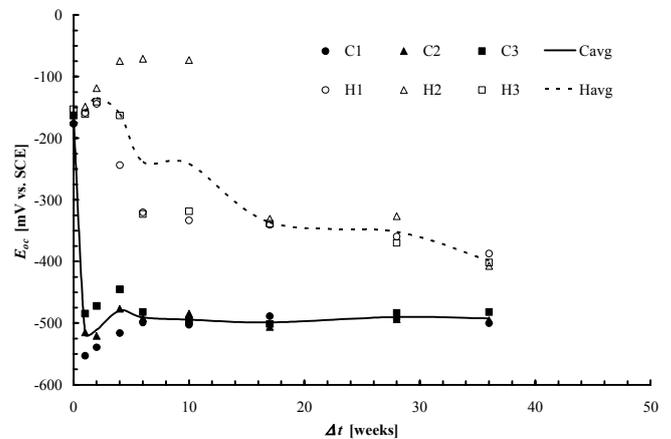
Figure 6. Corrosion potential E_{oc} measurements.

Electrochemical data are plotted as discrete points for each specimen representing the discrete nature of the proposed monitoring technique. The continuous line represents an idealized average behavior through the discrete data points. The values for the corrosion potential E_{oc} and the total corrosion current density i_{tot} are given in Figures 6 and 7. The values for i_{tot} are normalized against the entire exposed surface area of the WE.

Comparison between the different electrochemical monitoring techniques reveals consistency among the measurements. Specimens with more negative E_{oc} 's (the "C" type specimens) showed higher i_{tot} . The average difference ranges between a factor of 8-10 along the corrosion monitoring interval. Corrosion in the reinforced plain concrete specimens was significant enough such that corrosion products were visible at the crack surface. This is shown in Figure 8.

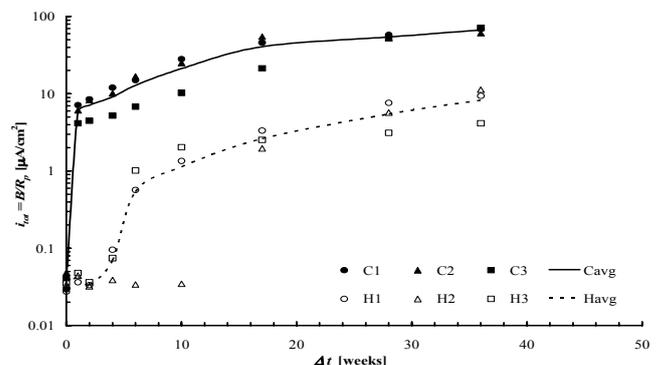
Figure 7. Estimated cracked beam specimen corrosion current densities.

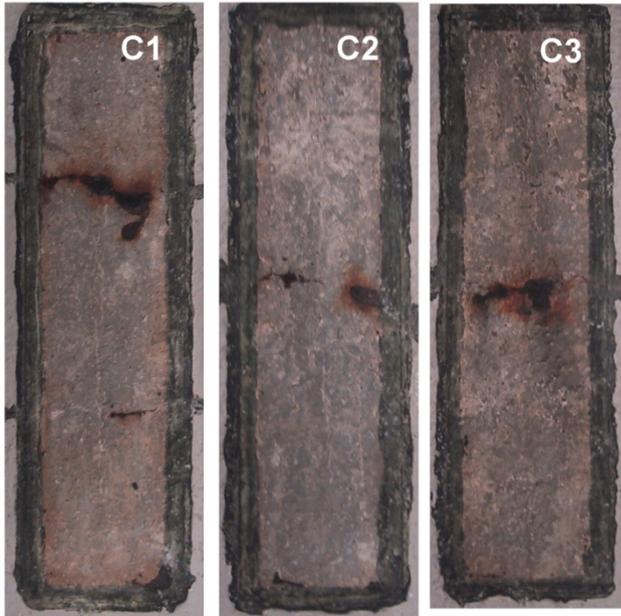
Figure 8. Reinforced plain concrete surface condition following salt water ponding (the black rectangular shape at the periphery of each specimen is the residue from the mastic caulk used to adhere the ponding dams to the concrete surface).

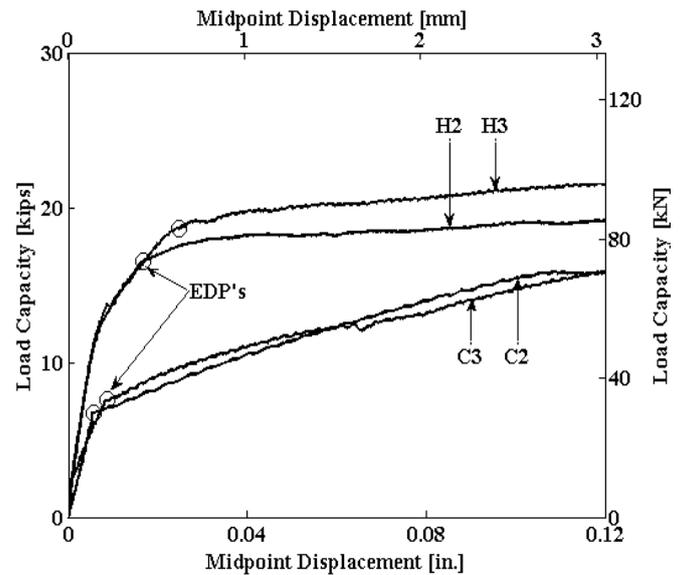
Figure 9. Monotonic flexure tests following 9 months of salt solution ponding.

A series of destructive tests were conducted to characterize the material post corrosion behavior after 9 months of Cl⁻ induced corrosion from salt water ponding. Monotonic, 4 point flexure tests were performed on 2 of the 3 samples for each material type and these results are presented in Figure 9.

Note that cyclic flexural tests (described in section 2) up to a load level of 42.3 kN (9.5 kips) were conducted on these specimens prior to salt solution ponding and that the load level was chosen so as to maximize the reinforced plain concrete cracked displacement while not exceeding the yield strength of the rebar. In Figure 10 the yield point of the rebar is highlighted as engineering design parameters (EDP) for both the reinforced plain concrete and reinforced HyFRC specimens. For both of the reinforced plain concrete specimens, the yield point of the rebar fell below the 42.3 kN (9.5 kip) mark, suggesting that significant section loss from corrosion had occurred where the rebar bridged the crack. In specimen C2, the post-yield flexural

stiffness began to flatten near a displacement demand of 3 mm so flexural testing was continued until rebar fracture occurred at an ultimate displacement of 3.1 mm.

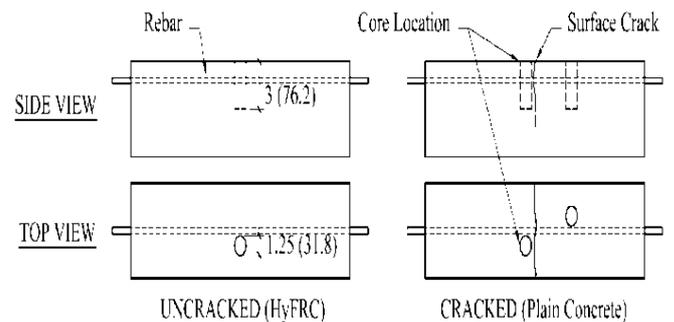
Figure 10. Schematic of core extraction location in beam specimens in [mm].

Following the flexure tests, the beam specimens underwent a series of procedures designed to determine the Cl⁻ concentration through the depth of the specimen and to extract the corroded rebar for visual and gravimetric assessment. In order to conduct the Cl⁻ concentration measurements 31.8φ x 76.2 mm cores were taken through the top surface of beam element adjacent to the WE. One core was taken from the central region of the beam, however for the case where visible surface cracks were present during corrosion monitoring (plain concrete specimens) two cores were taken; one adjacent to the crack and another relatively far (76.2-101.6mm) from the crack (Fig. 10). Core samples were dry cut in to 25.4 mm long segments to characterize the Cl⁻ concentration with depth. They were then prepared and tested per ASTM C1152 for acid soluble chloride content. These results are provided in Figure 11.

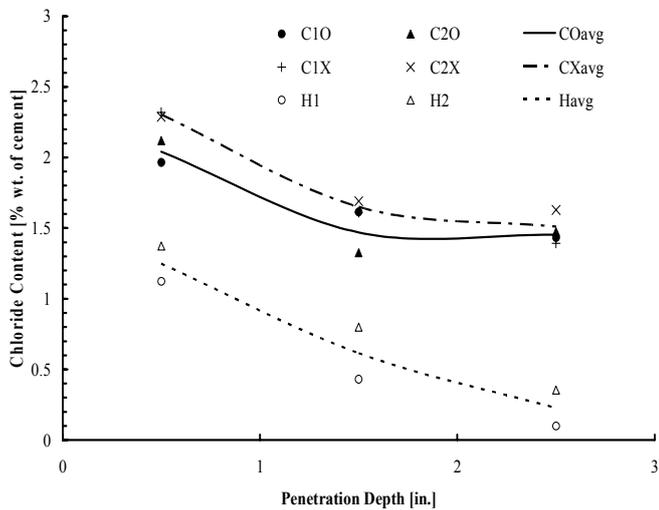
Figure 11. Chloride concentration profiles.

The convention employed for the “C” type specimens is such that an “O” following the specimen designation stands for the samples taken far from the crack and an “X” designates samples that were taken adjacent to the crack. Average behavior is characterized by an idealized, smooth line similar to the one used for the electrochemical measurements. Examination of Figure 11 shows a clear distinction between the HyFRC and plain concrete specimens, which is consistent with the electrochemical data. However, the distinction between the CO and CX specimens is not as clear. Some sensitivity to the transverse crack is apparent with slightly higher Cl⁻ concentrations in the CX specimens; however the difference between the “C” type and “H” type is much greater. It was anticipated prior to testing that the CO specimens would show Cl⁻ concentrations very similar to the H type because the cores were taken sufficiently far from the crack to represent an uncompromised matrix. Surface examinations of the “C” type beams after cyclic loading, prior to the start of ponding, provided validation for this assumption because surface cracks were not visible. However, the data suggests some mechanism is present in the “C” type specimens that is effectively increasing their permeability to Cl⁻.

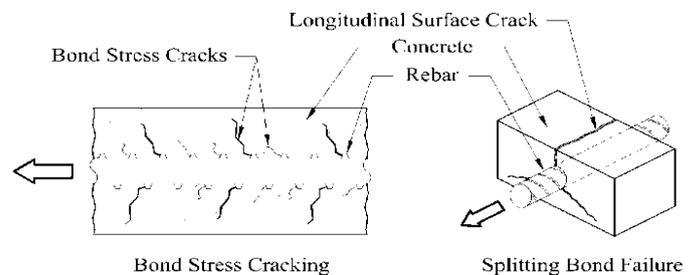
Figure 12. Cracking mechanisms from rebar/matrix bond interaction.

One possible explanation could be the presence of internal cracking from bond stresses. The magnitude of cracking is dependent on multiple factors which include the load on the rebar, the geometry of the rebar and the quality of and thickness of the surrounding concrete. Figure 12 schematically represents possible modes of cracking from rebar/matrix bond interaction which was shown to exist by others (Tepfers 1979). A close examination of the high resolution digital scans of the control specimens revealed fine cracks parallel to the rebar. This is consistent with splitting bond failure. Due to the fact that the cores were extracted

adjacent to the rebar, any internalized system of cracking that propagates from the surface of the rebar would increase the effective permeability of surrounding portions of the matrix which would show up in the Cl⁻ concentration profiles. The presence of the fibers in the H type specimens would assist in resisting this mechanism of cracking by two means. First, due to the fact that load based demands were used in flexure, the presence of the fibers effectively reduces the load demand on the rebar, thereby reducing the bond stresses that develop between the bar and matrix. This alone may have been sufficient to prevent cracking. Secondly, if cracks had formed the fibers would provide sources of toughening in the matrix, thereby reducing the magnitude of crack propagation and growth. It is important to note that the relatively aggressive curing regime of the beams (7 day wet, 21 day dry) may have contributed to cover cracking through mechanisms such as drying shrinkage. These explanations could not be verified directly, however, because of the destructive nature of core sampling and bar removal.

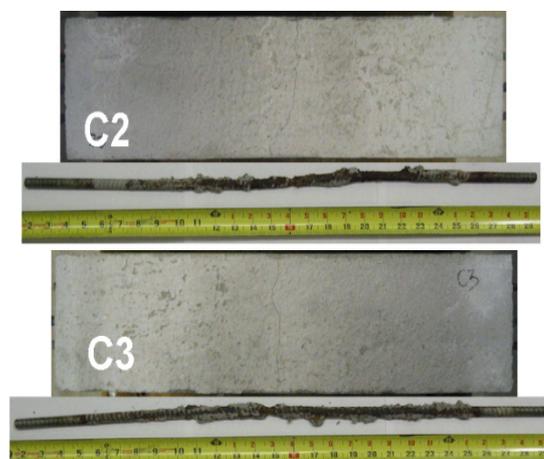
Figure 13. Corroded rebar in plain concrete beam specimens.

Following core extraction, the rebars were removed by destroying the surrounding matrix. The amount of corrosion product deposition along the bar was noted (see Figs. 13-14) and the rebars were then cleaned in an acid bath per ASTM G1-03. Following cleaning, the rebars were immediately weighed and digital scans were made of the area of greatest section loss (see Fig. 15).

It is noted that the 101.6 mm end segments of all the bars were tapped and covered to prevent exposure during corrosion testing which is the reason for the discoloration in the figures. Corrosion product deposition was observed over 87% and 99% of the exposed top surface area of the bars in specimens C2 and C3 respectively with a region of localized section reduction at or adjacent to the location of the visible surface crack. In the HyFRC specimens corrosion product deposition was observed in the central region of the bar (area of highest tensile demand during cyclic loading) covering 24% and 28% of the exposed surface area for specimens H2 and H3 respectively.

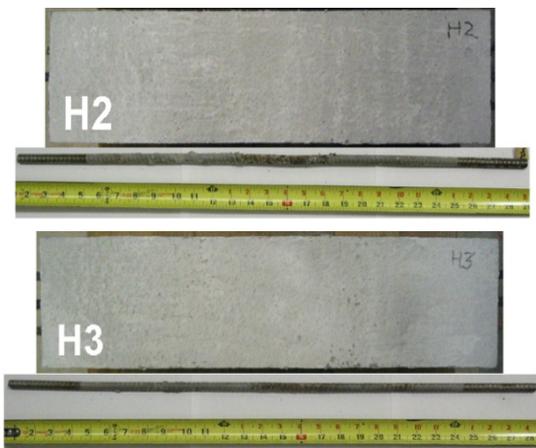
Figure 14. Corroded rebar in HyFRC beam specimens.

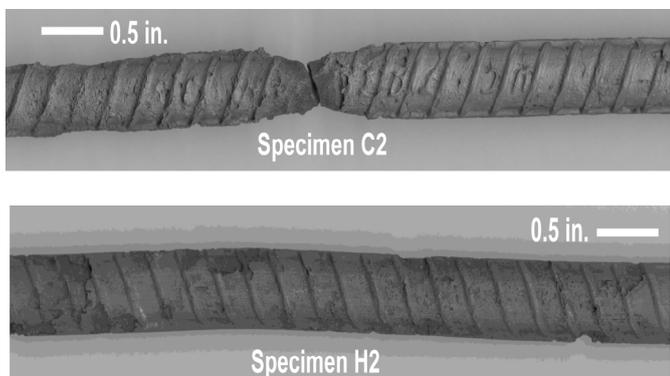
Figure 15. High resolution digital scans of the region of greatest section loss.

The digital scans of Figure 15 were of specimens C2 and H2 and represented the region of greatest damage to the rebar. From a qualitative perspective it is apparent that significantly more damage is visible on the C2 specimen. Note that C2 fractured during post corrosion flexural testing so it becomes difficult to differentiate between necking due to plastic deformation of the bar and section reduction due to localized corrosion at the crack. The remnants of a bar rib are visible across the fracture surface of C2 so it is apparent from a comparison of the surrounding ribs that a significant degree of localized corrosion was in fact happening at the point of fracture. The measured mass loss of the
