Visualization of internal defects in concrete structures by SIBIE

ABSTRACT: By applying the impact-echo method, SIBIE (Stack Imaging of spectral amplitudes Based on Impact Echo) procedure is developed as an imaging technique, which can visually display a cross-sectional view based on the impact-echo data. The procedure is applied to on-site measurement in concrete structures. In order to identify voids in delaminated zone between concrete piers of an express highway and pre-stressed concrete (PC) panels covered, the impact was driven with two-point detection. For estimation of the surface-crack depth, one-point detection was applied. From these results, an applicability of the procedure to on-site measurement for internal voids and cracks is demonstrated in existing concrete structures.

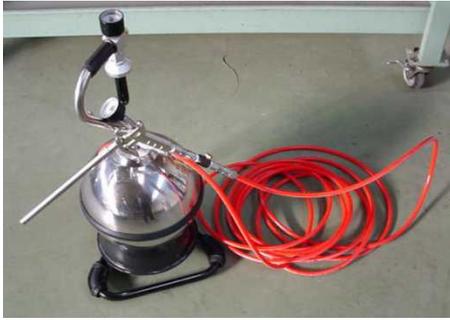
Figure 2. Portable compressor and a shooting device.

An aluminum bullet of 8 mm diameter and 17 mm length in Figure 1 is shot at the impact point by a projectile system via compressed air (0.05 MPa) shown in Figure 2. The projectile system consists of a portable compressor and a shooting device for the aluminum

bullet. Elastic waves generated are detected at the surface by an accelerometer next to the impact point. A cross-section of a specimen measured is modeled and divided into square elements as shown in Figure 3. Then, resonant frequencies due to reflection at the element are theoretically and virtually calculated, without taking into account whether the resonant vibrations occur or not. The travel distance from the input point to the output via the center of the element is calculated as denoted in the figure,

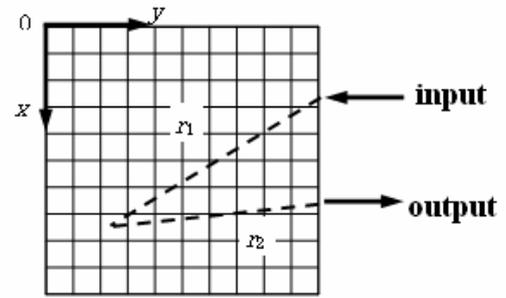
Figure 3. A cross-section divided into meshes.

Here C_p is the velocity of P wave. In a frequency spectrum of a detected wave, spectral amplitudes corresponding to these two resonant frequencies are just summed up at the element as a reflection intensity. Thus, a stack image is created at each element. Assigning stack images at all elements, a contour map on the reflection intensity is eventually obtained at the cross-section. As discussed in the previous paper [3], the minimum length of the square element, Δx , is determined from,

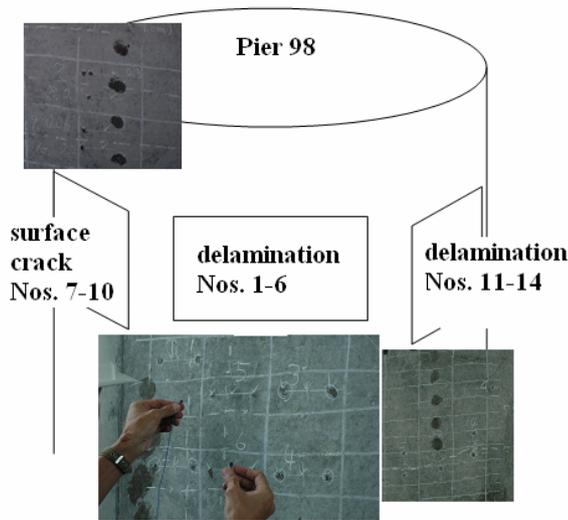
Figure 4. Pier 98 and selected points for the test.

Impact tests were performed at Pier 98 and at Pier 99. In Pier 98, three areas were selected as shown in Figure 4. At each area, right before the test, P-wave velocity was determined by employing an ultrasonic tester (MIN-02, Marui). The time of flight was measured 10 times at four locations with 50 mm interval on the panel surface. Dark circles in the pictures show the points where sensors of the tester were set up. At the points of Nos. 1 to 6, voids or delaminations were attempted to be detected by applying two-point detection. In the piers, delaminated area was identified in advance by hammer-hitting. At the point selected, the impact was driven by the shooting device. Two accelerometers were attached at two locations 50 mm horizontally apart from the impacted point, and elastic waves were detected and recorded.

At the semi-circular end of the pier, the points of Nos. 7 to 10 was selected. Because a surface crack extended in the vertical direction was found, the impact was driven at the location 50 mm horizontally apart from the surface crack and the accelerometer

was attached at the counter location 50 mm apart from the crack to detect elastic waves. At the other end of the pier, delaminated area was found and thus the points of Nos. 11 to 14 were selected and tested.

P-wave velocities measured are given in Table 1. The velocities were measured at four areas of pictures in Figure. 4-5. The velocities were measured on the surface at four intervals. Consequently, from the relationship between the distances and arrival times, the velocity was evaluated as the gradient of the highest correlation coefficient. It is noted that these velocities in the table are obtained by the surface method. It is known that the velocity measured by the surface method could be slower than that of the through-transmission method. This might affect results of the SIBIE analysis.

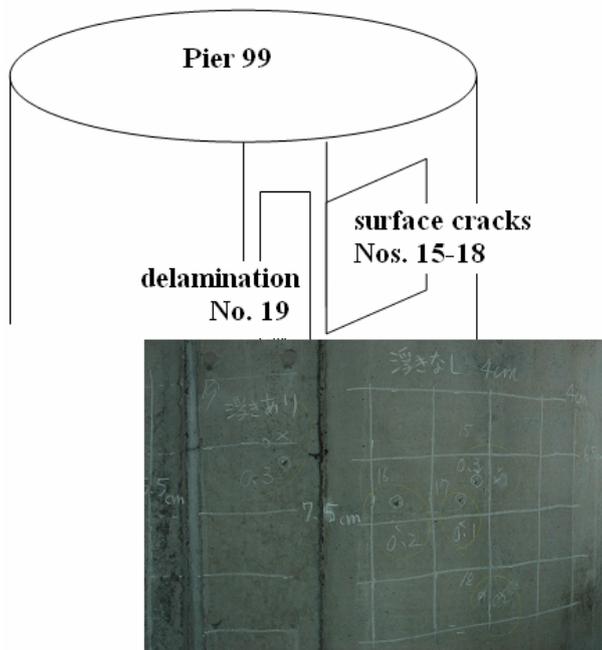
Figure 5. Pier 99 and selected points for the test.

In Pier 99, the points of Nos. 15 to 19 were selected and tested as shown in Figure 5. Again, at each area, P wave velocities were measured in advance. The point of No. 19 is located at a joint between a flat panel and a curved panel, where concrete was cast on site after a jointed device was set up at 40 mm depth.

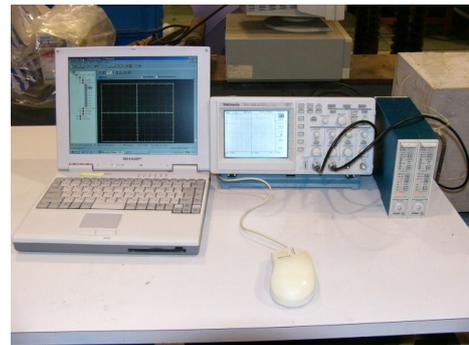
Figure 6. Data acquisition and analysis system.

At each point, the impact was driven five times and five waveforms were recorded after visually confirming the waves on CRT screen. A storage-type oscilloscope (TDS2014, Tektronix) was employed

to store the waveform data in time domain. A waveform was digitized at 4 μ sec sampling time (Δt) of 2048 recording words ($N=2048$). By employing the FFT software, frequency spectrum was determined, and then the SIBIE analysis was performed. Here, taking into account the thickness of PC panel (100 mm), 12 kHz was set as the lower-bound frequency in the analysis, which corresponds to approximately 150 mm depth. 40 kHz upper-bound frequency was selected due to the characteristic range of the accelerometer. Equipments for recording data and analysis are given in Figure 6.

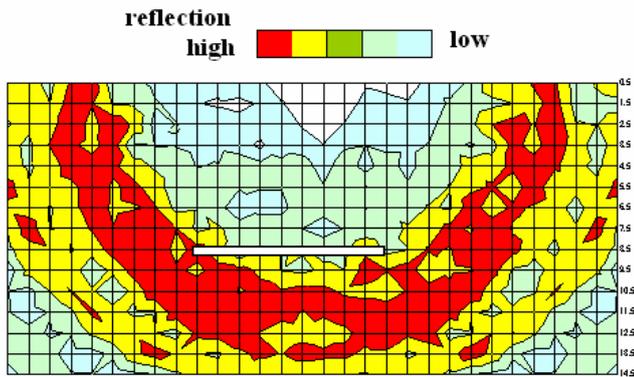
Figure 7. SIBIE result at the point of No. 1.

A result at the point of No. 1 is shown in Figure 7. The dimension of a mesh is 10 mm x 10 mm. The reflection intensity at each mesh is graded with 5 colors from high to low. The ordinate in the figures here-in-after denotes the depth of the cross-section with centi-meter unit. Because the delamination should exist at 100 mm depth, open rectangular area is inserted at 100 mm depth. The reflection intensity is classified by colors as indicate at the top. From the figure, it is realized that the delamination is really present, and the width of void gap could be around 30 mm. It is interesting that the effects of reinforcement at 50 mm depth and post-tensioning sheath at 85 mm depth are minor in the result. This is because the upper-bound frequency is set at 40 kHz, and thus the effect of shallow reflector becomes less dominant than the void.

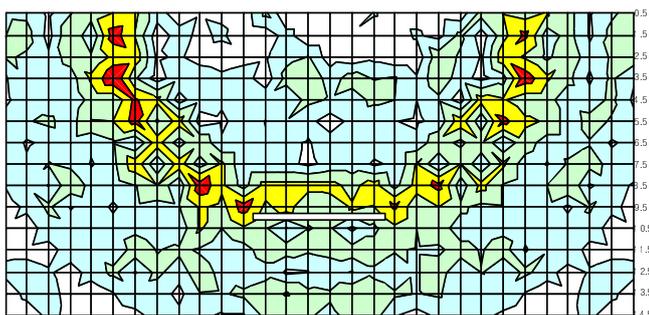
Figure 8. SIBIE result at the point of No. 2.

A result at the point of No. 2 is shown in Figure 8. The point was located around a transition zone between delaminated and well bonded areas. As a result, the reflection intensity at 100 mm depth is weak.

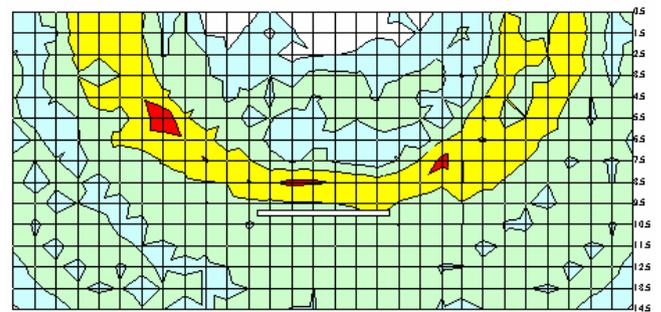
Figure 9. SIBIE result at the point of No. 11.

A result at the point of No. 11 is given in Figure 9. Weak reflection intensity is observed at an area upward apart from the assigned depth of the delamination (rectangular blank area). Because the thickness of PC panel is 100 mm, a shallower delamination than 100 mm is not plausible. This might be because the velocity of P wave was estimated as slower than actual. As realized in Table 1, P-wave velocity measured for Nos. 11 to 14 is the slowest of all. It is known that the velocity measured in the surface method could be slower than that of the through-transmission method. The area of Nos. 11 to 14 is a curved end of the pier, and thus the slower velocity might result in estimation of a shallower delamination in the analysis. It is noted that the reflection intensity is not so high in comparison with other cases. Therefore, it might suggest that the portion is not delaminated evidently.

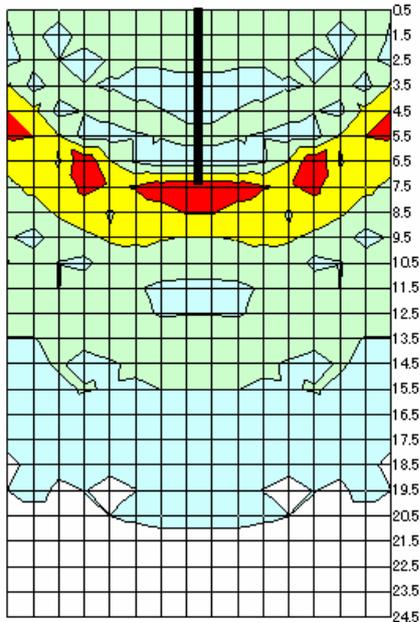
Figure 10. SIBIE result at the point of No. 8 (0.1 mm width).

A result at the point of No. 8 is shown in Figure 10. In the figure, a virtual crack is illustrated by a solid line, which is extended from the top surface to the zone of highest reflection intensity. The case illustrated is a surface crack with 0.1 mm width of crack-mouth opening. The depth is estimated to be around 80-90 mm, which is shallower than the thickness of PC panel (100 mm). It suggests that the surface crack does not reach up to the bottom of PC panel.

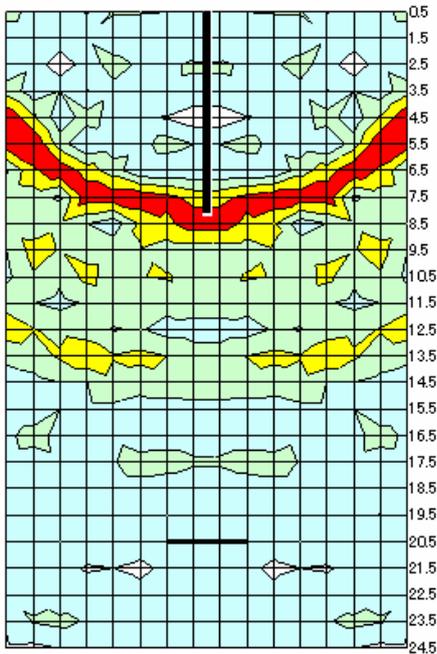
Figure 11. SIBIE result at the point of No. 10 (0.2 mm width).

At the point of No.10 in Figure 11, the depth is estimated around 95 mm. This implies that a surface crack could be referred to be a through-thickness crack in PC panel. Since the crack-mouth opening width was 0.2 mm, these two cases suggest that surface cracks with the width over 0.1 mm possibly extend up to the bottom of PC panels.

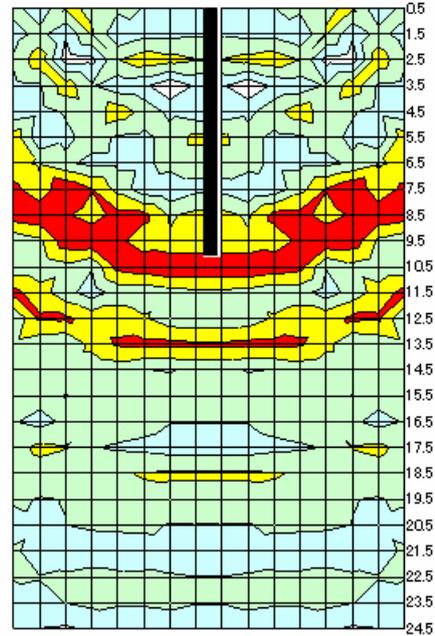
Figure 12. SIBIE result at the point of No. 17 (0.1 mm width).

Another case of 0.1 mm crack width is given at the point of No. 17 in Figure 12. Here, two zones of high reflection intensity are observed. One is located at around 100 mm depth. So, the crack line is drawn up to this depth, suggesting a through-thickness crack in PC panel. In the case, the crack width of surface opening was 0.1 mm. The second is observed at around 130 mm depth. This implies that the void of delamination is present below the surface crack. So, the surface crack reaches to the depth of PC

panel, and the delaminated void of around 30-40 mm width might be created between the panel and the concrete pier.

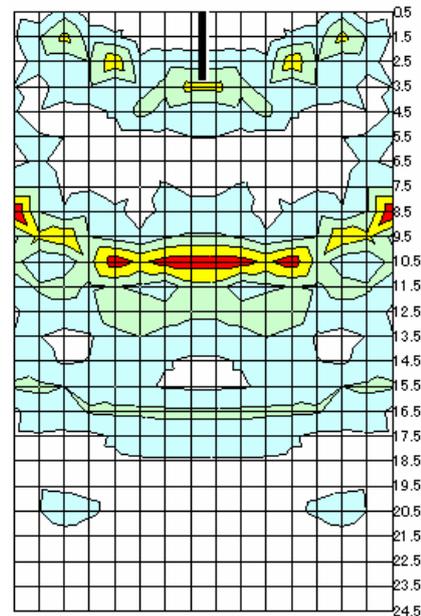
Figure 13. SIBIE result at the point of No. 19 (0.3 mm width).

A result of SIBIE analysis is shown in Figure 13. It is observed that the depth of a surface crack is around 40 mm, although the crack opening width was 0.3 mm wide. It is in good agreement with the depth of connection joint between the flat and the curved panels.

Consequently, the surface crack is arrested at 40 mm depth. In addition, the delamination is observed at 100 mm depth. Due to shrinkage of in-place concrete, therefore, the surface crack was created by external constraint from the both-side panels, and the delamination occurred at the interfacial zone between the cast concrete and the concrete pier.

The point of No. 19 is located on the in-place casting concrete, which corresponds to a jointed portion between a flat PC panel and a curved panel. In almost of all piers, surface cracks were observed, probably because of shrinkage at an early age and an external constraint in the hardening process.
