Effect of hogging moment on FRP debonding from the substrate of concrete beams

ABSTRACT: In recent two decades, the bonding of fiber reinforced polymer (FRP) on the tensile side of concrete members has been accepted as an effective and efficient method for strengthening and retrofitting concrete structures. In the present study, to investigate the failure behavior of the FRP strengthened concrete beams under practical conditions, the experimental tests different from the three-point or four-point bending tests are performed. To simulate a continuously supported concrete member, hogging moments are applied on the two ends of a beam specimen to achieve compression zones near the supports. The experimental parameters include the hogging-to-sagging moment ratio, the distance between the plate end and the support, FRP thickness and so on. According to the test results, with end zones of the FRP plate anchored within the compression zone, the longitudinal compression around the plate end can lead to a transition of failure mode from plate end failure to crack-induced debonding, associating with a corresponding enhancement of the moment capacity. For the beams failed in the mode of inter

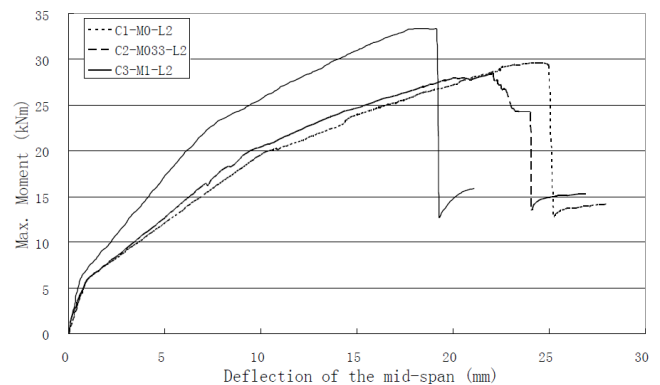
Figure 3. Moment-deflection curves for the specimens strengthened with 2 FRP layers.

In the experiments, the beams with two plies of FRP all failed by intermediate crack induced debonding. Figure 3 depicts the moment responses of all the 2-ply beams. For specimens with low hogging moment, i.e. C1-M0-L2 and C2-M033-L2, the initial cracks occurred at about 6 kNm, and steel yielded at the moment of about 20 kNm. With further increasing load, initial debonding of the FRP plate from the bottom of an intermediate crack occurred, as shown in Figure 4. This brittle failure was accompanied by a sharp drop of external moment, and the residual moment was very close to the yielding moment of the beam before strengthening. For C2-M033-L2, instead of a sudden debonding, the interfacial crack stopped near the point where the sectional moment was zero, resulting in a partial drop of the moment (Fig. 4). From the figure, the behaviors of C1-M0-L2 and C2-M033-L2 are similar before debonding. The latter specimen has a slightly higher stiffness after the first set of cracks occurred. For the specimen with higher hogging moment (C3-M1-L2), it shows higher stiffness and its debonding moment increases by 12.8% compared

to the other two specimens. However, in this case, the lowest deflection at debonding is obtained, indicating that the ductility of the specimen is decreased.

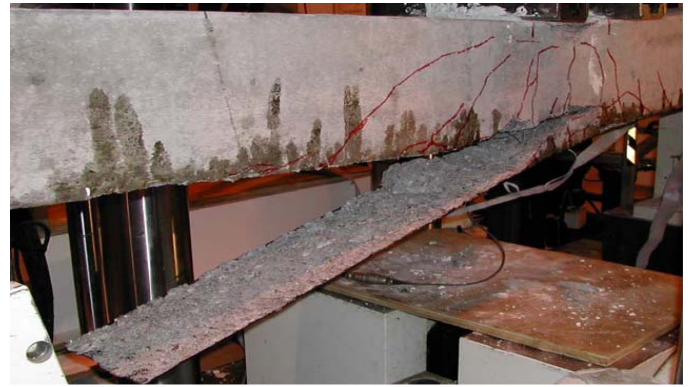
Figure 7. Intermediate crack induced debonding for the beam C5-M043-L6.

For the specimen C5-M043-L6, the ratio between the hogging and sagging moment was 0.43, and this strengthened beam failed in the mode of intermediate crack induced debonding. When the applied moment at the middle span was smaller than 7 kNm, the strengthened beam was still in elastic stage and the deflection of the beam increased linearly with the external moment. With further loading, a set of cracks formed at the middle span with a sudden change of stiffness. The deflection of the beam still increased linearly with increasing moment until the yielding point of the tension reinforcement was reached. Initial debonding of the FRP plate occurred from the bottom of a major flexural crack at the middle span at about 35 kNm. With increasing moment, debonding of the FRP plate gradually propagates along the concrete-to-FRP interface until final failure. The final crack pattern of the strengthened beam is shown in Figure 7.

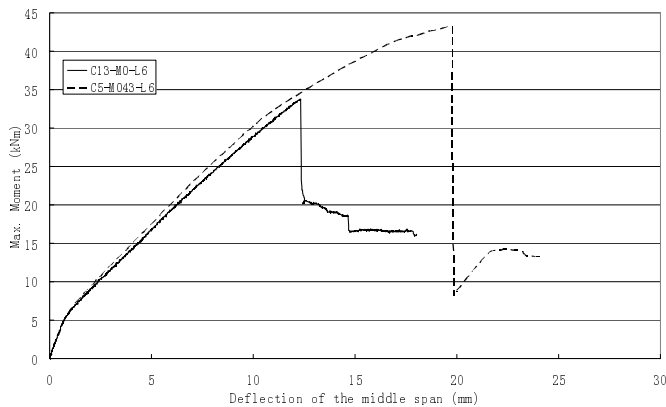
Figure 5. Moment-deflection curves for two typical specimens with 6 FRP layers.

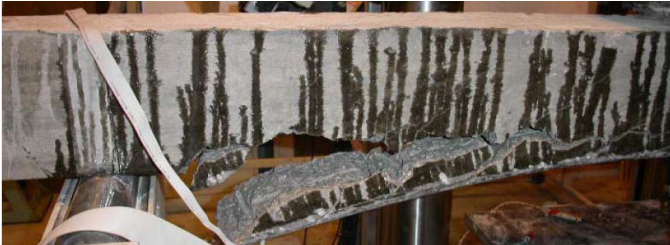
Figure 6. Concrete cover separation for the beam C13-M0-L6.

and flexural/shear cracks started to occur along the span of the strengthened beam, resulting in a reduction of the stiffness. The displacement in the middle of the span increased more quickly with the external loading. When the moment reached about 22.3 kNm, a flexural-shear crack formed at or near the plate end. With further increase of the external loading, this crack tended to grow into the concrete compression zone, towards the direction of the nearer loading point. When the crack was arrested by the internal stirrups, a peeling crack developed at the level of the internal bars. The propagation of this crack was immediately followed by the peel-off of the concrete cover as shown in Figure 6.
