CONSTRUCTION AND STRUCTURAL ANALYSIS OF THE DOME OF THE CATHEDRAL OF VALENCIA

ALONSO A.*, MARTÍNEZ A.†, LLOPIS V.†, MORENO J.†

ABSTRACT

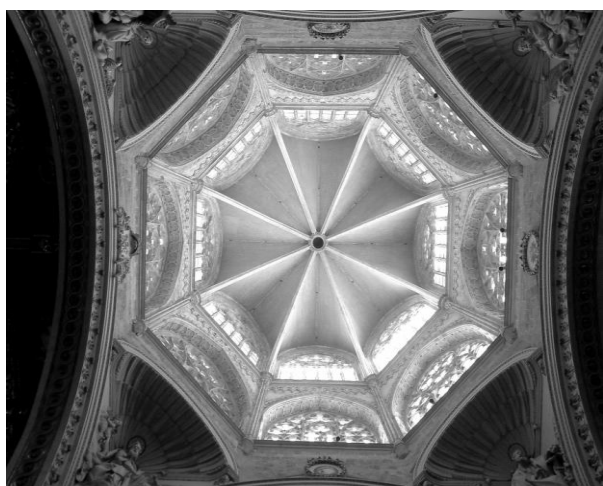
Figure 4:Image inside of the Cimborio

second tier in 1432 due to wind damage, and again in 1698, when they were replaced by alabaster panels. In 1731 general repairs were done to the arches and vaults, as a result of that new tracery and mullions were given. In 1863, under the direction of Joaquín M^a Calvo, new alabaster panels were put in place with iron frames. In 1919 Francisco Mora installed a reinforcing iron band over the windows in the upper tier. In 1978 Ramiro Moya replaced the iron frames of the alabaster panels with new ones made from stainless steel, the roof was strengthened with a reinforced concrete slab, a metal band was placed around the oculus and a stainless steel brace was added to the arches outside of the second tier (*figure 4*).

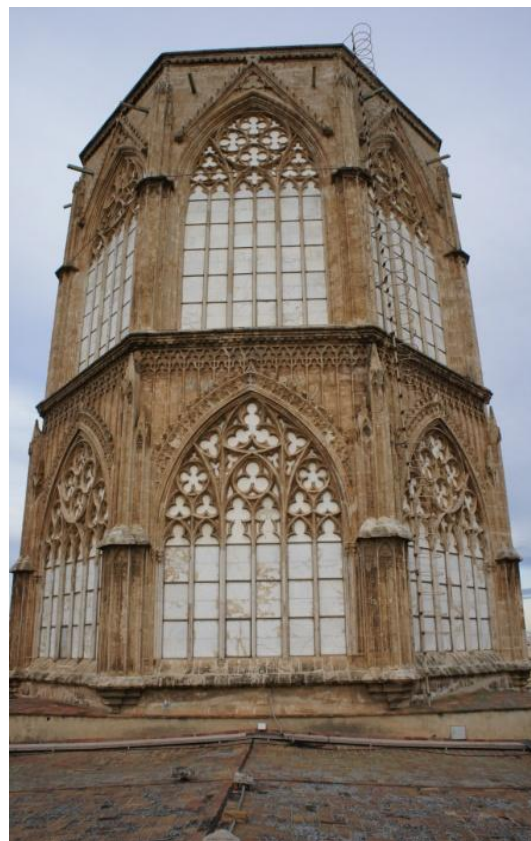
Figure 5:Image outside of the Cimborio

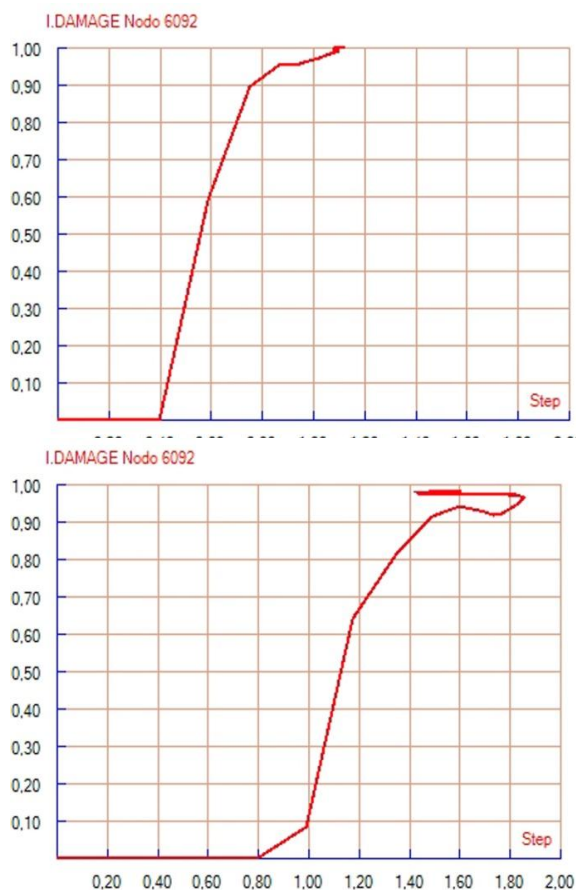
Figure 13: Two hypothesis of analysis with 0,05N/mm² and 0,1N/mm² tensile strength respectively

In order to study the results, the damage formulation is considered as the most important parameter in the structural behaviour. The damaged parts of the structure are compared under the two hypothesis described and it is found out that the safety margin of the structure is very low in the hypothesis with 0,05N/mm² tensile strength. For this reason the structure degrades and starts to break down at a load of 1,05 its own weight. Whereas in the hypothesis with 0,1 Mpa, the safety margin of the structure is bigger, getting a safety coefficient of 1,60 its own weight (*figure 13*).
