Induction healing of concrete reinforced by bitumen-coated steel fibres

Claudia Romero Rodríguez^{1,2,*}, Stefan Chaves Figueiredo², Bernardino Chiaia¹, Erik Schlangen²

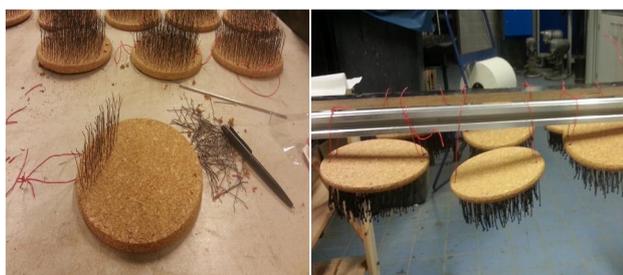
The steel fibres were embedded within one hooked extremity (10mm) in cork slabs. Kuwait 40/60 penetration class bitumen was heated in the oven at 160°C for 2 hours and poured into a basin inside which the slabs were sank and then hanged till bitumen got cold. The process can be seen in Figure 1.

Figure 1: Bitumen coating of steel fibres.

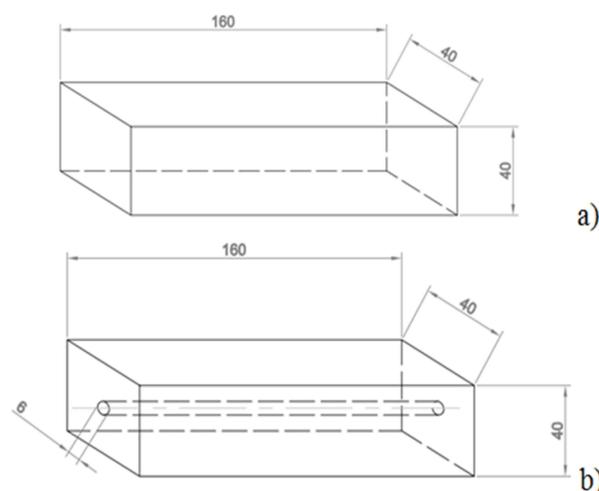
Massive prismatic beams, with dimensions shown in Figure 2a were used as specimens for microscopy and mechanical tests of healed specimens; while a hole along the length of the prisms was produced to perform permeability testing (Figure 2b) by introducing a smooth steel bar during the casting and pulling it out after 24 hours.

Figure 2: Geometry and dimensions of specimens a) for microscopy and mechanical testing, b) for permeability testing.

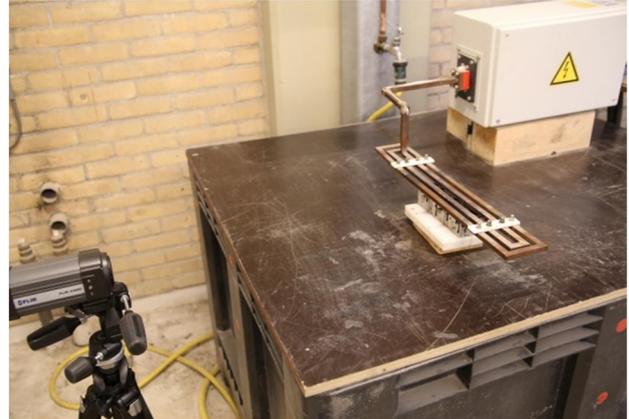
A full colour infrared camera FLIR, Type A320, was used to record temperature distribution on the samples surface (Figure 3). ThermaCAM™ Researcher Pro 2.10 was used for the treatment, processing and analysis of the recorded images.

Figure 3: Set-up of induction heating and infrared camera measurements.

Immediately after the introduction of cracking, the specimens were subjected to the healing intervention. An induction heating generator from HÜTTINGER Electronic Germany was used to heat the fibers inside the specimens; the cracked bottom was placed at 10mm from the coil. Frequency of the magnetic field was fixed at 70kHz and the capacity of the generator was 50kW. Such parameters have a tremendous influence on the heating rates [7], but they weren't studied within this research.

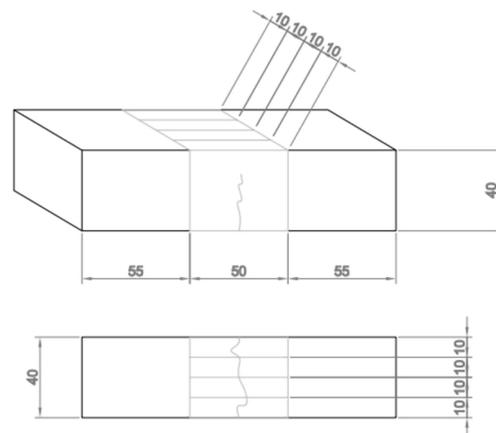
Seven days old prisms from b1fcon1, b2fcon2 and b3fcon2 mixtures were cracked, healed and impregnated with a yellow-dyed epoxy resin. Four longitudinal sections were sawn from each specimen as described in Figure 4 and a second impregnation was performed on them. Silicon carbide paper was used to grind and polish the sections with aid of a polishing machine.

Figure 4: Longitudinal sections obtained from healed specimens.

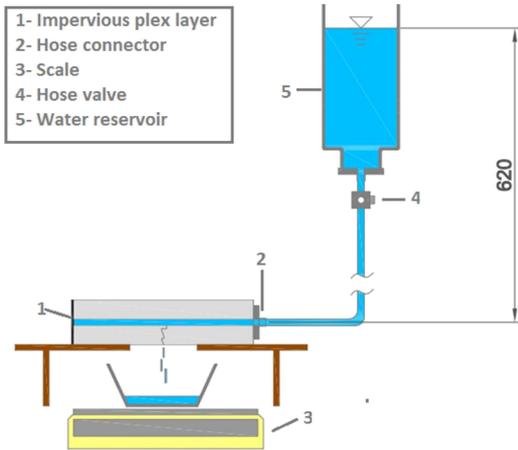
Permeability test via water flow which setup is shown in Figure 5 was used to verify the recovery on the crack water leakage rates after healing of 28 days old holed prismatic specimens.

Figure 5: Permeability test via water flow [8].

A hose was connected to one extremity of the longitudinal hole of the beam by means of a connector, while the other extremity was sealed with a plex layer to prevent the water from going out through it. The valve was opened and water started to flow inside the previously saturated specimens. Since the only escape path was the crack crossing the hole, water started leaking from it and the weight of water was measured as a function of time. The water head was kept constant at 0.62m, offering a water pressure in the hole of $p=0.061$ bar.

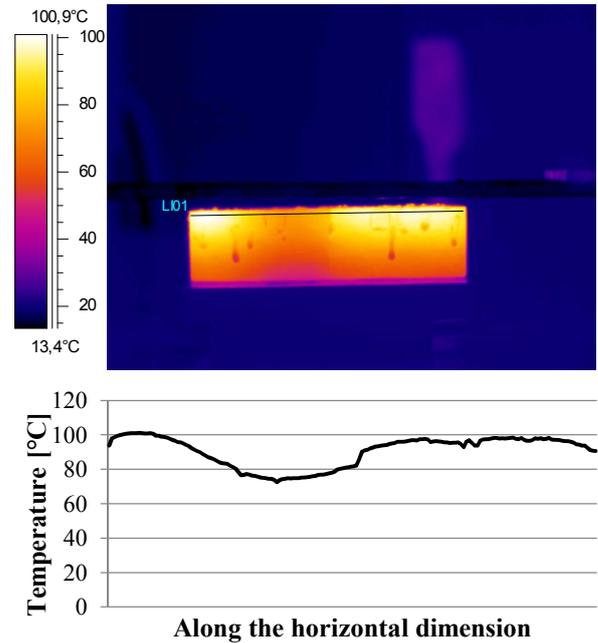
The average temperature of the line L01 near to the cracked bottom side of the beams (upside down in Figure 6) was measured during heating.

If the fibres distribution is not uniform, the heating speed won’t be constant along the line, as it can be observed in Figure 6. A uniform horizontal distribution of temperature should be expected because the distance from the coil to the line along which the measurement was made, remains constant and so the intensity of the alternating magnetic field. Each fibre develops Joule’s heat in direct proportion to it [7] but since the conductive filler is dispersed within the concrete matrix, the heat transfer from fibres towards concrete surface depends upon the fibres concentration near to it.

Figure 6: Thermal image of a b3fcon2 specimen after induction heating.

As expected, the temperature values went from higher to lower along the vertical dimension as a consequence of the increasing distance from the coil.

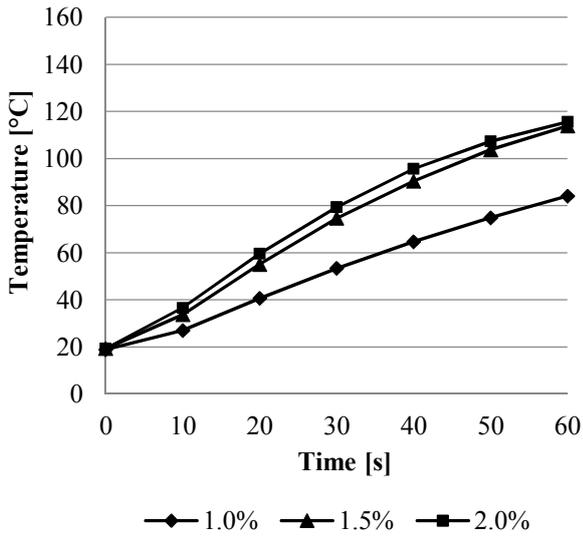
Figure 7: Average temperature of L01 vs. time during heating of concrete beams with different fibre contents.

The graph in Figure 7 shows the average temperature of L01 during heating for b1fcon2, b2fcon2 and b3fcon2. The higher the fibre content, the more concentrated were the fibres in the concrete matrix, hence the faster the heat transferred from the conductive fillers to the concrete surface; in fact, after 60 seconds of induced heating, b1fcon2 reached an average temperature of 82.7°C, while b2fcon2 and b3fcon2 showed temperatures of 116.2°C and 118.9°C, respectively. Notwithstanding, a modest increment in the heating speed could be observed from 1.5% of fibres to 2.0% which could be explained by the worsening of the distribution of fibres as a consequence of the aggravated workability when the volume percentage of fibres increases.

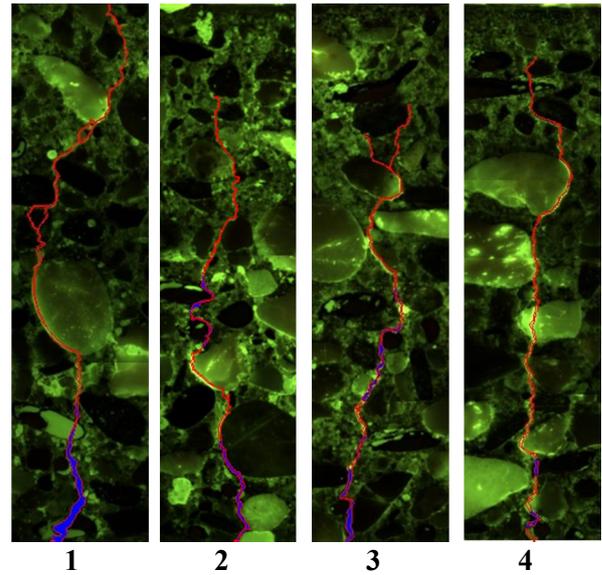
In Figure 8, the analysis of the assembled images of the four sections of one specimen from b1fcon2 is shown. The red closed polyline delimits the longitudinal area of the crack in each section while the blue-filled area within it represents the bitumen filling.

Figure 8: Image analysis of one specimen.

Both the total area of the crack and the portion of it filled with bitumen were calculated for each section. In order to calculate the healing efficiency of the entire specimen the assumption of constant bitumen filling along the thickness of each section was taken.

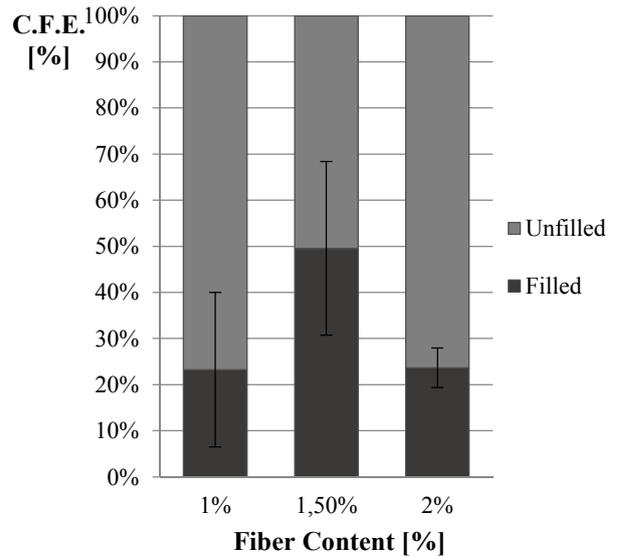
The histogram in Figure 9 shows the average Crack Filling Efficiency (C.F.E.) for b1fcon2, b2fcon2 and b3fcon2.

Figure 9: Average C.F.E. for b1fcon2, b2fcon2 and b3fcon2, corresponding to a fiber content of 1.0%, 1.5% and 2.0%, respectively.

Bitumen filling the crack occupied a 23% to 49.7% of the total area of the crack. The healed portion of the crack was approximately contained within the inferior half part of the specimen, located nearer to the coil. This is due to both the existence of higher temperatures and the larger width of the crack near to the coil. In farer zones the combination of high viscosity of bitumen due to a lower heating temperature and

On the other hand, an increment on the crack filling percentage of almost a 50% occurred when fibres amount was increased from 1.0% to 1.5%. In fact, fibres are randomly distributed in the concrete element and so the crack will be bridged by an increasing amount of fibres by increasing the fibre content, which implies a higher amount of bitumen flowing towards the crack. In spite of this, a decrease of the C.F.E. was obtained by further increasing the amount of fibres from 1.5% to 2.0% coherently with what was found in 4.1. regarding the distribution of fibres.

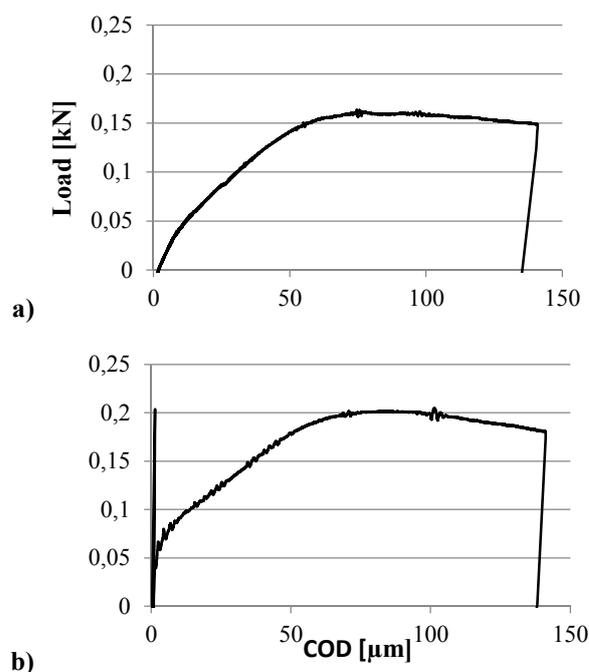
The migration of bitumen from the coating of the fibres to the crack leaves a cavity around the fibre and therefore the bond characteristics between fibres and concrete matrix change. Since the shape of the fibres resulting from the hand chopping cannot be defined as totally hooked-ended it is difficult to separate the influence of shape and debonding on the mechanical behaviour of the specimens after healing. Consequently, the recovery of the mechanical properties wasn't hereby investigated. Nevertheless, the mechanical behaviour of healed specimens was compared to that of unhealed specimens. Figure 10 shows the Load vs. COD curve of an unhealed specimen in a) and of a healed specimen in b) during a 3-Point bending test.

Figure 10: Load vs. COD for a) unhealed specimen, b) healed specimen.

The presence of an initial elastic branch was observed in the case of healed beams. This characteristic behaviour can be attributed to the elastic deformation of the layer of bitumen within the crack surfaces. The failure of the bitumen layer occurs for the chosen rate of displacement and afterwards the load is taken by the ligament and the slip of the fibres bridging the crack. Figure 11 shows the symmetry of the

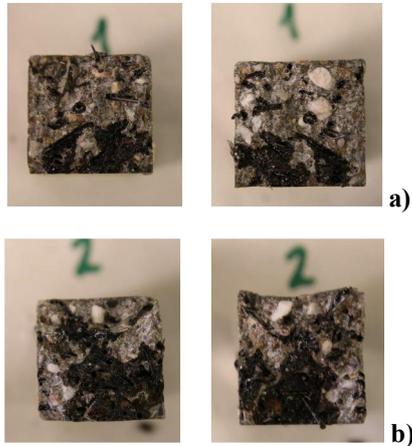
bitumen footprints on two pairs of crack surfaces; hence the failure is likely to occur within the bitumen layer instead of at the concrete-bitumen interface.

Figure 11: Symmetry of the bitumen layer fracture.

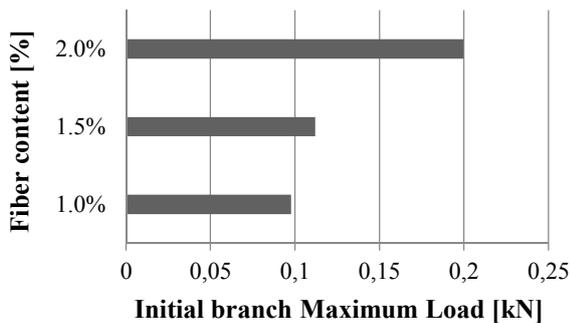
The area of bitumen observed on the crack surfaces was also found to be proportional to the entity of the initial branch maximum load for each specimen. Still, the thickness of the bitumen layer wasn't taken into account to throw such conclusion, thus some reservations should be kept. The average initial branch maximum loads for each fibre content is shown in the bar graph in Figure 12.

Figure 12: Initial branch maximum load for b1fcon1, b2fcon2 and b3fcon2.
