# PERFORMANCE OF PARTIALLY DAMAGED SQUAT SHEAR WALLS UNDER REVERSED CYCLIC LOADING

S. KANAKA DURGA<sup>\*</sup>, AND G. APPA RAO<sup>†</sup>

**Key words:** Shear walls, aspect ratio, quasi-static loading, ductility, retrofitting.

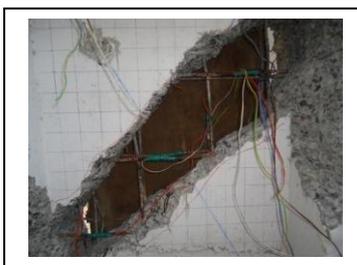
Figure 3: Removal of heavily damaged region of web.

The repair methodology involved removal of damaged concrete from the base of the web wall including lower portion of boundary elements and then replacement of damaged concrete as shown in Figure 2. In damaged areas, concrete was removed throughout the thickness of web as shown in Figure 3. The visual inspection of exposed reinforcement bars after removal of damaged concrete concluded that fracture of steel did not occur but buckling of bars was observed. Welding of steel bars was not required, whereas buckled bars were straightened. The damaged region was filled with same grade of concrete. Superplasticizer was added to make the concrete flowable for easy compaction. The maximum size of coarse aggregate was restricted to 12.5mm to enable easy packing.

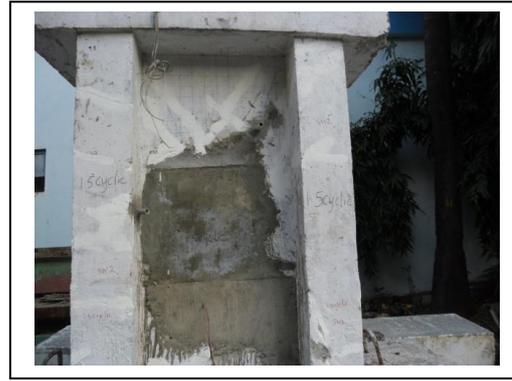
Figure 4: Replacement with new concrete.

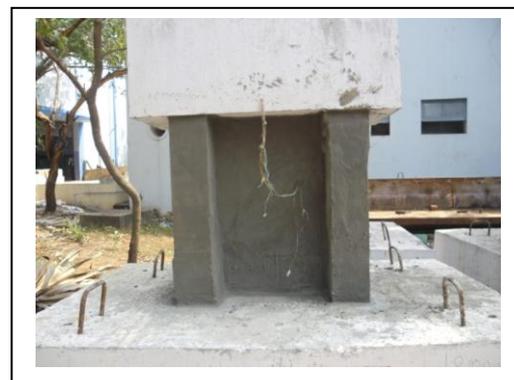
Figure 5: Shear wall after grouting and surface finishing.

The surface cracks were closed by grouting and surface coating using NITOBOND SBR cement grout. The grouting procedure started with formation of “V” groove on crack surface which are more than 1mm in width and depth was about 3 to 5mm. The width of the groove was about 10mm. The surface was made wet and the groove was filled with RENDROC CS paste. Holes were drilled in the crack and PVC pipes were inserted and then fixed using Rendroc Plug. The holes of width larger than 5mm were closed using Nitobond SBR modified. Hairline cracks were filled by coating with cement slurry mixed with Nitobond SBR which also rendered a finished surface. Finally, pressure grouting using cement slurry admixed with Nitobond S B R was done through the inserted PVC pipes to close the voids in the cracked concrete. After curing projected PVC pipe was trimmed off, and then filled with Nitobond SBR grout.

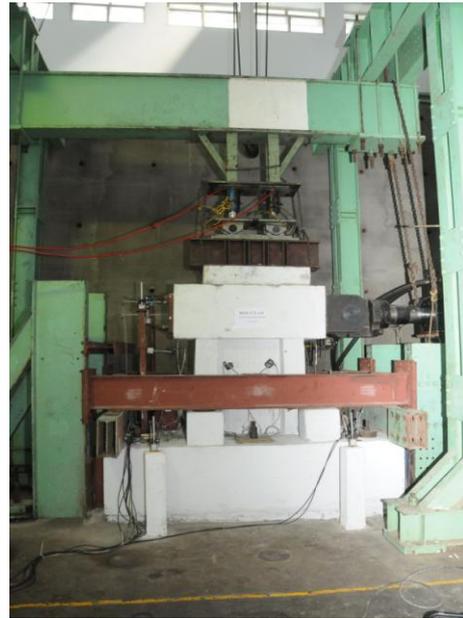
Figure 7: Test set-up of shear wall.

As-built wall specimen of each aspect ratio was tested under monotonic loading while the companion wall was tested under reversed cyclic loading. A total of three specimens were tested under monotonic loading and remaining three to reversed cyclic loading. Similar test set-up and loading protocol were maintained for both control and repaired specimens. The walls were tested by positioning in the vertical direction, fixed to a strong reinforced foundation block which was anchored to a strong floor using six 6-20mm diameter high tension bolts. A 1000kN MTS hydraulic actuator attached to the a strong wall was used to transfer horizontal load. The horizontal loading was applied at the top beam of the walls, wherein two metal plates were attached and connected through four high strength bolts passing through the top beam and actuator. The bolts connecting the actuator and top beam and also foundation block and strong floor were pre-tensioned. A constant axial load of 6T was applied using two hydraulic jacks of 50T capacity mounted on the top beam and in turn connected to the loading frame. The schematic sketch and test set-up is shown in Figures 6 and 7 respectively.

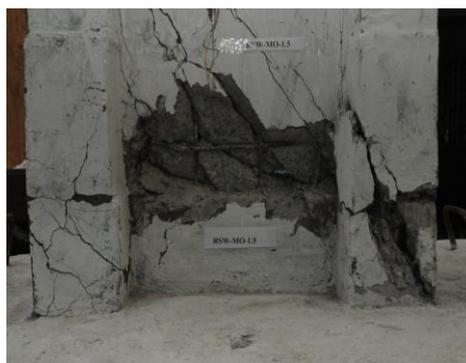
**Figure 9:** Spalling of concrete in web region and compression flange of RSW-MO-1.5.

Buckling of the longitudinal steel reinforcement was observed at the bottom edge of the boundary elements during monotonic loading. The compression flange

exhibited significant crushing of concrete in the bottom part of the boundary element. The failure of repaired walls subjected to monotonic loading is shown in Figures 9-11.

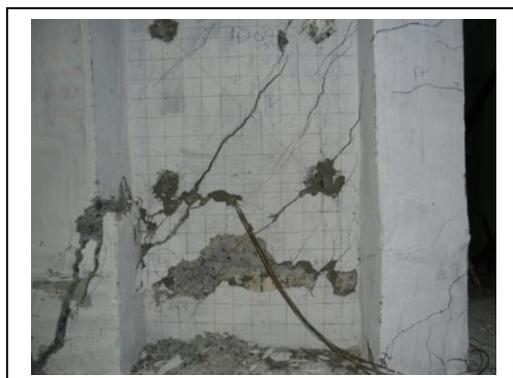
**Figure 10:** Spalling of concrete on compression flange and bottom portion of web wall in RSW-MO-1.25.

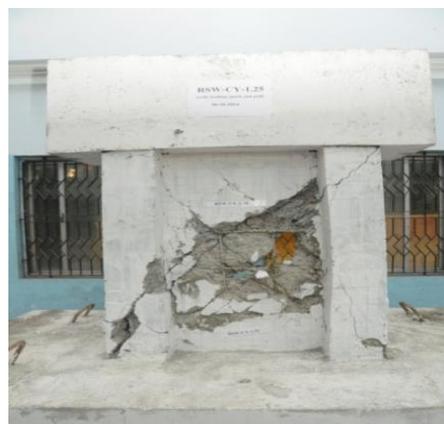
**Figure 13:** Complete cracking and concrete crushing of web wall and boundary element in RSW-CY-1.25

reduced (a sudden fall in strength) at the failure stage. Failure was dominated by shear mechanism. Failure of walls subjected to cyclic loading is shown in Figures 12-14.

The crack widths are generally high on the web wall and at higher displacements led to crushing of concrete when reversed cyclic loading was applied. Buckling of yielded steel bars was accompanied by spalling of crushed concrete in the web region.

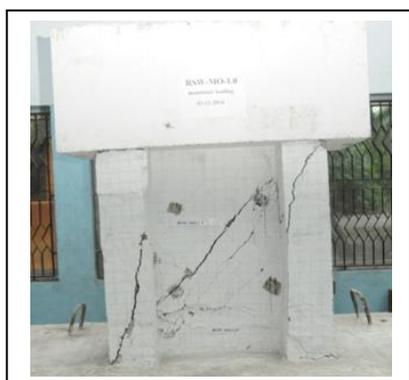
**Figure 11:** Final cracking pattern in shear wall RSW-MO-1.0.

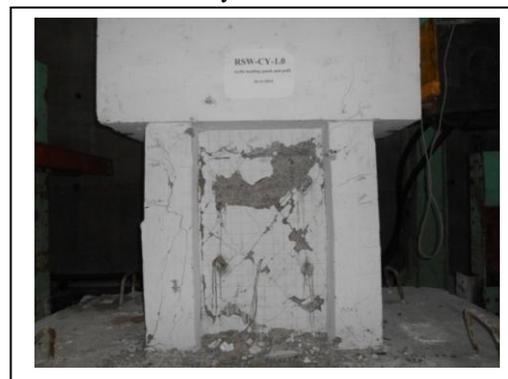
**Figure 14:** Final cracking pattern in shear wall RSW-CY-1.0

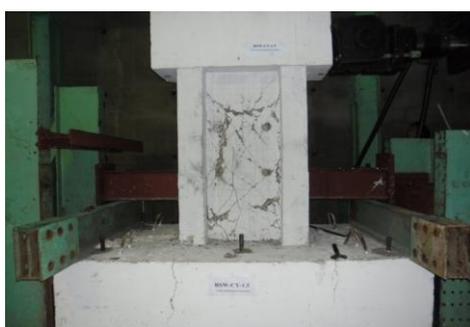
**Figure 12:** Final failure of shear wall RSW-CY-1.5.
