# IMPROVEMENT OF IMPACT-ECHO METHOD BY APPLYING IMAGE RECOGNITION OF SOUND SPECTROGRAM

**Key words:** Impact-Echo Method, Spectrogram, Image Recognition, Machine Learning

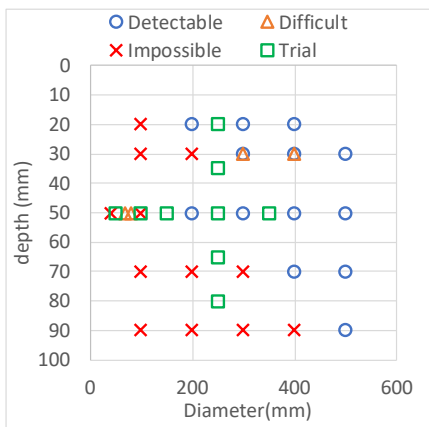
Figure 1: Setting of Void Parameters

Two test specimens of 850mm square and 300mm thickness were cast with embedding round shaped polystyrene foam thickness of 10mm to simulate voids in the concrete. The diameter and depth of voids were decided around the border where it was possible or impossible to detect the voids by impact test by a human, with reference to previous studies<sup>11),12)</sup> as shown in Figure 1.

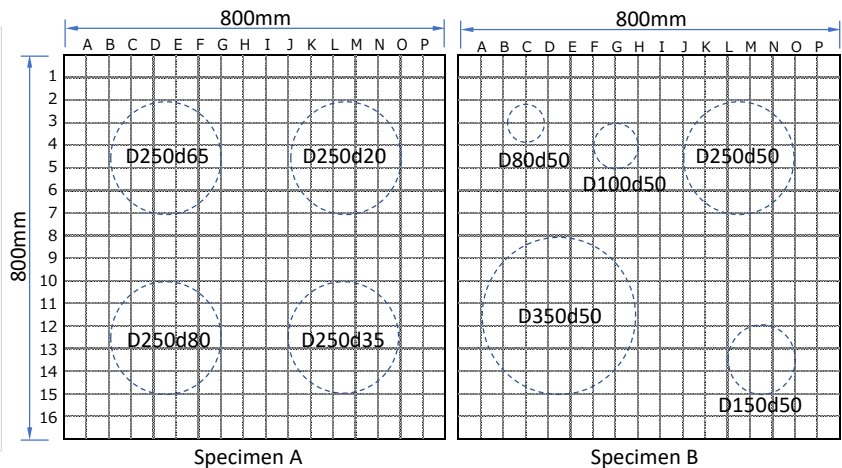
Figure 2: Arrangement of voids

The arrangement of voids in test specimens is shown in Figure 2. Lines are drawn in 50mm pitch on the surface the specimens vertically and horizontally to manage the hit point. The specimen A has voids with the diameter of 250mm (hereinafter abbreviated as D250, the same applies to others), and the depths are 20mm, 35mm, 65mm or 80mm. The specimen B has voids with the depth of 50mm (hereinafter abbreviated as d50, the same applies to others), and the diameters are 80mm, 100mm, 150mm, 250mm or 340mm.

defect-free area near the center of the specimens, G7 to J10 of specimen A, and I8 to O11 of specimen B. Also, considering the influence of the voids or border of specimen, impact sounds were obtained from the edges of the specimens, rows No.1, 16 and columns A, P, where the concrete is not constrained.

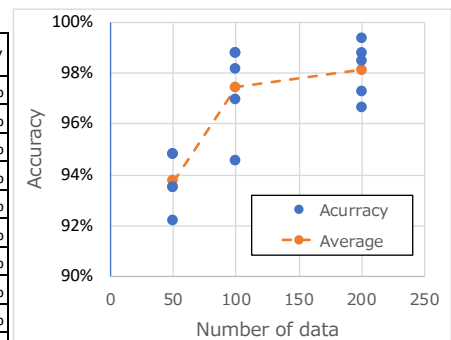
**Figure 3:** Accuracy and number of training data

Figure 3 shows the relationship between the number of training data and accuracy obtained. Training was done 5 times in each number of training datasets, and the number of training data was changed from 50, 100, to 200. It was observed that the average accuracy was not improved a lot over 100 training data. Therefore, 200 training data seems to be adequate for this study.

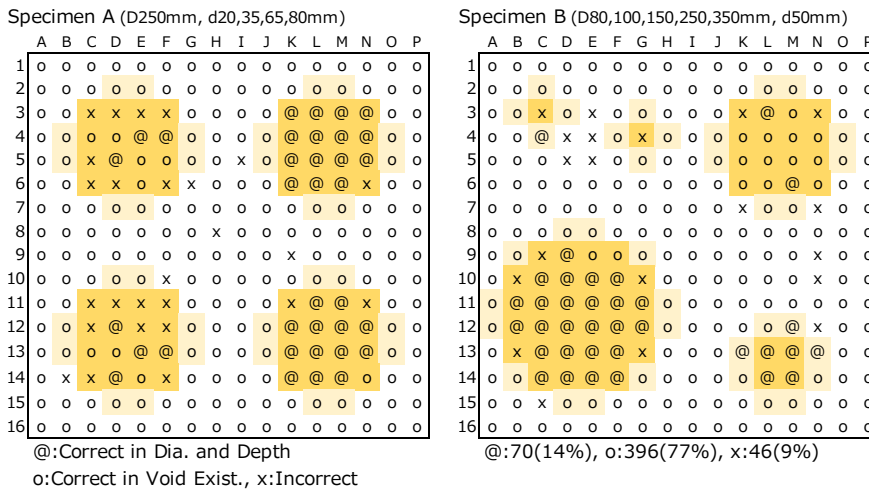
Figure 4: Result of estimation by machine learning

Figure 4 shows the estimation result by the discriminator. The hatched part of the dense orange is the point where the void is located beneath, the hatched part of the thin orange is the boundary of the void. Symbols in the cell indicate estimation results. In the figure, “@” indicates that the discriminator correctly answered the diameter and the depth of the void, “o” indicates that correctly distinguish if there is a void or not, and “x” indicates the presence or not of void was incorrect. Regarding the boundary part, both the prescribed void specification and also no void were taken as correct answers.

Looking at the estimation results of the void-area (dense hatched part), in the shallow void (right side of the A specimen) and the relatively large void (lower left of the B specimen), the diameter and depth are correct in many regions. However, the correct answer rate is low in the

deep voids (left side of the A specimen) and small voids (upper left of the B specimen). From this, it can be inferred, as same as the auditorily similar for human, the impact sound of the deep or small void is difficult to distinguish for the discriminator.

The overall correct answer rate by adding “@” and “o” was 91%, which is lower than the accuracy of around 98% obtained in the verification phase of machine learning. Although the cause of this is not clear, since the impact sound of the training data was collected at one time, the variation of impact sound is very small. Also, the evaluation data was obtained only 1 impact sound recorded at another time. Because of the condition above, it is possible that the difference of recording condition or environmental condition may affect the impact sound to

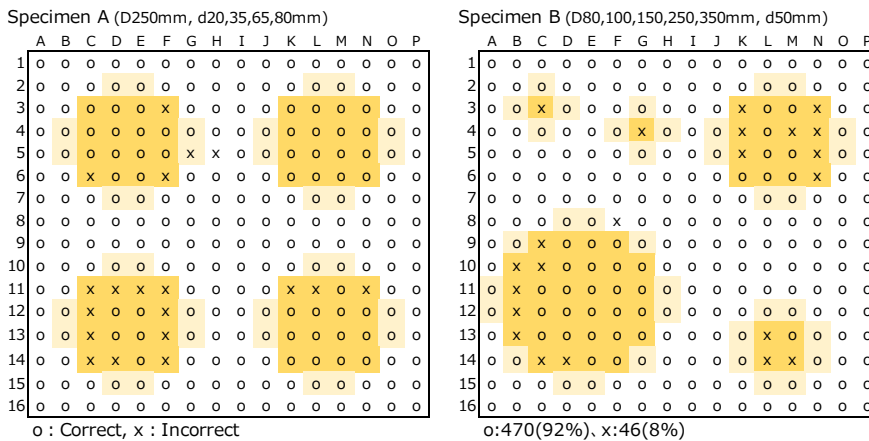
Figure 5: Result of estimation by a human expert

As a comparison with conventional impact-echo survey, a blind test was conducted by an expert of the method. As shown in Figure 5, the result is almost the same tendency as the estimation by the discriminator shown in Figure 6. Also, the correct answer rate was almost the same as 91% by machine learning (“@” and “o”), and 92% by an expert (“o”). When viewed individually, it can be seen that the correct answer rate decreases in the "deep voids" and "small voids" by the expert and also by the discriminator. However, it is considered that it is meaningful to be able to make a stable judgment by machine learning without a human expert because the judgment by a person is largely affected by the skill of individual or the differences of the environment.

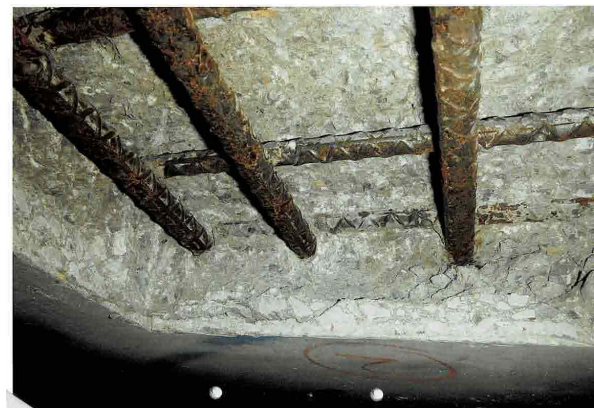
Figure 6: State of deterioration on the bottom surface of concrete slab

A deterioration investigation was carried out on a concrete pier about 30 years after construction in Japan. The pier has a concrete cover of around 80 mm, but due to salt damage, corrosion of the rebar has progressed, and flaking of concrete has occurred over a wide area (Figure 6). In the survey, the results of impact-echo survey and visual observation on the bottom surface of the concrete slab were done. The result was compared with the estimation by neural network generated from impact sound data separately acquired on site.

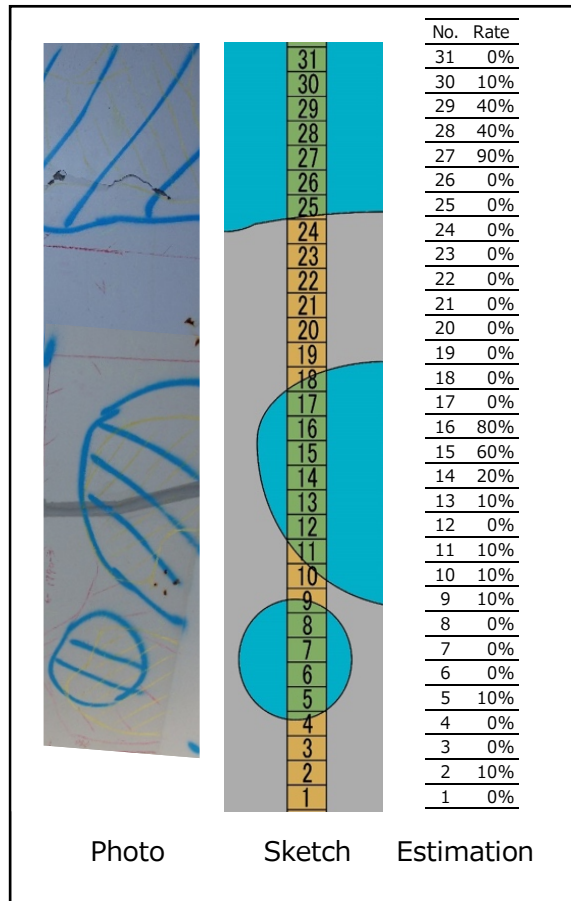
Figure 7: Expert's diagnosis and estimation by the neural network on site

In the process of the deterioration survey, it was judged by the impact-echo survey expert that there is flaking in the area shown by blue marking or blue hatching, in the photograph and sketch of Figure 8. On the other hand, in the same pier, 334 impact sounds were recorded from the area where there is clearly a defect such as flaking from impact sound and also the area where it is normal from impact sound. These impact sounds were converted into spectrograms and given as training data to create a neural network. With this network, for

each of the 31 sections set on the lower surface of the slab, shown in Figure 7, estimation was made for each of 10 impact sounds per section. In each section, the percentage of the number of times that there was a defect was shown in Figure 7. From this result, it can be seen that the area determined as defect by machine learning is roughly included in the area that the expert judged as defect.

The reason that the area of defect determined by machine learning is narrower than the expert's judgment is that the impact sounds for training data of defect were taken from the area only where a severe flaking is occurred. We took the sound in the area where we can surely estimate from the impact sound that there is defect, and used it as training data for defect. Therefore, it is considered that the determination of the presence of defects is more severe tendency than the determination of the expert (a minor defect is not determined as defects). In order to solve this, it is necessary
