Break-up of concrete structures under internal explosion

ABSTRACT: When an explosion occurs in a concrete structure, debris throw is one of the major hazards and dominates the safety distances. To gain insight into concrete break-up, a series of one-way spanning clamped concrete slabs exposed to internal blast were tested under various loading densities. A combination of special powerful X-ray pulsars, high-speed video and strain gauges are employed to capture the initial concrete deformation and its subsequent break-up process. An overview of the tests, the results and the interpretation of the break-up process are presented in this paper.

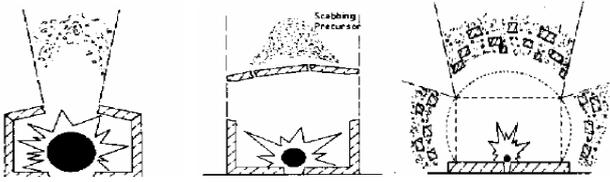
Figure 1. The three overloading regimes: shock-, blast impulsive- and gas pressure overloading, respectively.

The response and failure mode of a structure results in the final break-up and debris formation. The KG adopted the terminology of three dominant overloading conditions based on the difference in debris throw physics, i.e. the overloading conditions of composite-shock, impulsive shock and gas pressure. These conditions can be characterised as follows:

Local effects happen at shock overloading at small distance of charge-to-wall. The shock load exceeds the concrete compressive strength. Spallation crater, scabbing and material failure occur. Theoretically, at high loading densities (= charge weight /internal volume) a complete wall may be destroyed in the shock-overloading mode. Typical debris size is the size of the aggregates. Scabbing debris from the structures outside starts at highest velocity, but their individual and total mass is small.

The blast impulsive overloading results in minor local damage. At points of load concentration the load typically exceeds the shear strength of concrete and reinforcement steel. Typical debris size is large pieces (torn-off at weak points) or complete roof slabs torn-off along the edge restraint. Debris from blast impulse overloading starts with an initial velocity (due to direct momentum transfer) but will be accelerated to its launch velocity by the gas pressure.

Failure due to gas pressure overloading occurs at a much later time than in the other overloading regimes. The structure fails due to the generated gas pressure and not due to the initial shock loads. The structure distorts and the wall moves during the loading process. In some situations the structure may be blown up like a balloon. The transient load exceeds the tensile strength of concrete but not the

strength of the reinforcement steel. The concrete typically will be blown out through the reinforcement mesh. The mesh withstands and the typical debris size is the mesh size.

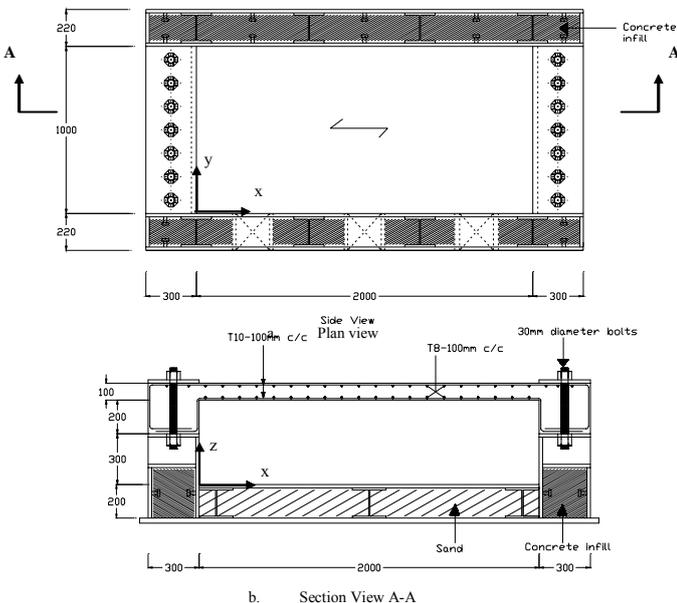
A composite steel-concrete explosion box was designed on which concrete slabs could be clamped and tested. Figure 2 shows the box and the test slabs with the dimensions. The test-slabs are designed to be representative for the case of 1/5 scale roof slabs of ammunition magazines. The average compressive cube strength at the 28th day is 46 MPa and the average tensile splitting strength is 4 MPa.

Figure 2. Explosion box with one-way clamped RC-test slab.

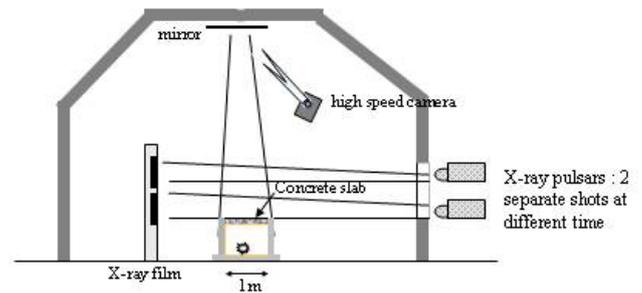
The general test layout is shown in Figure 3. There are 4 main sets of data recording: the x-rays, the high speed video, the strain gauges and the pressure history recording. There are 2 x-ray pulsars placed at

the central window shooting the side view of the slab and the 2 pulsars will produce two images at different time at different height. A high speed video is also applied to record the entire explosion event. The video is viewing from the top of the slab via a mirror. In this way, a three dimensional picture of the slab response process is recorded. The strain gauges are pasted on one half of the span to study the initial response before visible movements can be seen from the x-ray and video recordings. Three pressure transducers are placed at the sidewalls to give an indication of the load on the slab. A total of 8 tests with loading density between 0.5kg/m³ to 4 kg/m³ were conducted. The hemispherical charges are either single charge or double charges and placed at the bottom of the box.

Figure 3. Experimental and diagnostic set-up.

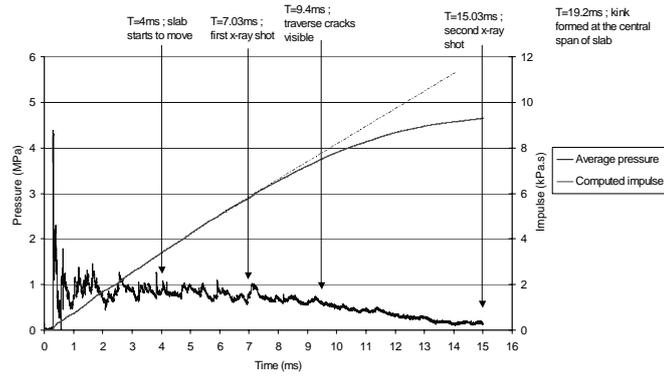
The information obtained from the x-ray and the high speed video are coupled to the average pressure history measured from the pressure gauges as shown in Figure 4. The slab's partial side views were taken at two heights at two different times as shown in Figure 5. Although large traverse cracks can be seen from the high speed video at t=15ms (Fig.6), the slab did not disintegrate into individual debris pieces as they are still held together by the reinforcement. The large traverse cracks are not obvious in the x-ray photos because the slab's width of 1m is too dense for the x-ray to penetrate through.

Figure 4. Pressure and impulse history for 0.5 kg test.

- The failure mode changes from bending failure to shear failure at the loading density of 2 kg/m^3 .
- The strain gauge records offer the early time response information which was not provided by the optical diagnostics (high speed video and x-ray), see Figure 4.

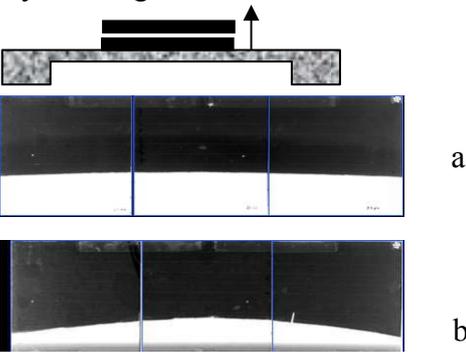
Figure 5. X-ray pictures at $t=7.03$ msec and 11.6 cm translation (a) and at $t=15.03$ msec with 38.6 cm translation.

An attempt was made to reconstruct the slab deflection curve based on the position of the slab as given in the x-ray photos. The position of the slab outside the x-ray films are extrapolated using a simple curve fitting function in the AUTOCAD software. The result shows that the vertical displacement at the left edge is about 34mm and 73mm for $t=7.03\text{ms}$ and $t=15.03\text{ms}$ respectively. If this displacement predictions are true, then the slab will be completely sheared off by $t=15.03\text{ms}$. However, there is a possibility that the slab edge is not completely sheared off yet at $t=7.03\text{ms}$. The AUTOCAD drawings also showed a more pronounced curvature at $t=15.03\text{ms}$, suggesting that the failure is by bending.

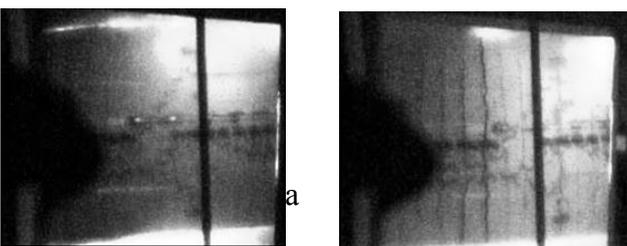
Figure 6. Snap shots from high speed recordings (a) at $t=7\text{msec}$ (no cracks visible) and (b) at $t=15$ msec with extensive lateral cracking.

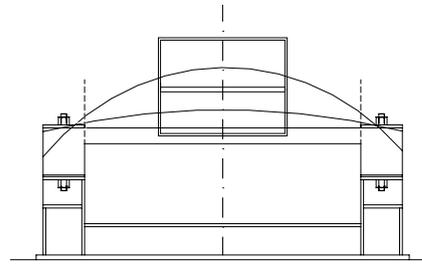
Figure 7. Extrapolated deflection curves, from X-ray shots for the 0.5 kg test.

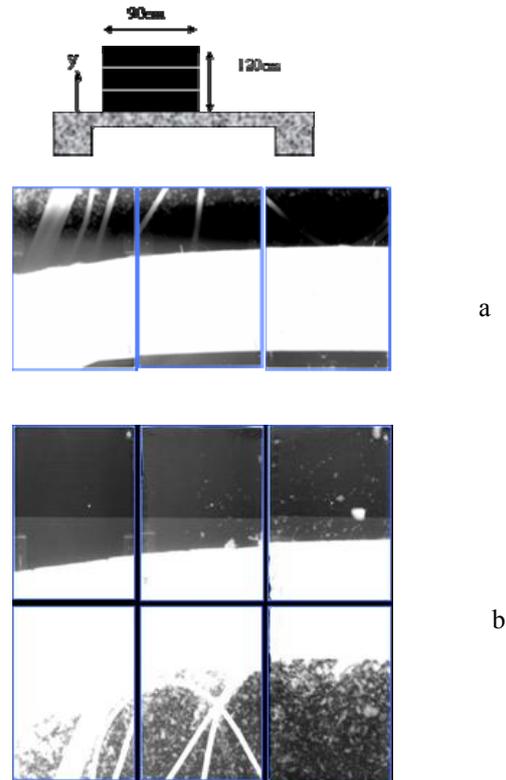
The x-ray photos for the 2 kg case (test 6) are shown in Figures 8. There is minimal spalling at the top of the slab and no local breaching occurs.

Figure 8. Side view of x-ray shots for the 2 kg test (test 6) at $t=6.37$ msec and 23.5cm translation (a) and at $t=14.33$ msec with 71.4 cm translation (b).

The second x-ray photo (Fig 8b) shows that the concrete debris is still held together by the reinforcement even though large traverse cracks can be seen from the high speed video (Fig 9). The x-ray photo also shows a lot of concrete cover spalling at the bottom of the slab. This is due to the effect of the reinforcement resistance, as the slab moves the concrete cover is pulled off. The x-ray shots from the test with 4 kg charge also show that the damaged material travels together for at least the first 50 cm.

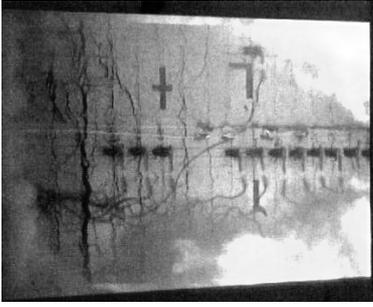
Figure 9. Snap shot high speed recording test 6, at 9.8 msec.

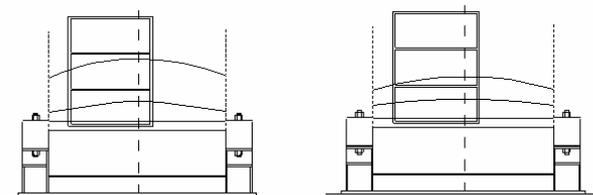
The slabs' deflection curves based on their respective x-ray photos are reconstructed for the 2 and 4 kg tests as shown in Figure 10. (Note that the x-ray shots in the 4 kg test are taken at an earlier stage, so the travel distance is smaller than in the 2 kg test). The first x-ray shots show that the edge displacements are already more than 100mm. This implies that the slabs have already been detached from their support when the first x-ray shot is made. The high-speed video also confirms that the slabs are sheared off from its edge supports as traverse cracks can be seen at that position. Subsequently, the slab bending increases and more traverse cracks occur throughout the slab. Hence the failure mode of the slab for the 2 and 4 kg tests is shear. Further deformations in the later stages appear to be predominantly bending.

Figure 10. Extrapolated deflected shape of slab at the first and second x-ray shot for the 2kg test (left) and 4 kg test (right).

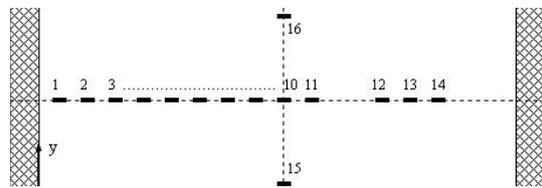
The strain gauges are placed on top of the slab surface to record the deformation of the slab after the first few milliseconds of the explosion. The strain gauges are all uniaxial, measuring in the span direction. No gauges were applied in the transverse direction, assuming the dominance of one-way spanning and curvature in the traverse direction is negligible. Their positions are indicated in Figure 11. The strain gauges 1 to 10 are placed at equal distances on one side of the slab. Additional strain gauges 12 to 14 are placed to counter-check this assumption of symmetry at $x = 1000\text{mm}$. The last two gauges, 15 and 16 are placed to counter-check if curvatures near the edges are the same as curvature in the central axis ($y = 500\text{mm}$).

Figure 11. Position and numbering of the strain gauges on the top surface of the slabs.

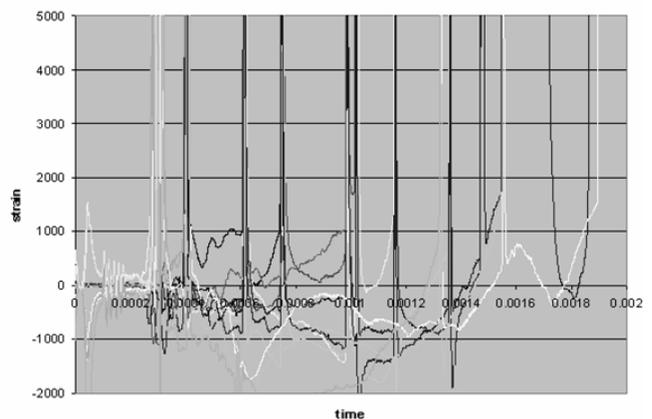
Figure 12 gives an example of a set of strain gauge records. It illustrates that the recorded information is extremely complex and hard to analyse. In the early time response, the energy transfer into the slab induces stress waves. The propagating and reflecting waves lead to the (final) structural response.

Figure 12. Example of a set of strain gauge recordings.

Therefore, the strain gauge records exhibit the (local) deformation due to the wave propagation as well as the early time structural response dominated by the higher eigenmodes of the slab. Because of the complexity and the many uncertainties, the authors decided to focus on the recorded failure sequence and combine this information with the other data and the known physical phenomena of shock loading and

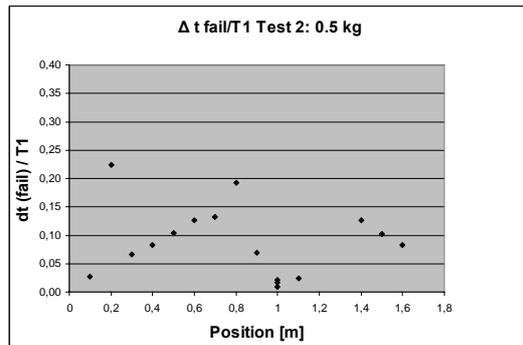
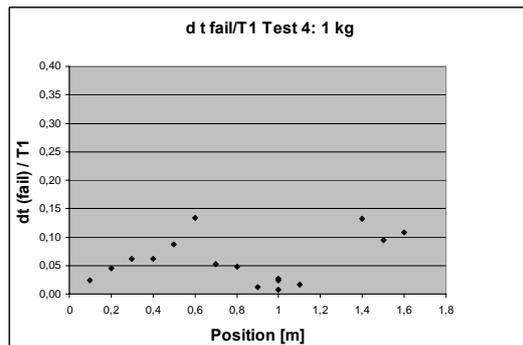
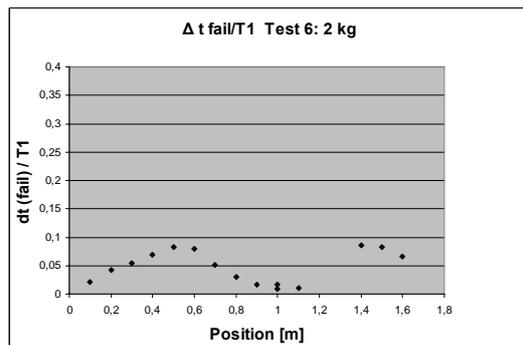
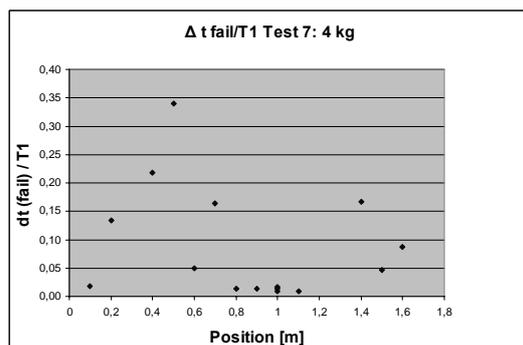
First the time of failure (dt_{fail}) is determined for the strain gauge locations. To analyse the local and global structural response, these times of failure were adjusted for the shock arrival times. The latter were determined using the pressure gauge data and the ConWep code (Department of the Army, 1992).

Structural response is possible after the energy is transferred to the structure by numerous stress wave rays through the slab thickness. E.g. 8 rays at a velocity of 3500 m/s through the slab of 0.1 m thickness gives that structural response is possible after 0.2 msec. Therefore, the first response just above the charge is only possible after 0.2 msec. The result (dt_{fail}) for the 0.5 kg test is given in Figure 13 and clearly shows that the slab above the charge fails immediately after the shock impact. Most probably, wave phenomena dominate and local failure occurs while the structural response is still very limited.

At the supports however, failure is delayed, structural response dominates the failure process. After the delay, a “failure wave” travels through the structure from the support towards the middle of the plate with a velocity of about 340 m/s.

Figure 13. Time to failure dt_{fail} at strain gauge locations after shock arrival.

- Sequence of failure starts in the centre above the charge within 0.2 – 0.4 msec, followed by the failure at the support;
- The time to failure decreases with increasing loading densities in the range of 0.5–2 kg/m³;
- For this range of loading densities, immediate failure occurs above the charge after the shock hits the slab. Then failure at the support occurs and a “bending failure wave” is initiated travelling from the support to the middle of the slab with a velocity of about 300-400 m/s;

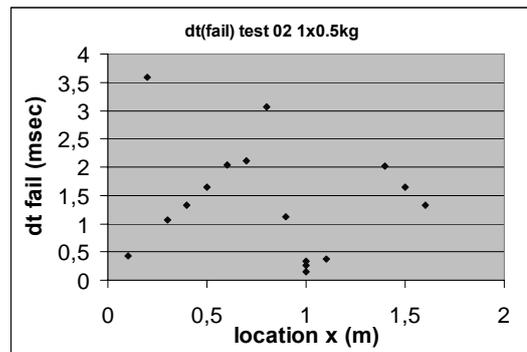
The other tests were analysed in a similar way as described for test 2. The time intervals between shock arrival and failure are given in Figure 14. Note, in this figure the intervals are related to the first eigen period of the clamped slab ($T_1 = 16.1$ msec), because the ratio t/T_1 will be used in the structural response analysis given in the next section.

Figure 14. Time interval between shock arrival and failure for the single charge tests in the 1 m³ explosion box.

- For higher loading densities, such as 4 kg/m^3 , the time to failure increases significantly, and the sequence of failure in the slab becomes less clear. From the failure sequence some “failure waves” can be recognised only for small parts of the slab and the velocities are about 300 m/s.

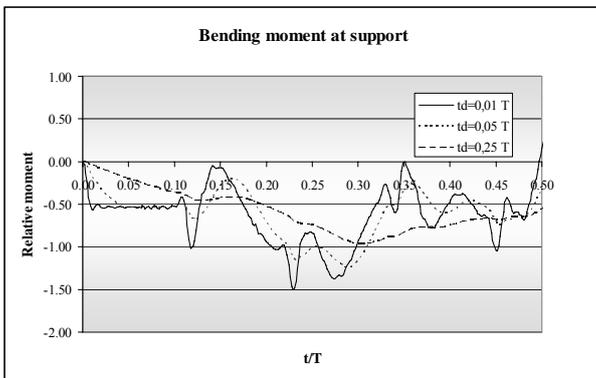
Figure 15. Bending moment at the support, related to the SDOF solution

The shear forces and bending moments at the supports, as a function of time, are given in the Figures 15 and 16. In these figures the results are given for equally distributed loads and three load durations which are related to the first eigenperiod (T_1) of the slab i.e. 0.01 ; 0.05 and $0.25 T_1$. At the vertical axes the ratio of the “exact dynamic support reaction” and the “static support reaction times the DLF (dynamic load factor) is given. Besides the time dependency, the ratio shows the differences between the exact (FE) calculation and the simplified SDOF- approach.

It seems that the increasing dominance of the dynamic shear forces is more or less controlled by the rate effects in concrete. Based on the LE-analysis, the increasing shear forces will not lead to a change in failure mode or mechanism. However, the contribution of the bending moment increases for small values of t_+/T_1 (Fig. 15 and Tab. 2). The combined high amplitude shear and bending might lead to

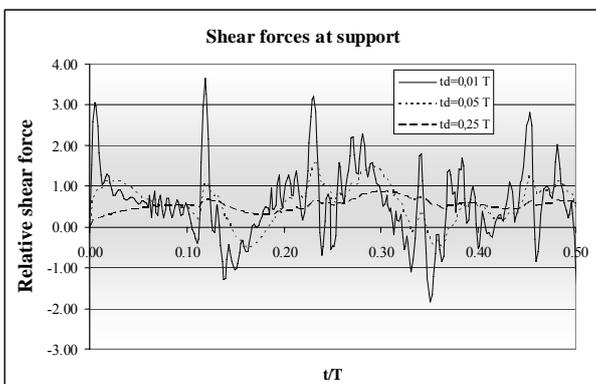
Figure 16. Shear forces at the support, related to the SDOF solution.

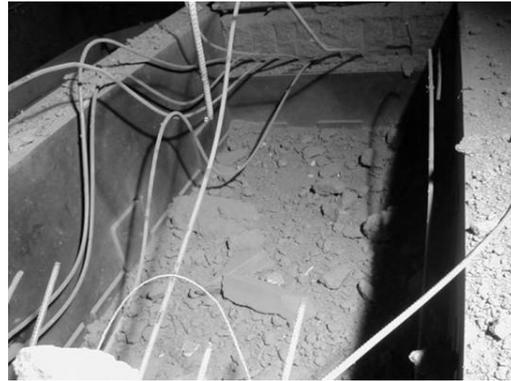
Test 2. single charge, 0.5 kg

Observations of the debris and the reinforcement also provide some evidence of the response of the slab. For test 2, a large number of reinforcement grid-sized debris is found dispersed outside the steel box. Some of the reinforcement bars are not broken but are very heavily deformed as shown in Fig. 17. These evidences show that large bending deformation occurred before failure. The reinforcement played an important role in the break-up as a large number of the debris resembles the reinforcement grid size. This type of failure is classified as gas-

Figure 17 Difference in reinforcement failure for 0.5 and 4 kg charge.

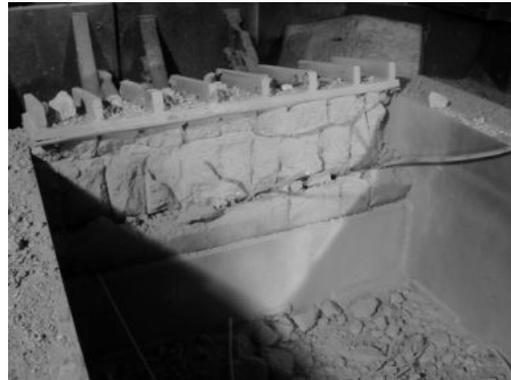
Test 7. single charge, 4 kg

For test 6 and test 7, grid-sized debris are lesser and most of the debris mass is found inside the steel box. The reinforcements failed at a shorter distance from the edge beam. These evidences show that the slab has undergone a more abrupt shear failure and the entire concrete slab translates vertically upwards. When the slab hits the roof of the bunker, it falls back into the box and that explains why most of the debris is found there. This failure mode is classified as blast-impulsive failure (see section on break-up modes).
