Repairing and strengthening methods for RC structural members

ABSTRACT: In this study, the repairing and strengthening methods of reinforced columns and beams which are damaged during earthquakes have been compared. Due to earthquake and/or vertical loads, damaged or insufficient structural components can be repaired and strengthened with various methods. Reinforced jacketing, repairing with steel plates and repairing with FRP components are more used methods. We often come across these three methods in practise. These three methods have advantages and disadvantages. In this study, 21 beams were investigated experimentally. The experimental research is done on 6 reference beams and 6 cracked beams with its bottom U shaped reinforcements and by adding steel ropes to carrying points. Also 3 beams were retrofitted with steel plates on their tension zone and 6 beams were retrofitted by full jacketing. Strength degradation, energy dissipation, ductility and rigidity of the members using these methods given above are compared in the final section of this experimental investigation.

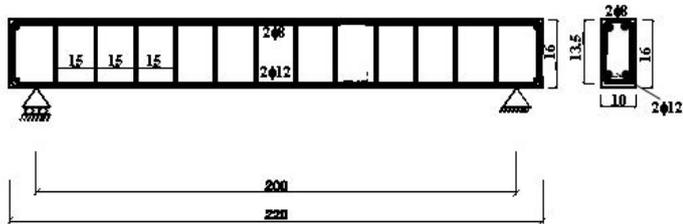
Figure 1. Specimen detail.

21 beams are examined to find out the efficiency of damaged beams which were repaired. All of these beams have a 2000mm clear span, and the dimensions of 100*160*2200mm. The main reinforcement is 2 ϕ 12, the mounting reinforcement is 2 ϕ 8, the stirrups are consisted of 8mm diameter grade S420 bars and spaced at 150mm. The concrete grade is C16. (Figure 1, Figure 2)

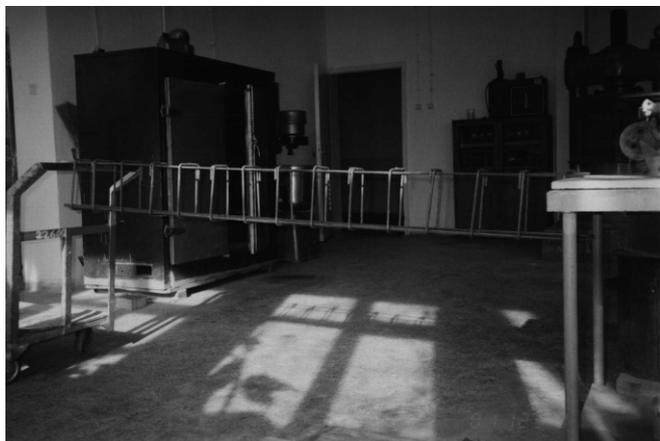
Figure 2. Preparing phase of beam specimens.

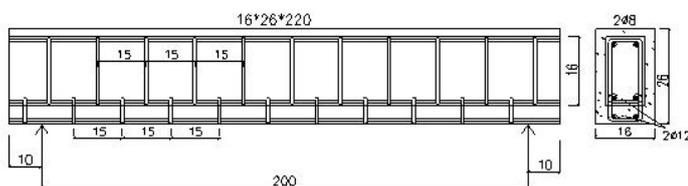
Figure 3. Reproduction detail of u-shaped stirrup anchoring.

The beams are produced in five sets. 6 specimens (KM11, KM12, KM13, KM21, KM22, and KM23) that make up the first series are damaged and repaired by U-shaped stirrups. Additional reinforcement is $2\phi 12$; Additional stirrups are $\phi 8/150$ (Figure 3 and Figure 4)

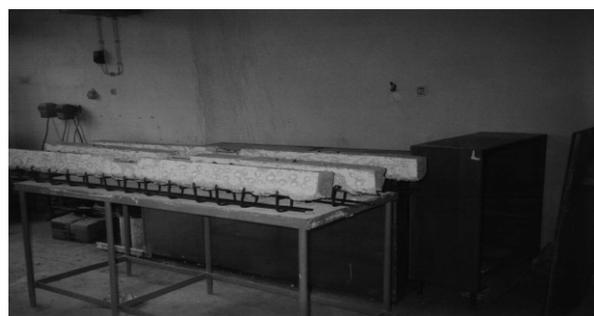
Figure 4. U-shaped stirrup anchoring from underneath.

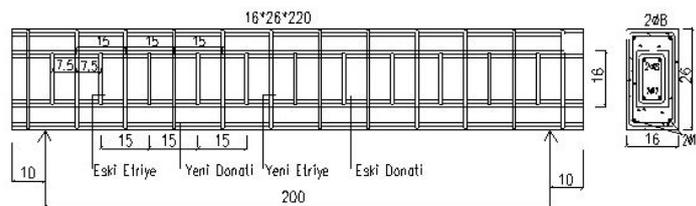
Figure 5. Detail of damaged beam strengthened by jacking.

Beams making up the second set (KM41, KM42, KM43, KM51, KM52, KM53) are made up of C20 concrete and grade S420 bars with 100×160 mm dimensions and damaged. Grade S420, $2\phi 12$ reinforcement is added up to the tensile zone of damaged beams and the beam is wrapped up by 8mm diameter stirrups spaced at 150mm. Also the undersides of the beams are opened up to the cover and

additional reinforcements are connected with existing reinforcements. (Figure 5, Figure 6)

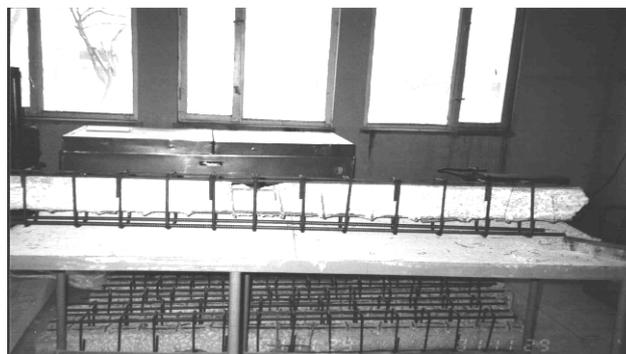
Figure 6. Jacketing Process.

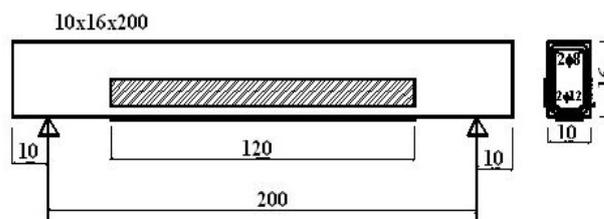
Figure 7. Details of the beam repaired and strengthened by steel plate.

Three beams are made as a the third set and repaired by epoxy resin plates. These beams (KM31, KM32, KM33) are repaired by bonding St37, $6 \times 50 \times 1200$ mm epoxy resin plates to both sides of the beams' bending zone and tensile zone (Figure 7, 8). The epoxy mortar used to bond the steel plates has two components, namely resin and hardener. The density of epoxy mortar is 1.7 kg/ liter, compressive strength is 65 N/mm^2 , bending strength is 30 N/mm^2 , tensile strength is 20 N/mm^2 , concrete adhesion is 3.5 N/mm^2 and steel adhesion is 20 N/mm^2 . The epoxy mortar is produced with these characteristics at a 1/3 mixture ratio.

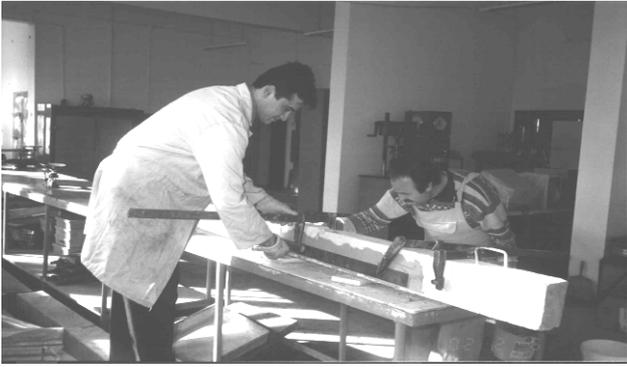
Figure 8. Process of placing the epoxy plates.

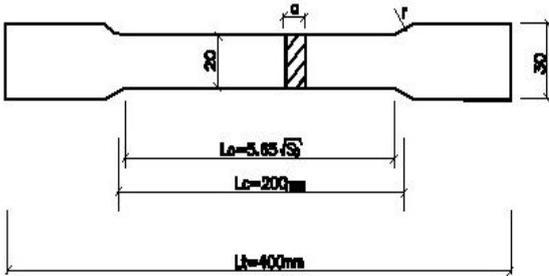
Figure 9. Steel specimen used for strengthening.

Three specimens of steel plates are prepared for reparation which are grade St37, 400mm long and have the dimensions of $6 \times 50 \times 1200$ mm. The yield strength of the bonding plates are $f_{yk}=300 \text{ MPa}$ with $f_{su}=412 \text{ MPa}$ breaking strength and $\epsilon_{su}=\%12.7$ breaking elongation. The specimen model can be seen in Figure 9.

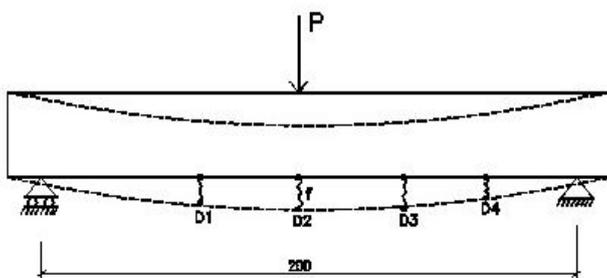
Figure 10. Displacement measurement points and testing system.

The beams that were produced as a test specimen had a span length of 2000mm and were loaded until they broke up with a medium degree of damage. Loads were increased 1962 N every phase. In every load phase, the displacement values of beams having ½ and ¼ points of span length were recorded digitally and by researchers (Figure 10)

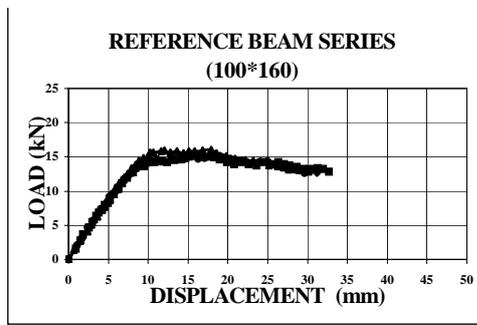
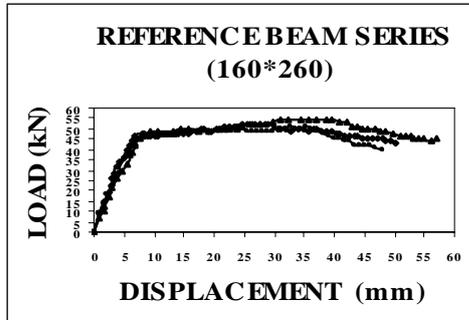
Figure 14. Load-displacement graph of reference beams (RKM1, RKM2, RKM3 (100*160) and (160*260)).

The load-displacement curves of test components repaired by jacketing and steel plates are compared with the load-displacement curves of the reference beams (Figure 11, 12, 13, 14) The strength values, rigidity, ductility, load bearing and energy dissipation capacities are examined and the results can be seen at Tables 5, 6 and 7. Also the cracks that emerged during the test process are examined both before and after the strengthening of repaired beams.

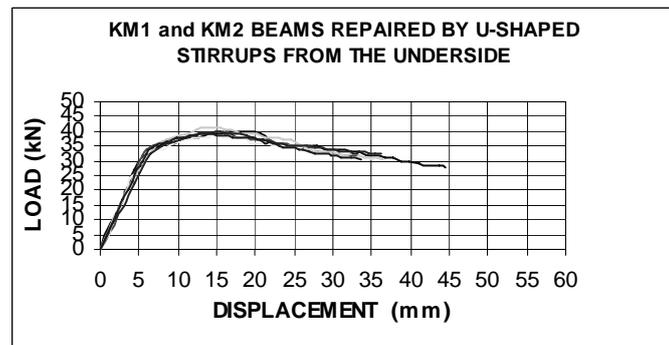
Figure 11. Load-displacement graph of beams which were repaired by jacketing from below.

are repaired by steel plates and exposed to reloading afterwards. The load-displacement curves that are estimated by the values determined through the loading and breaking of the specimens according to the program, are drawn by both reading from the comparator at points D1, D2 and D3 according to the loading and reading points shown at Table 10 and upon being saved to computer records at point D2 (Figure 11-14). The values used to make up the curves are taken from LVDT that is placed in the middle of the beam span and from comparator. In general, the numbers and widths of cracks at bending zone of the components are similar to each other. The reference beams that make up the second and third group are exposed to loading as well and the displacement values due to loading are recorded. As far as the strengthening through reinforced concrete jacketing goes, the load-displacement curves of the beams that are repaired by damaging ended up similar to the load-displacement curves of the reference beams that are identical to the dimensions after jacketing (Figure 11, 12). The load-displacement curves drawn by repairing the steel plates are similar to the load-displacement curves belonging to the simple beam. However, the results cannot come close to those estimated by reinforced concrete jacketing (Figure 13).

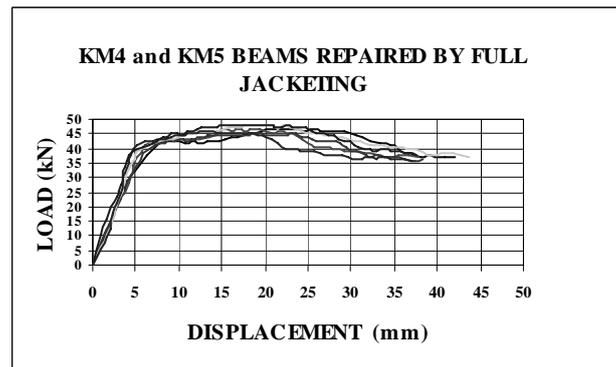
Figure 12. Load-displacement graph of beams which were repaired by reinforced concrete jacketing.

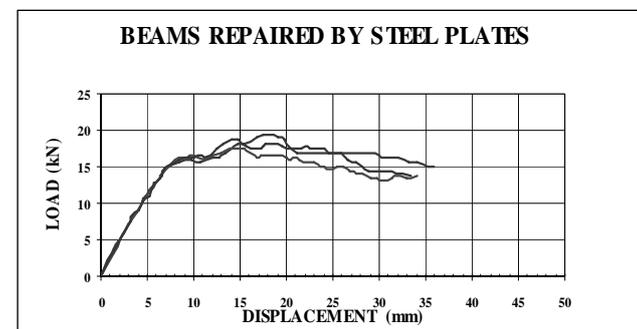
Figure 13. Load-displacement graph of beams which were repaired by steel plates.
