CONSTRUCTION AND STRUCTURAL ANALYSIS OF THE DOME OF THE CATHEDRAL OF VALENCIA

ALONSO A.*, MARTÍNEZ A.†, LLOPIS V.†, MORENO J.†

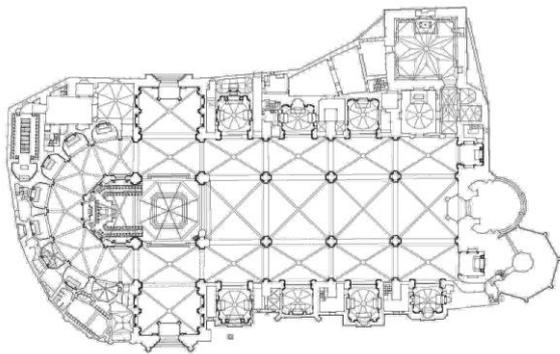
Figure 1: Plan of the Metropolitan Cathedral Basilica of Valencia

The Cimborio, is impressive both for its beauty and the absence of supports, it rises over the transept of the Cathedral of Valencia, with a floor plan in Latin cross (*figure 1*), the nave is divided into three perfect squares, with a series of rectangular side-chapels on both sides. The ceiling consists of simple cross vaults with four stone ribs and several solid brick lay endwise. The polygonal apse is surrounded by the ambulatory that leads off to the chapels [1].

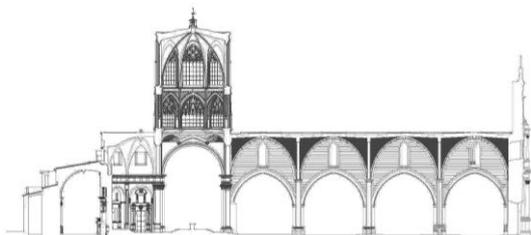
Figure 2: Longitudinal Section of the Metropolitan Cathedral Basilica of Valencia

The almost identical nave and transepts height do not wholly conform to the French Gothic proportion tenets, but it is an evidence of the difficulty on load transfer from the nave to the transepts (*figure 2*).

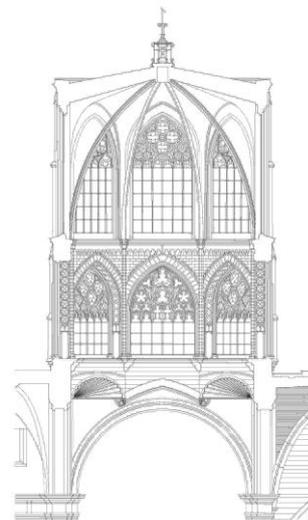
Figure 3: Section of the Cimborio

The octagonal dome rising over the centre is supported by four pillars, (*figure 3*) 19.20m high and 6.18m wide, the dome is composed of two very similar tiers, the upper ones are taller than the ones below. This ties difference

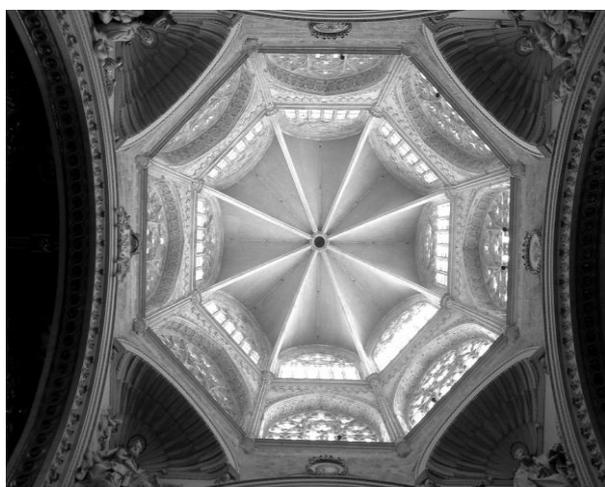
Figure 4:Image inside of the Cimborio

second tier in 1432 due to wind damage, and again in 1698, when they were replaced by alabaster panels. In 1731 general repairs were done to the arches and vaults, as a result of that new tracery and mullions were given. In 1863, under the direction of Joaquín M^a Calvo, new alabaster panels were put in place with iron frames. In 1919 Francisco Mora installed a reinforcing iron band over the windows in the upper tier. In 1978 Ramiro Moya replaced the iron frames of the alabaster panels with new ones made from stainless steel, the roof was strengthened with a reinforced concrete slab, a metal band was placed around the oculus and a stainless steel brace was added to the arches outside of the second tier (*figure 4*).

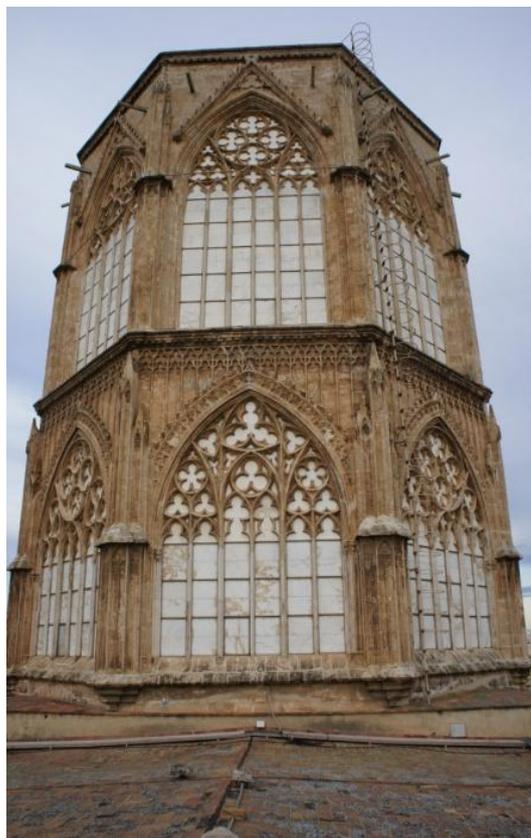
Figure 5:Image outside of the Cimborio

In order to make the best possible survey of the present state of the dome, a study was carried out by non-invasive laser scanner. The method involved in this technique is based on a capture of the points, their referencing, extraction and analysis, besides obtaining 2 and 3D drawings, which provide us precise information about the real situation of the structure. A high-density points cloud is generated that enables us to identify the current settling and deformations present in the dome (*Figure 5*).

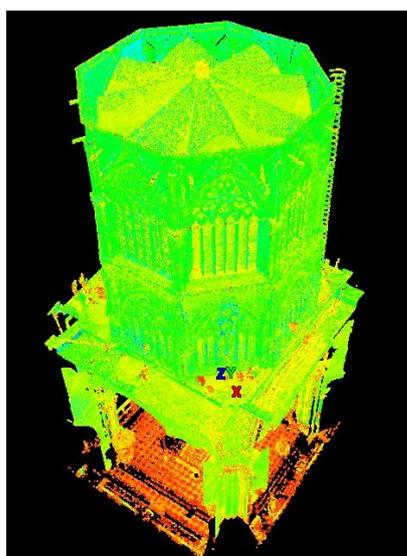
Figure 6: Image obtained with Laser scanner technique

Based on the graphic geometric survey obtained from the laser scanner, a 3D model was generated by CAD applications that allowed us to create a calculation model based on a solid finite elements mesh to reproduce the 3D geometry of the Cimborio, with a total of 249252 d.o.f, 47615 solids, distinguishing between 2191 tetrahedral and 45424 hexahedral elements (figure 6, 7 & 8).

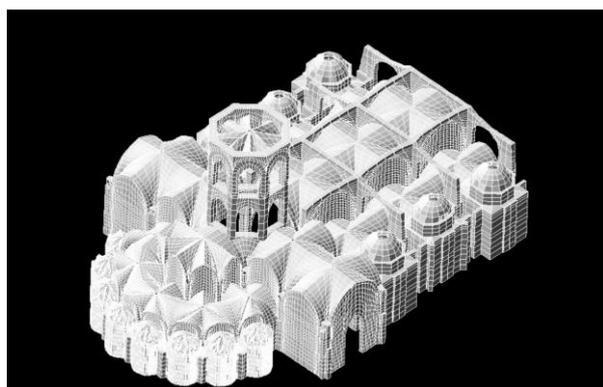
Figure 7: 3D Cathedral and the solid finite elements mesh models.

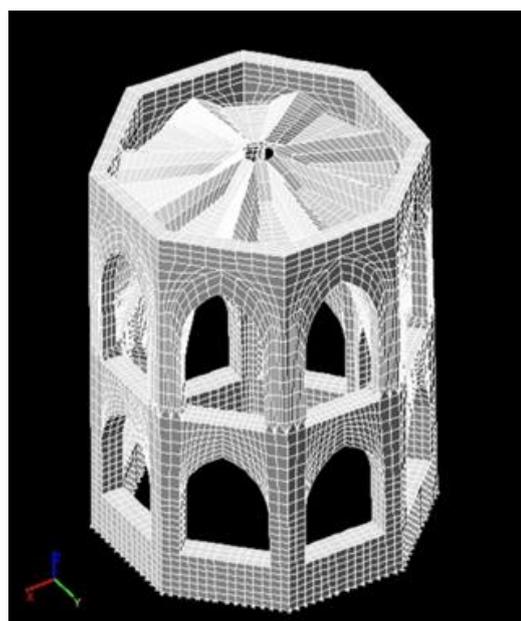
Figure 8: 3D model of the Cimborio and the solid finite elements mesh model

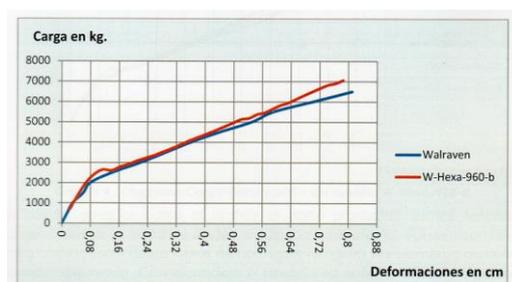
Figure 10: Load-Deflection, comparative between the experimental and numerical model

Described model has been implemented in ANGLE software by the authors. Attempting to calibrate this model with ashlar tests it results extremely difficult due to calibration is made with experimental concrete models, those are concrete elements with a similar behaviour to masonry, particularly Walraven [6] tests on a reinforced concrete beam have been employed, and the tests made at University Polytechnic of Valencia by Valcuende and other authors [7] about concrete non-reinforced beams. (Figure 10&11)

The results of the developed numerical model have a precise adjustment to the experimental results:

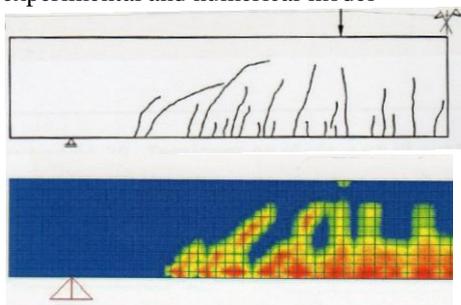
Figure 11: Strength distribution and cracking map

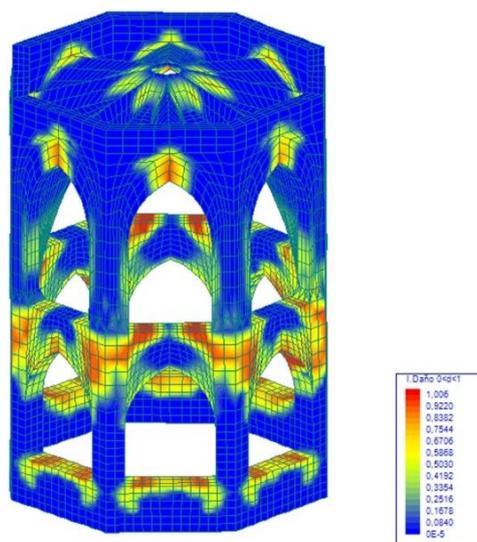
Figure 12: Model of damage dead load

It has been developed a non-linear static analysis of the Cimborio model. The most important parameter of the stability of the structure is the masonry tensile strength. As we do not have very reliable tests, it is considered the average strength values, which have been obtained from different authors. The model has been processed under two conditions. Firstly, we have used a 0,05 N/mm² tensile strength, which is a much lower value compared to the reference one. This is a hardly null value compared to 0,1N/mm² used in a second analysis (*figure 12*).

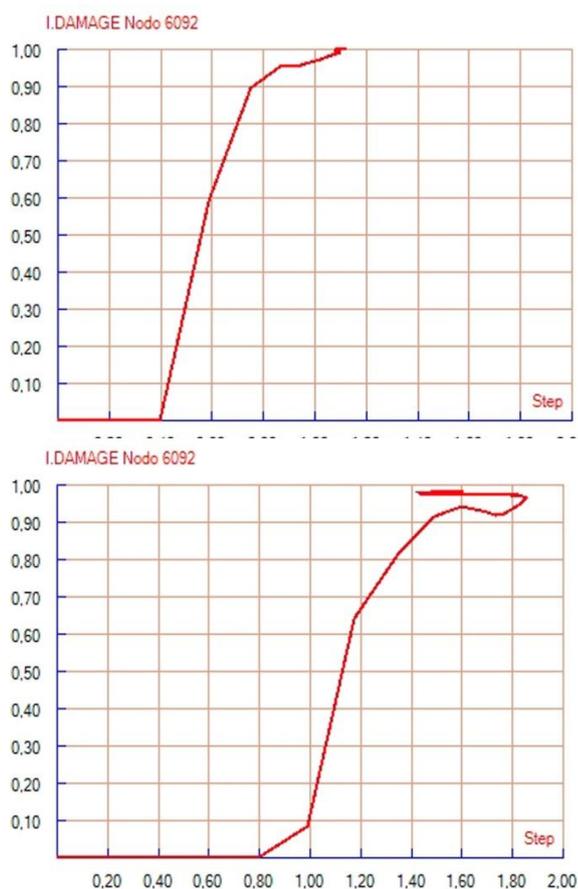
Figure 13: Two hypothesis of analysis with 0,05N/mm² and 0,1N/mm² tensile strength respectively

In order to study the results, the damage formulation is considered as the most important parameter in the structural behaviour. The damaged parts of the structure are compared under the two hypothesis described and it is found out that the safety margin of the structure is very low in the hypothesis with 0,05N/mm² tensile strength. For this reason the structure degrades and starts to break down at a load of 1,05 its own weight. Whereas in the hypothesis with 0,1 Mpa, the safety margin of the structure is bigger, getting a safety coefficient of 1,60 its own weight (*figure 13*).
