A study on re-deterioration of surface-coated sluice structures due to frost damage

I. Naitoh & F. Taguchi

Civil Engineering Research Institute, Sapporo, Japan

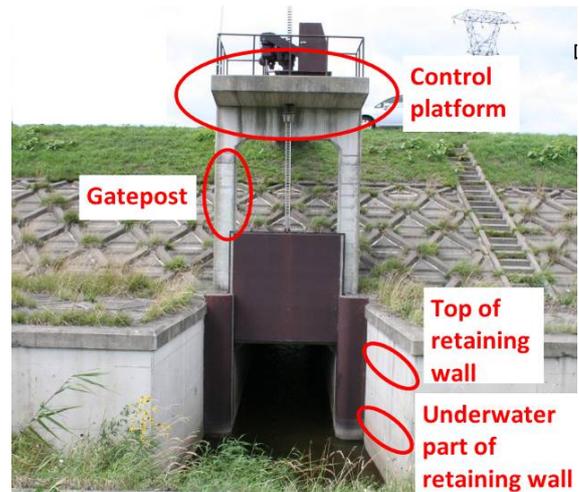
Photo 1. Sluice parts examined.

Photo 1 shows the sluice parts examined (i.e., the control platform, gatepost and retaining wall). Two parts of the retaining wall (top and underwater) were examined. The degree of frost deterioration in sluice concrete was evaluated using an appearance rating method as shown in Table 2. The appearance

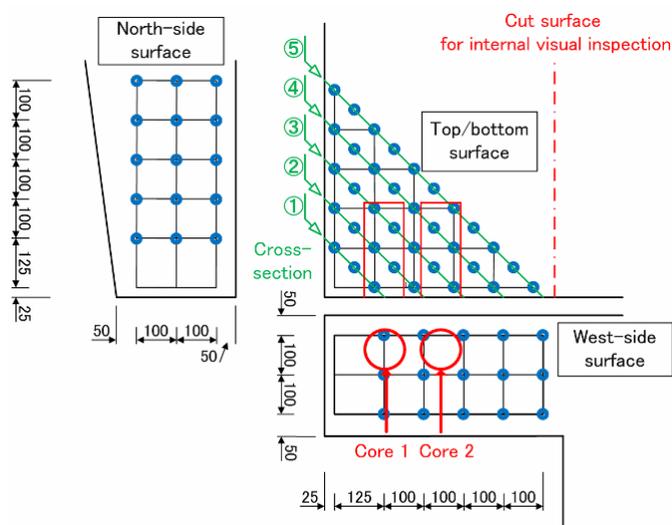
Figure 2. Tomography measurement sections and core positions.

After Ultrasonic Propagation Velocity Measurement, a part near the measurement sections was cut off (Fig. 2) and the repair and deterioration conditions under Surface coating material were visually observed from the cut surface for comparison with the results of analysis based on Ultrasonic Propagation Velocity Measurement and Adhesive Strength Test Method.

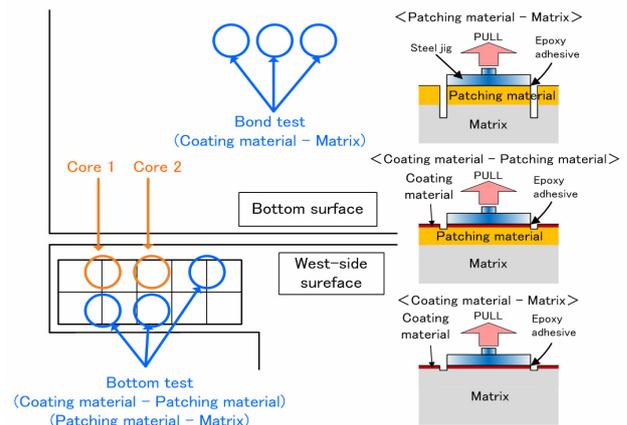
Figure 4. Adhesive Strength Test Method positions and test patterns.

Figure 10 shows Adhesive Strength test Method results. Adhesive Strength between Surface coating material and Patching material was 1.630 N/mm^2 . The catalog standard value is 1.5 N/mm^2 or larger. Since NEXCO's (Nippon expressway Company) quality standard (JHS-416) (NEXCO.2004) for Patching materials (known as the common reference values for Adhesive Strength in Japan) specifies Adhesive Strength between Surface coating material and Patching material as 1.0 N/mm^2 or higher and that between Patching material and concrete as 1.5 N/mm^2 or higher, Adhesive Strength assessed in this study can be considered sufficient. However, Adhesive Strength values between Surface coating material and Matrix and between Patching material and Matrix were very low (0.507 and 0.404 N/mm^2). In these sections, fracturing occurred in the deteriorated Matrix but not in the adhesive surface with Matrix, as shown in Photo 3. Since external influences had been blocked until cracking in Surface coating material occurred 18 months after the repair, deterioration in sound Matrixes was unlikely at the post-repair stage. Accordingly, it was highly likely that the deteriorated parts of Matrix remained at the time of repair.

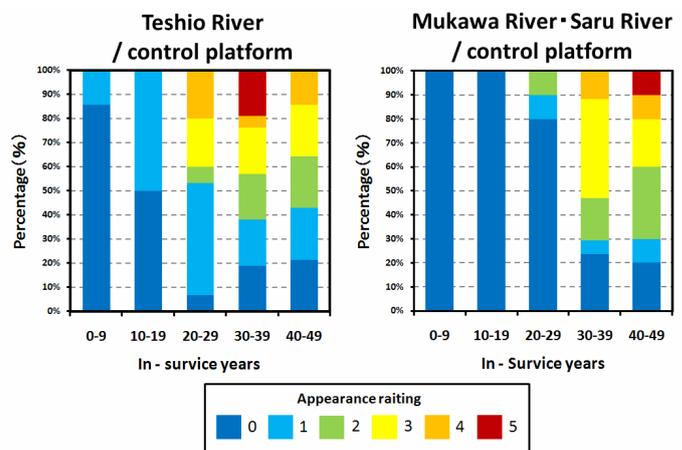
Figure 6. Appearance ratio of each sluice control platform by the number of in-service years.

Figure 5 shows the results of appearance rating by section based on external visual inspection, and Figure 6 shows the results of control platform appearance rating by the number of in-service years. By part, the control platform rating was generally the highest, followed by the underwater part of the retaining wall, the top part of the retaining wall and the gatepost. Control platform frost deterioration was especially severe, with a rating of up to 5 in some cases. Since control platforms have a shape on which snow is likely to accumulate and their structure is relatively thin, they are more susceptible to the influence of freeze-thaw action caused by the retention of snowmelt and other factors. Conversely, gateposts are not susceptible to freeze-thaw action as they stand behind control platforms and are minimally exposed to snow accumulation and sunlight. It was found from this that parts directly affected by water supply are also affected significantly by freeze-thaw action, and that the degree of deterioration found in them increases.

By region, the ratio of parts rated three or higher was generally greater on the Mukawa and Saru rivers than on the Teshio River, although no ratings of four or higher were observed except for control platforms. Conversely, while some gateposts and retaining walls were rated four on the Teshio River, the ratio of lower ratings was generally higher compared with those of the Mukawa and Saru rivers. Looking at the number of in-service years, ratings tended to be higher for structures that had been used for 20 years or more on the Teshio River and for 30 years or more on the Mukawa and Saru rivers. It can therefore be said that frost deterioration progressed faster and its degree tended to be greater in the Kamikawa region, while the phenomenon tended to

occur regardless of part types in the Hidaka region, although the progress of deterioration there was slower and no significant deterioration was observed. Figure 7 shows the repair and re-deterioration rates in the two regions. While the repair rate was around 20% in both, re-deterioration occurred in more than half of the sluices after repair. It also occurred in all surface-coated sluices in both regions.
