MULTILEVEL DETECTION OF DAMAGE AND REPAIR IN HEALABLE POLYMER-MATRIX COMPOSITES

Key words: Composites, Damage, Self-healing, Acoustic Emission Technique, Digital Image Correlation, Tensile Test

Abstract: We present some results obtained in the ongoing research project entitled “*IN MOOSHEAC - INnovative damage MONitoring Of Self-HEaling Composites by acoustic emission in civil and aerospace applications*”. The research program aims at utilizing Nondestructive Evaluation (NDE) techniques for monitoring the healing process of healable composites and to investigate their structural properties post healing. In this campaign, samples of composite thin rectangular strips were designed and manufactured on purpose, and then tested in the lab under tension. The samples were supplied by a company that has developed a new type of resin - HealTech™ - giving composite materials the ability to heal micro cracks and delamination in about one minute after a localized heat supply. Acoustic Emission (AE) technique was used to detect damage, while Digital Image Correlation (DIC) was adopted to measure surface deformation. Data from both techniques were employed to assess material repair.

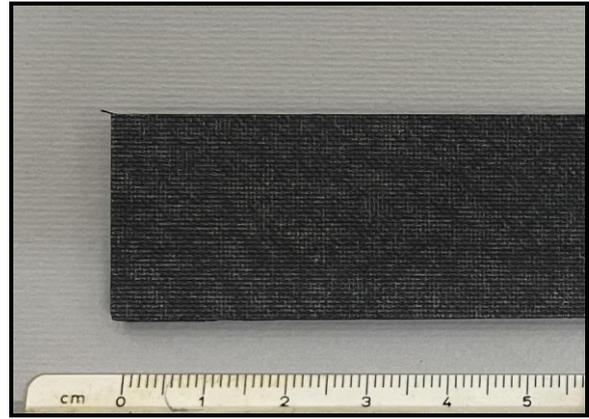
The samples analyzed (Figure 1) consisted of strips with the following average dimensions: 25 mm on the short side, 250 mm on the long side, and a thickness of 3.5 mm. The sample comprised a double layer of carbon fibers arranged in the orientations of 45°/0°/-45°/90°.

Figure 1: Detail of one of the specimens utilized.

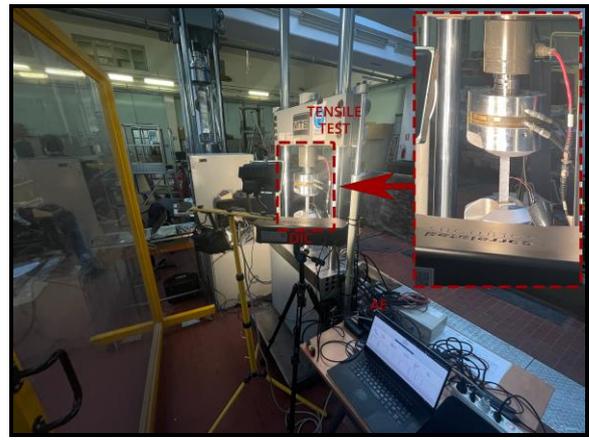
Figure 2: Detail of test setup and apparatus.

The samples underwent three distinct tests concurrently (Figure 2): tensile tests in displacement control utilizing a servo-hydraulic universal machine by MTS equipped with a 100 kN load cell; acoustic emission (AE) technique employing a single sensor (model LT18-003-PRD00-R0, Lunitek SrL, Sarzana, Italy, with a frequency range of 15–625 kHz) positioned at the exact center of the sample, along with a data acquisition system using a sampling frequency of 5 MHz and storing the data in a parametric format, for damage detection; and digital image correlation (DIC) to monitor strain distribution in the samples, utilizing two monochrome cameras (VIC-EDU System) set to capture images every 2 seconds under optimal lighting and focus, with data analysis conducted using VIC-3D software (both from Correlated Solutions®).

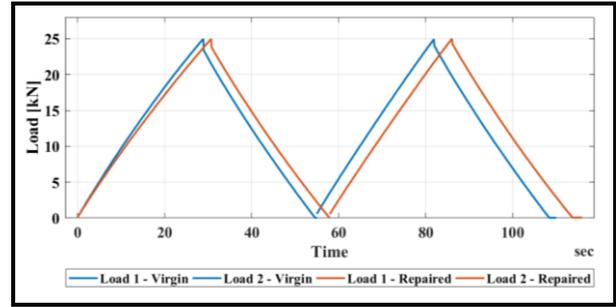
Figure 3 shows the load - unload sequence for the virgin and repaired versions of the sample (Load 1 and Load 2 indicate the two consecutive loading steps).

Figure 3: Load - time of the tensile test.

As previously shown in Figure 3, the force was applied and removed twice in the tensile test. From the Figures 4 and 5 it is possible to verify that the sample holds a residual deformation after each stage of applied force, both before and after the repair process. Moreover, the stiffness of the repaired version is lower than that of the virgin version.

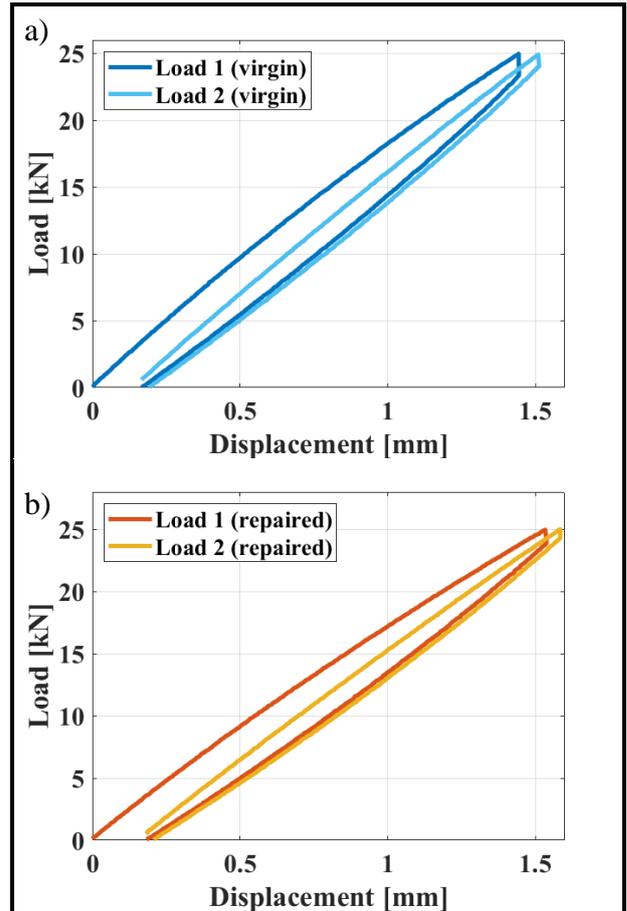
Figures 4a and 4b show the load vs displacement curves for the virgin and repaired versions of the sample, respectively

Figure 4: Load-displacement response from the tensile test for the virgin (a) and repaired (b) versions.

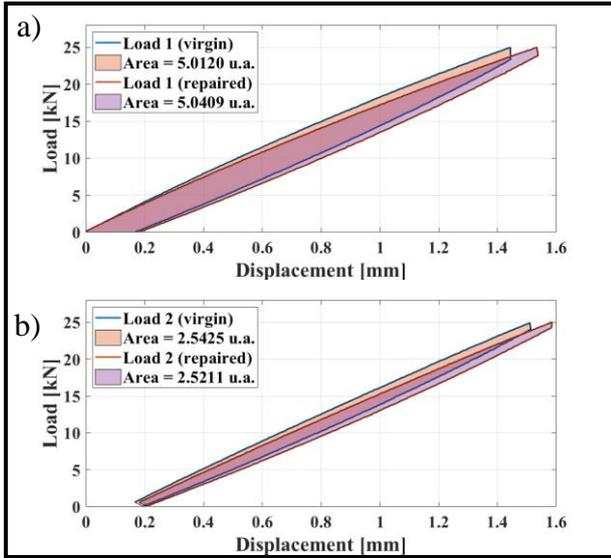
The responses of the virgin and repaired versions are compared in Figure 5, where the curves are grouped by load steps. In the same figure, the areas enclosed in the load - displacement curves are highlighted with indication of their measures. We can observe that: (i) for each load step, the areas of the virgin and repaired versions are similar; and (ii) the area enclosed in Load 2 step is smaller than that of Load 1 step.

Figure 5: Load-displacement response and area for the Load 1 (a) and Load 2 (b) steps. (u.a. = unity of area).

The results from tensile test also show that the sample holds a residual deformation after each unload. This holds both for the virgin and repaired versions. Moreover, it can be noted that the repaired sample shows a lower stiffness compared to its virgin version (Figure 5).

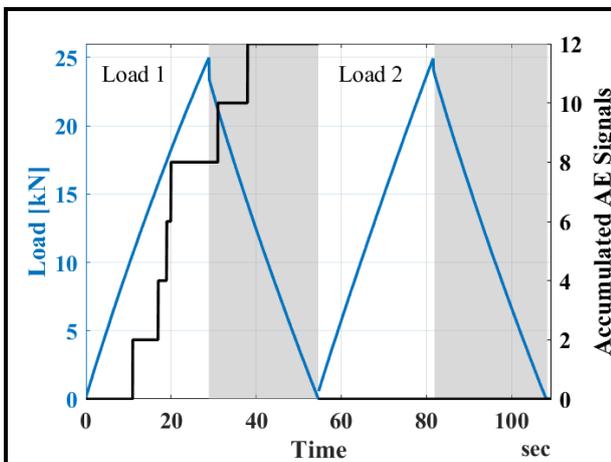
To analyze the evolution of the AE signal during the tensile test, a threshold amplitude of 6.7 mV was established. Figures 6 and 7 show the load and the accumulated AE signals plotted vs time for the virgin and repaired versions, respectively.

Figure 6: Accumulated AE Signals for the virgin sample.

For each version of the sample, Load 1 step exhibits more AE activity than Load 2 step, highlighting the absence of AE signals in the Load 2 step for the virgin sample (Figure 6). Furthermore, when considering the AE activity for both the virgin and repaired versions, it is evident that the repaired version displays a greater number of AE signals compared to the virgin case. Specifically, the repaired version presents a total of 33 (25 + 8) cumulative AE signals, while the virgin version shows only 12 (12 + 0) cumulative AE signals.

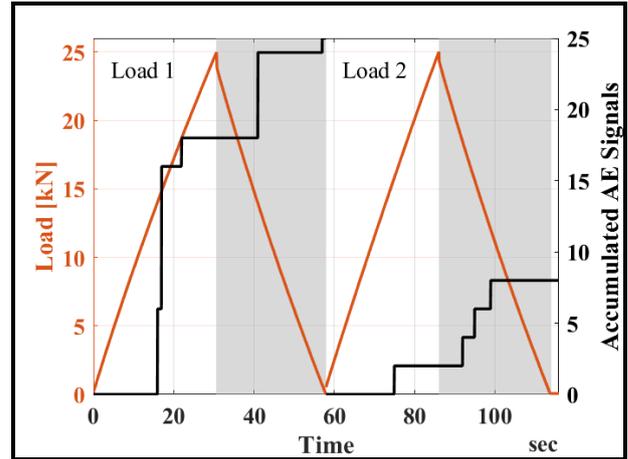
Figure 7: Accumulated AE signals for the repaired sample.

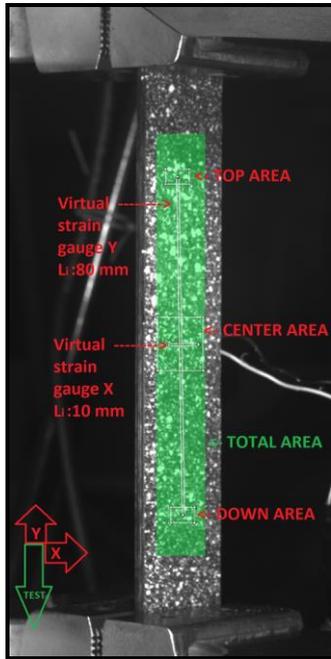
For the post-processing in VIC-3D, for each specimen the area of interest (green area in Figure 8) was defined, then within it three other sub-areas (top, center, down) were identified and two virtual strain gauges added: one longitudinal of length 80 mm and one transversal of length 10 mm. The region designated for strain calculation was effectively divided into subsets of sufficient size to encompass enough distinctive pattern information, differentiating it from adjacent areas. Given the small dimension of the speckle, the subset size was determined to be 29. The step size, which dictates the pixel distance between each data point, was established at 1 (the minimum) to increase the number of data points, even though this resulted in a longer analysis duration. The final operation involved establishing the initial point for the analysis, ensuring that correlation

Figure 8: Detail of test setup and apparatus.

A detailed analysis of the longitudinal deformations reveals that the average deformations align with the elongations observed in the virtual extensometer depicted in Figure 8. Moreover, throughout the entire region, the repaired sample exhibited higher deformation peaks than the virgin sample, attaining deformations of 0.014 (1.4%). The sample repaired in load phase 2 exhibited a maximum deformation of 1.3%, which is marginally larger than that of the virgin sample (1.2%). Upon analyzing the center and down sub-areas, it is evident, particularly in load phase 1, that the repaired sample exhibits a deformation consistent with that of the virgin sample, thereby underscoring the repair that has occurred. A comparable phenomenon

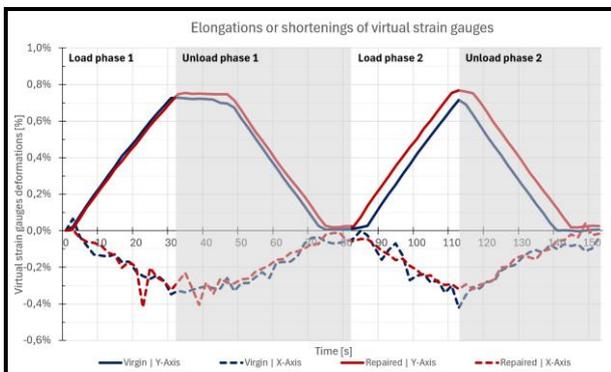
Figure 9: Elongations or shortenings of virtual strain gauges over time.

Figure 9 shows the percentage elongations and contractions of the virtual strain gauge during the test. Figure 10 displays the longitudinal strains for the entire area, along with the upper, central, and lower sections. In both figures, the values for the unaltered (virgin) specimen are in blue, while the repaired specimen values are in red. The average values are represented by a solid line, while the maximum values recorded in the analysis area at that specific moment are

Concerning the elongations along the Y-axis, it was evident that during load phase 1, the trend of the repaired sample aligns with that of the virgin sample. The repaired sample exhibits a marginally elevated percentage of deformation, indicating residual deformation consistent with the tensile test results. The elongation along the Y-axis in load phase 2, in terms of percentage and behavior, aligns with phase 1. Upon completion of the tests on the repaired samples, a residual deformation of approximately 0.03% is observed. The recorded shortenings along the X-axis of the virtual extensometer are less linear than those along the Y-axis; this can be ascribed to both the small size of the cross-section and the fact that the transverse virtual extensometer pertains to a specific section of the sample.

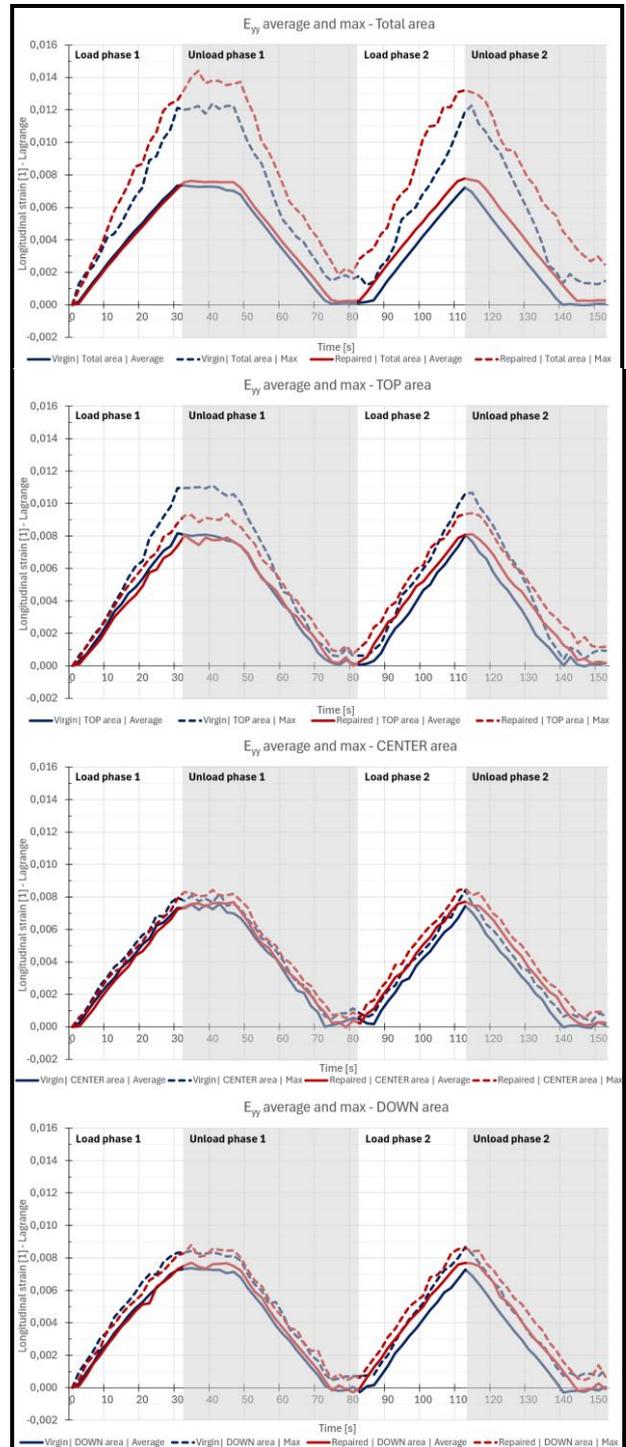
indicated by a dotted line. The four phases of the test have been delineated into white and grey areas, specifically: loading at 25 kN, unloading, reloading at 25 kN, and finalizing the unloading process.

Figure 10: Longitudinal strain (E_{yy}) value over time, from top to bottom respectively total area of interest, top area, center area, down area.

transpired in the top sub-area, where there was a decrease in the maximum deformations of the repaired sample, diminishing from a peak of 1.1% to approximately 0.9%, thereby indicating an enhancement (recover) in local performance attributable to the repair (note that maximum strains do not necessarily occur at the same point).

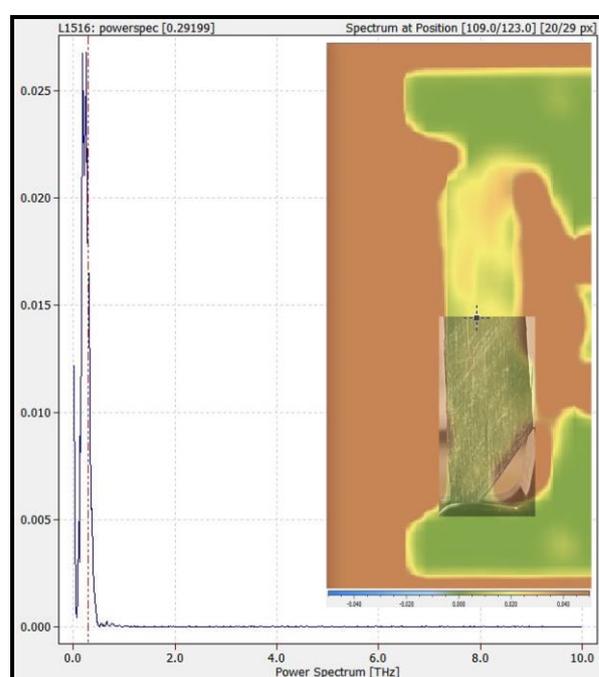
In anticipation of future investigations, Figure 11 shows the THz power spectrum (in transmission setup) of the center point of the fragment, showing the highest peak at 0.29 THz; on the right, a 2D image of the whole fragment at that specific frequency is shown.

Figure 11: THz fragment power spectrum and 2D image at 0.29 THz.
