COMBINATION OF INSPECTION AND MONITORING TECHNIQUES FOR THE DETECTION OF FRACTURES IN CONCRETE WITH SELF-HEALING PROPERTIES

CHRISTIAN U. GROSSE^{*}, FABIAN MALM[†]

Key words: NDT, fractures, self-healing, acoustic emission, ultrasound, vibration analysis

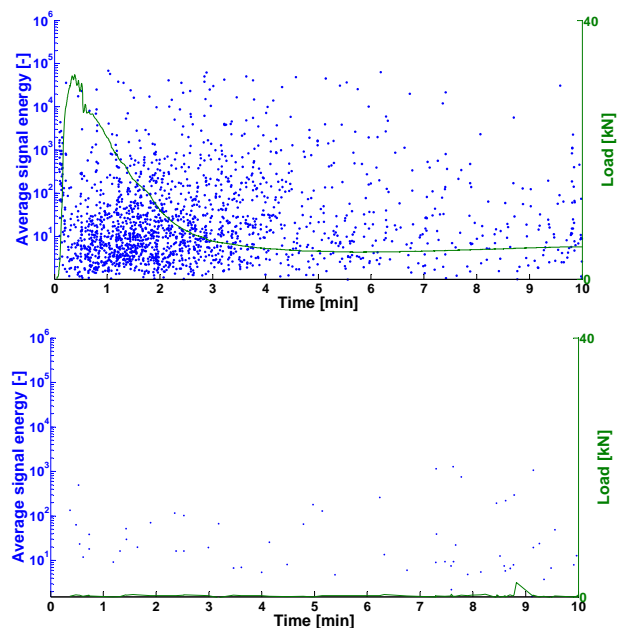
The AE activity during the initial and final loading is shown in the two graphs of Fig. 3 for the reference specimen (“REF”) and the two graphs of Fig. 4 for a concrete specimen with encapsulated polymeric healing agents (“PUR”) along with loading curves.

Fig. 3: REF specimen: initial cracking of the specimen (top) and re-cracking after reload (bottom)

During initial loading (upper graphs), many AEs occur with high energies in the peak and post-peak period due to fracture processes.

During reload the reference specimen exhibit no strength regain and only a few AEs with lower energies are observed (Fig. 3, bottom). The PUR specimen instead reveals a regain in strength and an increased number of AEs with higher energies (Fig. 4) compared to REF. A localization of the AEs of the PUR sample (Fig. 5, top) confirms that the emitted elastic waves emerge from polymeric fractures at the interface. Fluorescent pigments trace the distribution of the polymers after fracturing to make them more visible (Fig. 5, bottom).

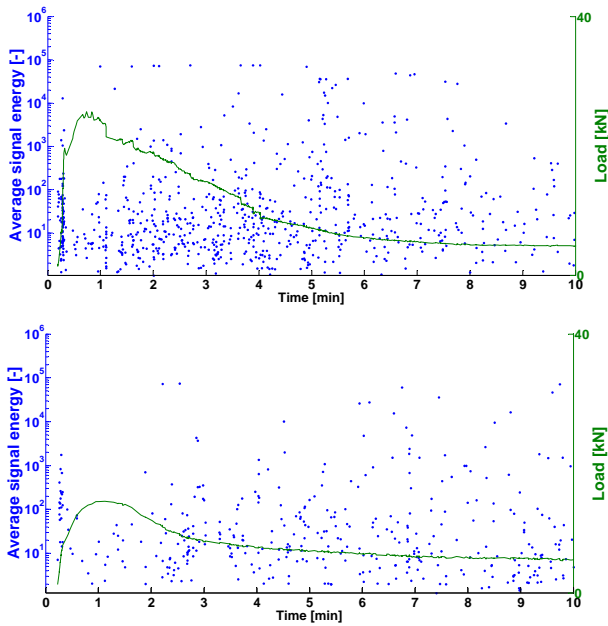
Fig. 4: PUR specimen (4 pairs of capillaries with embedded healing agents): initial cracking of the sound specimen (top) and re-cracking after reload (bottom)

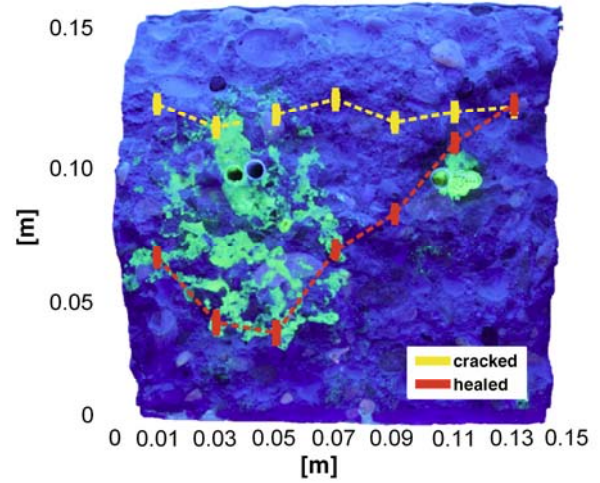
Fig. 8: Cross-section: Determined crack depth after cracking (blue) and after curing of the PUR (green)

Fig. 8 displays (yellow curve) the calculated crack depth as a result of delayed onset times on seven parallel transmission paths (0.01-0.13 m) along the cross-section. The three-point bending causes a nearly monotonic crack line along the specimen's width. Due to the wedge-shaped crack fracture a clearly visible determination of the final crack tip is impossible. After seven days of curing the ultrasonic transmission measurements were repeated (red curve). The polymer filling finally leads to a rebond of the crack flanks identified by shortened time delays of the propagating acoustic waves. Subsequently, the crack depth decreases at these locations where the polymer flows and hardens.

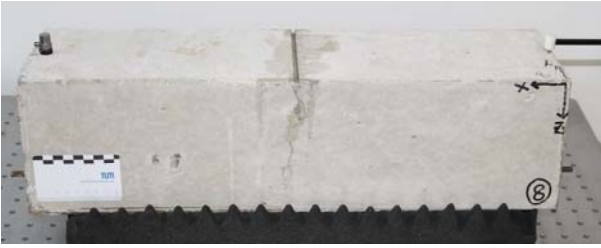
The setup for vibrational testing for a typical measurement using the specimen mentioned in section 2 is shown in Fig. 9 where the instrumented impulse hammer is visible at the right and the modal sensor at the left side.

Fig. 9: Determination of the dynamic flexural modulus vibration analysis

Similar to ultrasonic testing measurements at three different states have been performed to determine the healing efficiency: initial, cracked and healed. By the mechanical excitation of the entire concrete beam using e.g. an instrumented vibration hammer, resonance frequencies help to determine the longitudinal, shear and flexural elasticity moduli. In the cracked state all moduli decrease compared to the initial state due to the weakening of the structure.
